LUGGAGE COMPARTMENT DOOR GARNISH SUB-ASSY OUTSIDE

760BX-03

REPLACEMENT

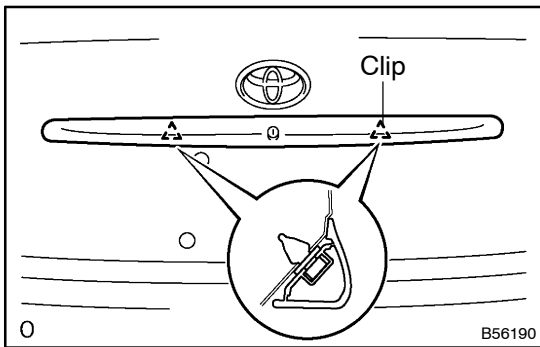
1. REMOVE LUGGAGE COMPARTMENT DOOR COVER

- (a) Remove the 15 clips and luggage compartment door cover.
