SPEAKER CIRCUIT

CIRCUIT DESCRIPTION

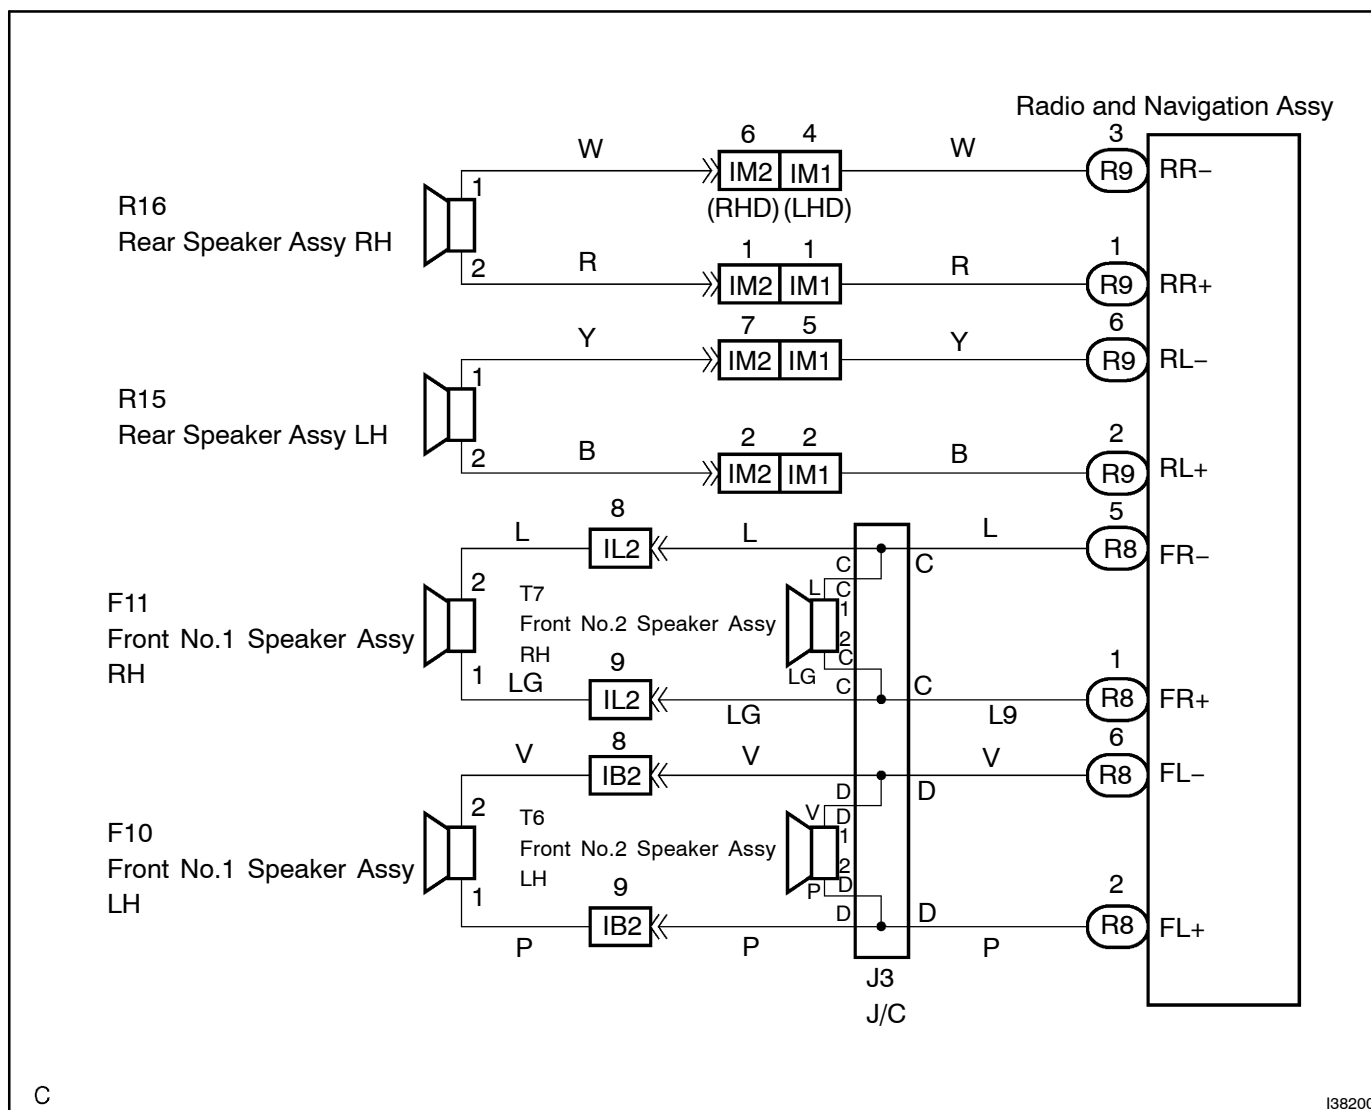
WIRING DIAGRAM

The sound signal that has been amplified by the stereo component amplifier (built in the radio and navigation assy) is sent to the speaker from the stereo component amplifier (built in the radio and navigation assy) through this circuit.

If there is a short in this circuit, the stereo component amplifier (built in the radio and navigation assy) detects it and stops output to the speaker.

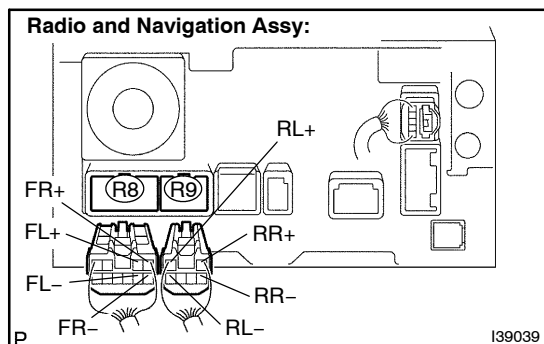
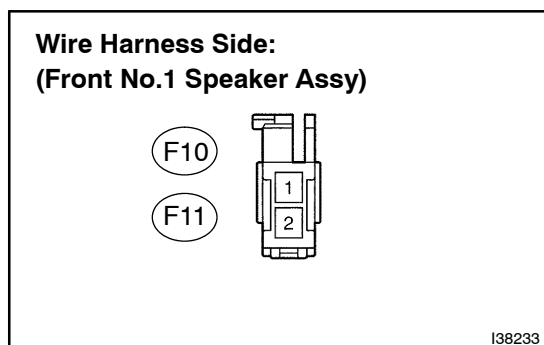
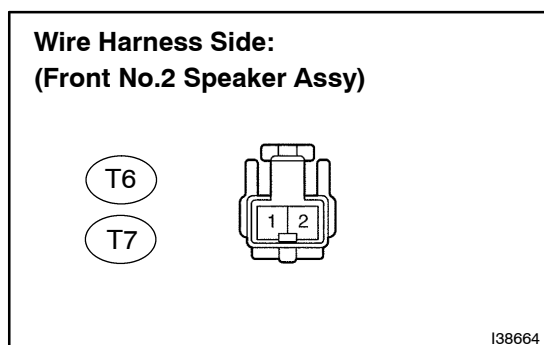
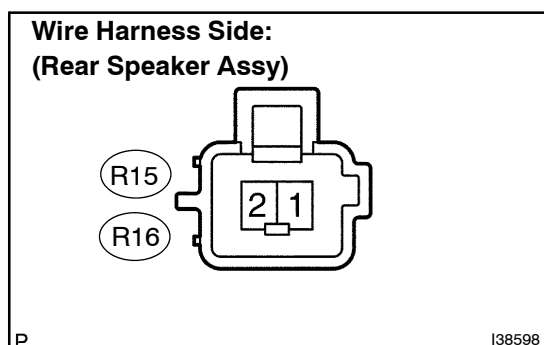
1 CHECK HARNESS AND CONNECTOR(RADIO AND NAVIGATION ASSY – SPEAKER ASSY)

- Disconnect the connectors from the radio and navigation assy R8, R9 and speakers.
- Measure the resistance according to the value(s) in the table below.

Standard:

REPAIR OR REPLACE HARNESS OR CONNECTOR
