# Repair of post-tensioned precast beam to column connections

## SUMMARY

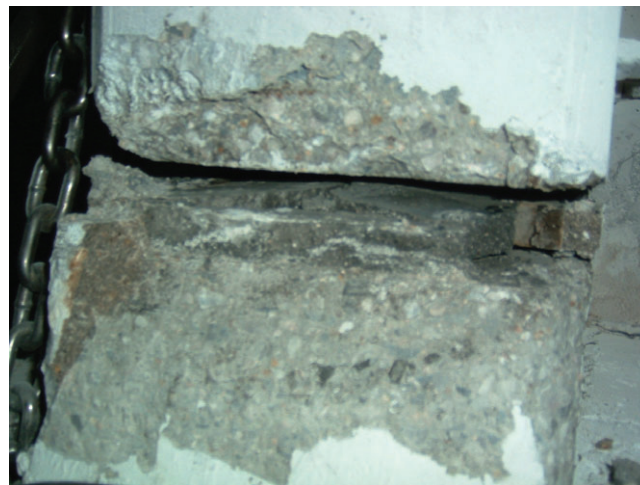
Figure 5. Cracking of the corbel of the AP1R test specimen.

The loading capacity of AP1R specimen at 1.5% drift in the forward direction was 1.4 kN more than its load capacity in the backward direction. At the end of the test, the loading capacity of AP1R specimen in the forward direction was 9 kN more than its loading capacity in the backward direction. The initial stiffness of the AP1R specimen in the backward and forward loadings was seen to be higher than the initial stiffness of the reference specimen. After load of nearly 7.8 kN, the epoxy filling between the column and beam from the surfaces of the column and beam began cracking and this caused a decrease in the stiffness of the specimen. The experimental specimen continued to carry the load during the later cycles at a lower stiffness. Excessive damage was not observed at the concrete side of the specimen during the test. The bottom edge of the beam touching the corbel at the corbel side was crashed. The cracking of the concrete at the bottom part of the beam and grout caused 5-kN load loss in the specimen at this loading (Figure 5).

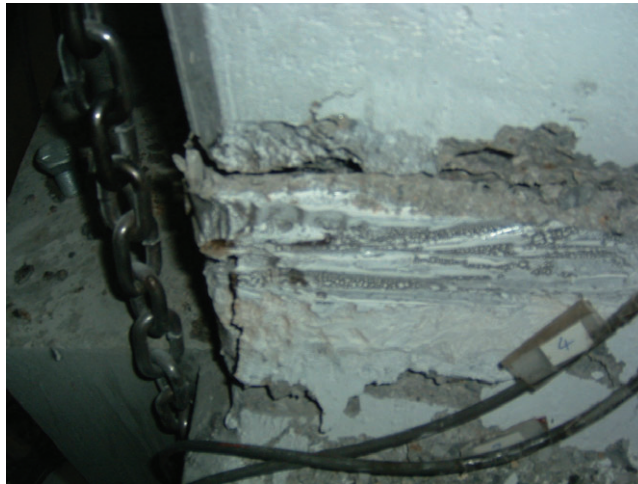
Figure 6. View of connection of the BP1R test specimen after experiment.

The loading capacity of BP1R specimen at 1.5% drift in the forward direction was 1.9 kN less than its load capacity in the backward direction. At the end of the test, the loading capacity of the BP1R specimen in the forward direction was 1.3 kN more than its loading capacity in the backward direction. The initial stiffness of the BP1R specimen in the backward and forward loadings was seen to be lower than the initial stiffness of the reference specimen. When the load applied to the specimen reached nearly 7.4 kN, the loss of the initial stiffness of the specimen increased. The reason for this loss was the cracking of the epoxy resin present in the connection from the bottom surface of the beam. Due to the cracking of the epoxy resin on this surface, a loss of stiffness was observed in the specimen. At the end of the test, no serious damage was observed in the connection of this specimen (Figure 6).

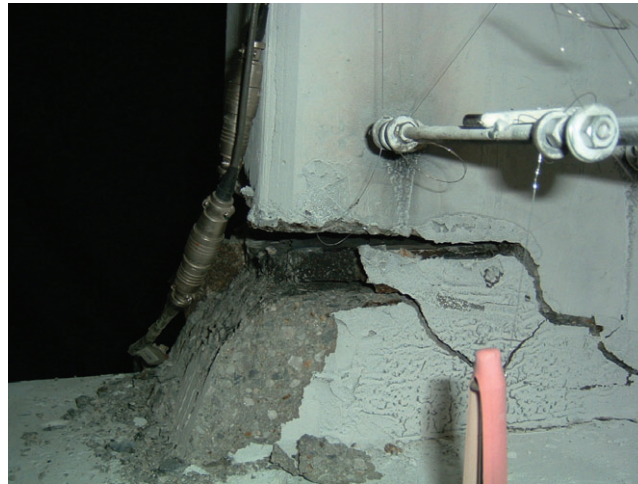
Figure 8. Fallen state of the parts of the concrete at the upper corner of the corbel of the DP1R specimen.

The experimental specimen continued to carry the load during the later cycles at a lower stiffness. The bottom edge of the beam touching the corbel at the corbel side was crashed during the backward loading of the last cycle. The cracking of the concrete at the bottom part of the beam caused a 6-kN load loss of the specimen at this loading (Figure 8).
