Microstructural and Fractographic Aspects of Corrosion Fatigue

J. I. Dickson, Li Shiqiong, and J.-P. Baïlon

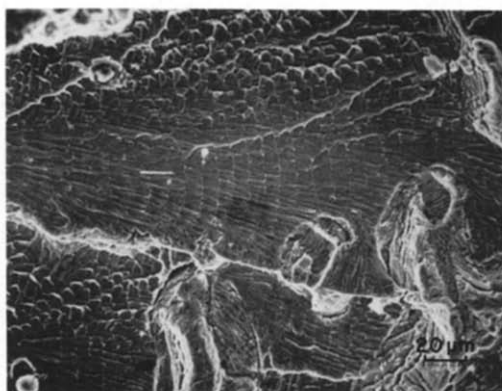
FIG. 13. Corrosion-fatigue fractographic aspect of the ferritic phase of duplex KCR 171 stainless steel tested in white water [26]. The brittle striations have a less brittle aspect near the large river lines, associated in part with a change in the inclination of the average local orientation of the fracture surface. The more ductile aspect observed here results from a greater amount of ductile stretching accompanying cracking.

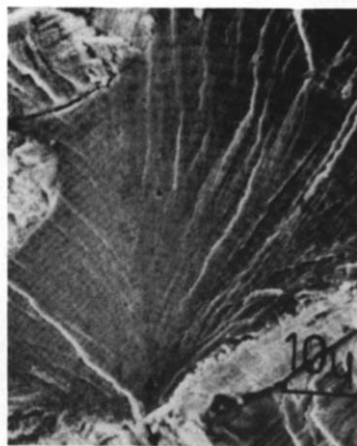
FIG. 17. Initiation, at α - γ interface, of cleavage-like corrosion-fatigue cracking in a ferritic grain of KCR 171 ahead of the macroscopic crack front. The ductile striations in the austenitic grain on the other side of this interface indicate local cracking propagating back toward the macroscopic crack front.

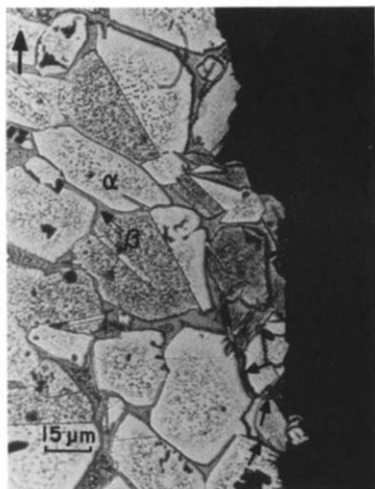
FIG. 20. Metallographic section at a corrosion-fatigue surface of a 12% Mn-8% Al-2% Ni bronze in the SC condition [53]. Some decohesion can be seen at α - β interfaces within 30 μm of the fracture surface.

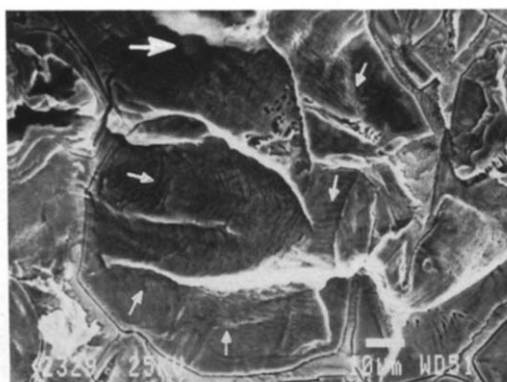
FIG. 23. The corrosion-fatigue fracture surface of the 12% Mn-8% Al-2% Ni bronze in the SC condition [51–53]. Decohesion at the α - β interfaces has proceeded ahead of the macroscopic crack front and facilitated the initiation of fatigue cracking in the adjacent α -grains. The large arrow indicates the macroscopic crack propagation direction; the small arrows indicate local crack propagation directions.

The microfractographic evidence [51–53] indicated that the accelerated corrosion-fatigue propagation for the AC and SC conditions was essentially the result of decohesion (Fig. 23) being produced during
