Rainfall-triggered debris flows following the Wenchuan earthquake

C. Tang · J. Zhu · W. L. Li · J. T. Liang

Abstract On 24 September 2008, 72 debris flows were triggered by heavy rainfall in the central part of the area affected by the Wenchuan Earthquake. This paper describes the process of debris-flow initiation and transport in the study areas and presents field observations on the roles of rainfall, lithology and the presence of faults. It is likely that following the ground shaking, the critical amount of accumulated precipitation and the hourly rainfall intensity necessary to initiate debris flow was reduced compared with values before the earthquake. A case study in the Xishanpo gully is presented; the debris flow from which caused a thick accumulation in the already devastated city of Beichuan. It is concluded that the whole of the area shaken by the Wenchuan Earthquake is now more susceptible to debris flows, which may be initiated by localized heavy rainfall. Care must be taken to properly assess this new type of geo-hazard.

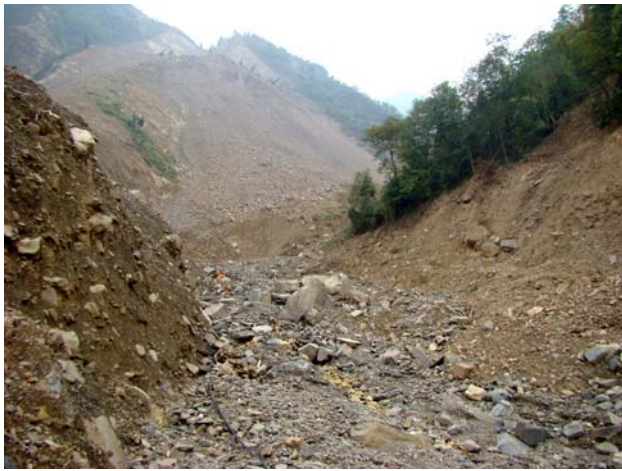
Fig. 7 Photograph of debris flow that mobilized from a landslide on the south flank of Xishanpo gully. Relief from the landslide

In the upper reaches of the Xishanpo gully, three landslides with surface areas of more than 10,000 m² were triggered by the Wenchuan Earthquake, as well as ten smaller landslides and rockfalls. The catchment area of the Xishanpo gully is delimited on the aerial photograph taken on 18 May 2008 in Fig. 6. It can be seen that the largest landslide is at 880 m to 1,200 m asl and has a length of 410 m and a width of 250 m. The average thickness is 10–15 m hence the volume of this landslide is estimated to be 1.1 million m³. It blocked the drainage channel, forming a 120 m long deposit in the gully with a height of 5–10 m (Fig. 7).

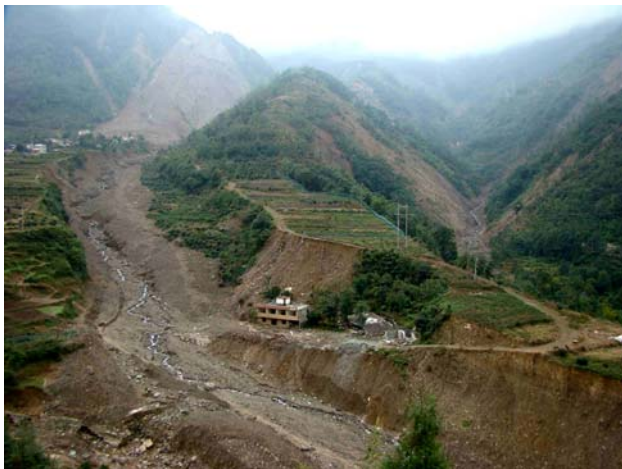
Fig. 8 Photograph showing debris flow channel deeply incised in an old alluvial fan, debris flow tracks and source areas

- 1) the first stage is the mobilization of shallow landslides. The surface runoff causes the material precariously balanced on the sides of the slopes to move into the gully
- 2) in the second stage, the overland flow of water resulting from the intense rainfall was concentrated in the steep channels and scoured the debris from the gully in a debris flow; this phenomenon has been described as the “fire hose effect” (Coe et al. 1997; Griffiths et al. 2004). Figure 8 shows the channel character of the debris flow transport path, incised in old alluvial fans.

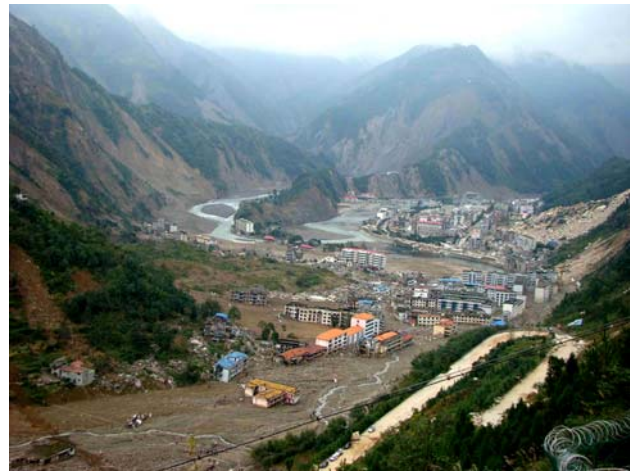
Fig. 9 Debris flows inundated old Beichuan city. Photograph taken September 24, 2008

After the debris flow moved out of the steep gully, it rushed into Beichuan old city (Fig. 9), forming an accumulation some 900 m long with a maximum width of 150–200 m. The surface area was 0.17 km² and the thickness of the deposits reached 9–12 m in the upper segments. Near the centre, the debris was 7–8 m thick, with clasts of 50–300 mm forming about 50% of the total deposit. Figure 10 shows the situation before and after the debris flow. Relatively large boulders and wood blocks are concentrated in the front part of the deposit. Comparing the property closest to the camera, it can be seen that six floors are visible on 12 June while following the debris flow deposits, only three storeys can be seen.

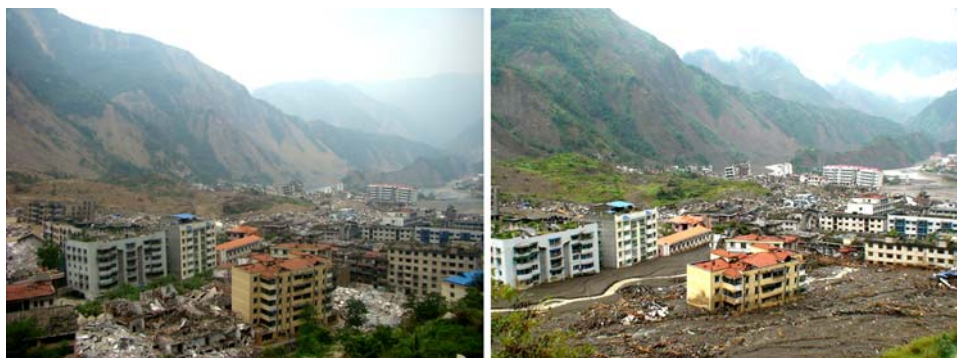
Fig. 10 Characteristics of the deposits due to the debris flow in Beichuan City (*the left photograph* was taken on 12 June, 2008; *the right photograph* was taken on 24 September, 2008)
