# Fire, Water, and Soot—A Cautionary Tale

by Stanley H. Pine

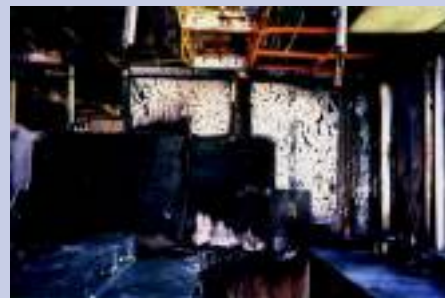
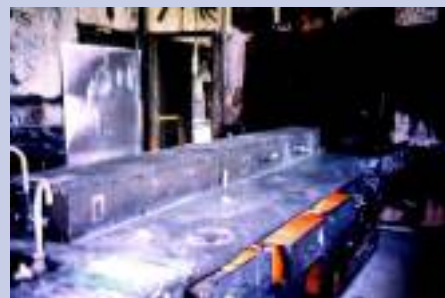
Fire damage to laboratory work benches and walls was extensive.

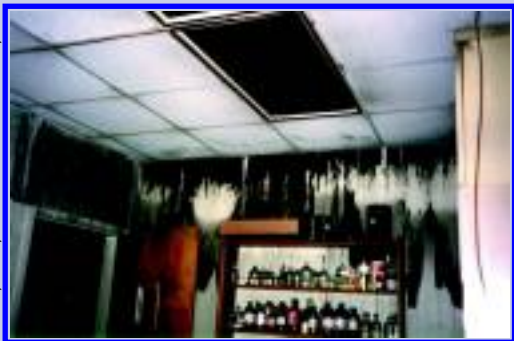
Extensive damage from soot and water-vapor condensation in a laboratory away from the actual fire zone.

The smoke damage was most impressive. Most of the seventh-floor rooms in the outer perimeter were severely blackened. It appears that a cloud of hot steamy, soot, generated in part, I believe, from the fire-fighting efforts (we have no fire sprinkler system in this 1970-vintage laboratory building), engulfed the outer perimeter of the seventh floor and then condensed on walls, ceilings, and every other surface. The long side of the rectangular building measures almost 200 feet, and soot traveled the entire distance!

What we found on the eighth floor was surprising. Initial observations suggested that, other than in the area directly over the fire zone, there was very little soot on laboratory benches and equipment. However, once the laboratory cabinets and drawers were opened, a very different picture emerged. Everything in these closed units was even more soot-covered than what we found in the seventh floor (the fire floor) cabinets. In this case, the soot and hot gases that moved through the seventh-floor ceiling plenum area also flowed upward through holes for utility pipes that led into the eighth-floor laboratory cabinets. The failure of the building contractor to seal all of these passages 28 years ago markedly increased our cleanup costs (and increased the damage from laboratory water spills over the years.)

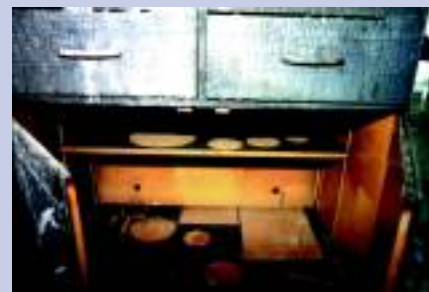
Charred outer doors were effective in limiting fire damage within a closed wooden cabinet in which containers of flammable liquids were stored.

It was interesting to see how effective closed wooden cabinets, not specifically designed for fire safety, were in protecting flammable solvents. Gallon bottles of flammable solvents in closed cabinets in the less damaged of the two burned laboratories did not ignite even though the outer surfaces of the wooden doors were deeply charred. In addition to proper fire safety cabinets, I would suggest that all flammable chemicals be stored in closed (with wooden or metal doors) rather than open laboratory shelves.

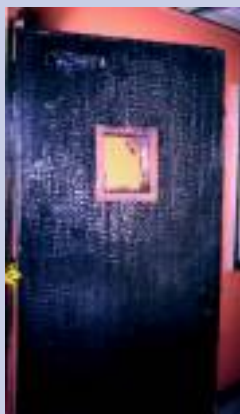
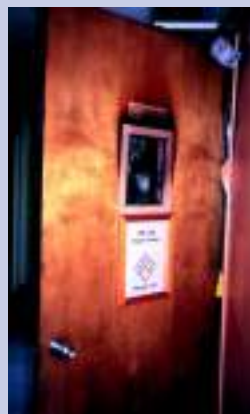
Laboratory side (burned, on left) and corridor side (right) show the effectiveness of fire safety doors. Note the safety viewing window.

Provision for fire isolation played an important role in limiting the spread and damage from the fire. Each laboratory is equipped with one or more two-hour fire safety doors. These were closed at the fire-zone laboratories and very impressively kept the fire from entering the corridor area and spreading more widely. The fire side of the doors was deeply charred, whereas on the outside (the corridor side), there was almost no evidence of fire. When we instruct people in fire safety, we always tell them to close the door as they leave the burning laboratory. That lesson was clearly emphasized by our experience. It is also a good reminder to close inner and outer laboratory doors when leaving the area.

Another feature in our laboratory safety doors is a small,

8 × 8-in. safety-glass window. We have a lot of trouble stopping students from covering the window with pictures or notes, but this experience emphasized the value of those windows. The students who first heard the ignition immediately ran toward the laboratory to see what had happened. But wisely they looked through the window and saw the room aglow in red. They did not open the door but sounded the alarm and rapidly exited the building—a very fortunate decision for their personal safety.

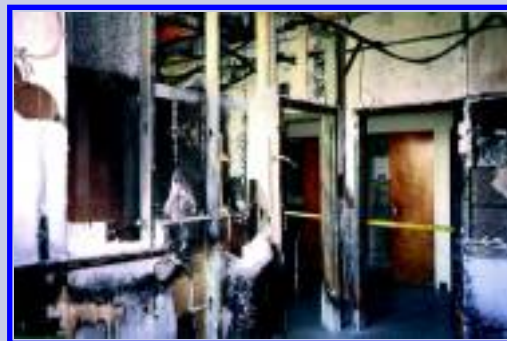
View from inside the burned lab looking toward the corridor shows how effectively the closed doors served to limit the spread of the fire.

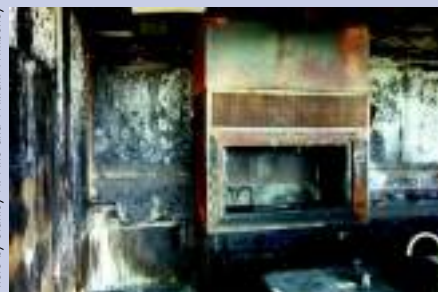
A burned hood in the laboratory adjacent to the one in which the fire is believed to have started.
