Honda City 2012

Car Detail

Inspection Date
06 Aug 2022

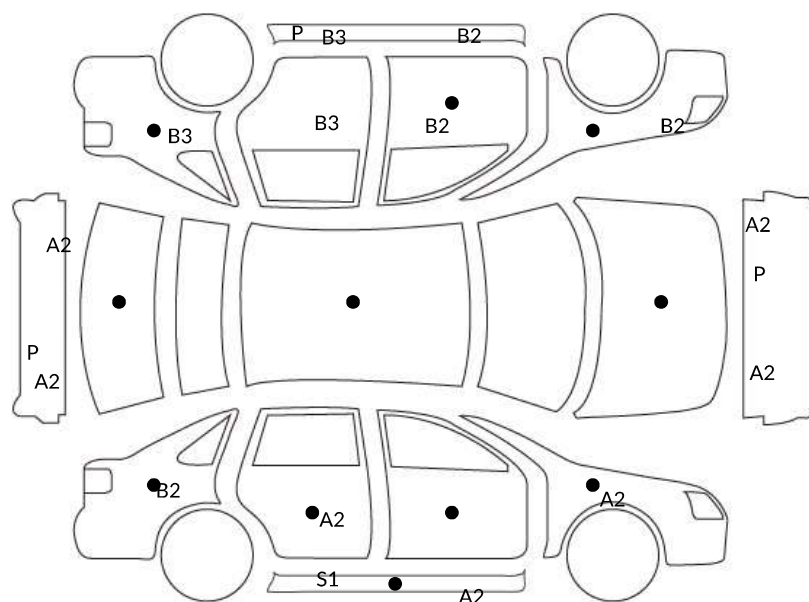
Exterior Condition

B3: Big Dent with scratch (size like elbow)

B1: Small dent with scratch (size like a thumb)

A1: Small Scratch

S1: Rust

B2: Dent with scratch (size like flat of the hand)

P: Paint marked

A2: Scratch

●: Minor Scratches/Dents

Gari ki left rail p rust ha. Gari ki body p nishan han. Normal rims ki wjha se disc pads and disc plates check krna mumkin nhi.

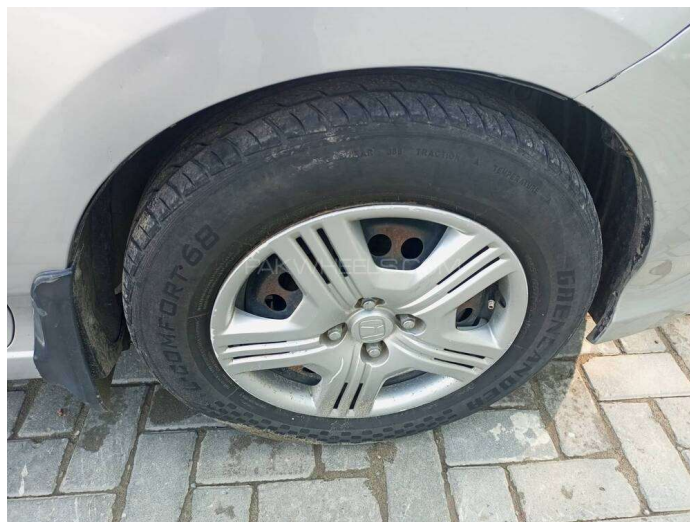
Tyres		71%	
Tyres			
Front Right Tyre ⓘ	5.2mm (remaining tread)		
Front Left Tyre ⓘ	5.7mm (remaining tread)		
Rear Right Tyre ⓘ	5.9mm (remaining tread)		
Rear Left Tyre ⓘ	5.8mm (remaining tread)		
Tyre Size	195/65/R15		
Rims	Normal		
Wheel Caps	Present
