TEMPERATURE AND HUMIDITY MONITORING AT THE LOWE ART MUSEUM

This study aimed to analyze the temperature and humidity of the Lowe Art Museum on the campus of the University of Miami, assessing how well the temperature and humidity conditions align with ideal standards for art. Using an Arduino Uno with a DHT22 sensor, 47 data points were collected across different locations within the museum. A calibration test confirmed the presence of a consistent offset in the sensor readings, thus suggesting equipment limitations and systematic errors in the experiment. Analysis of the data revealed discrepancies between the recorded and ideal values. Created heatmaps visualized a trend of higher temperature leading to a lower humidity across the museum. External perspectives were considered to find the greenhouse effect leading to higher temperatures and art materials causing humidity fluctuations. These findings emphasize the importance of environmental monitoring to ensure optimal conditions in a museum setting. Potential solutions for the museum are stated.

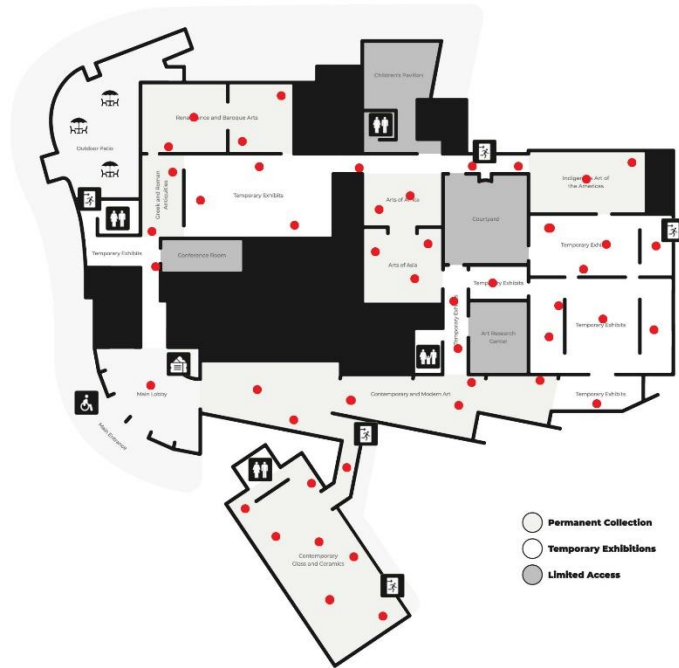
FIGURE 3: DATA COLLECTION LOCATIONS

In total, 47 data points were extracted. As shown in Figure 3.

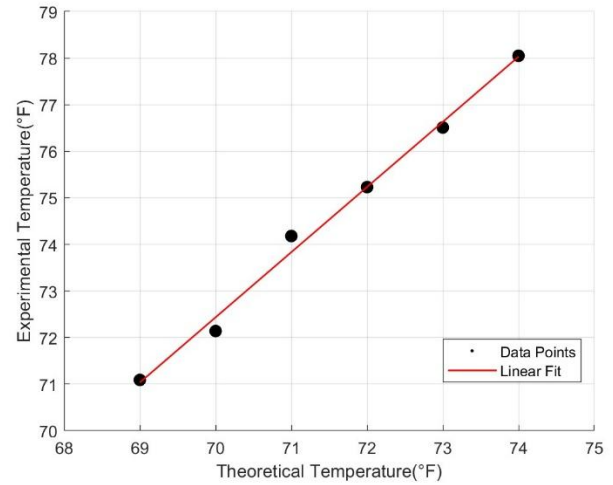
FIGURE 4: LINEAR REGRESSION OF TABLE 1

Once these values were acquired, a linear regression was run plotting the experimental against the theoretical in Figure 4.

This output an R^2 -value of 0.9935, corresponding to an R-value of 0.9967 which is the correlation coefficient for the data. This R-value is strong positive which means that it can be confidently assumed the values recorded on DHT22 have a consistent offset. This offset was then calculated using the average of the differences in temperature which comes out to a value of 3.03°F . This offset wasn't displayed in Figure 5 which highlights sources of error. After data collection, it was discovered that the temperature control systems fluctuate by $\pm 3^\circ\text{F}$, thus, showing that the offset may hold true depending on what the true temperature is in each room. Additionally, the sensor may have developed this offset from the total wear and tear that has been applied over time. Time of day also might have played a role affecting external temperature, humidity, and cloud cover. For personal errors, timing mistakes are possible as the sensor may not have been allotted enough time to adapt to new locations or calibration time not being consistent would affect the findings. For the data analysis the actual data was plotted.

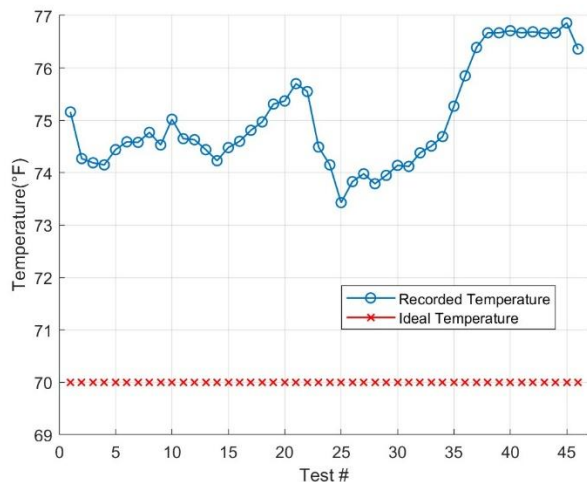
FIGURE 5: LINE PLOT OF RECORDED TEMPERATURES

The museum had data loggers in each exhibit. Surprisingly, these were not all reading the constant value provided which was 70°F . For analysis purposes, even after seeing these varying numbers it was assumed the value remained constant. The findings are demonstrated by creating line plots with markers that show the experimental and ideal temperature and humidity values shown in Figures 5 and 6 respectively.

In Figures 5 and 6, it was observed that there is a large gap between the experimental and ideal values found.

Using these plots, it was clear that standard statistical testing was pointless for the data since there was a significant difference in sample mean and sample variance. This showed that either the sensor was reading offset values, or the museum displayed

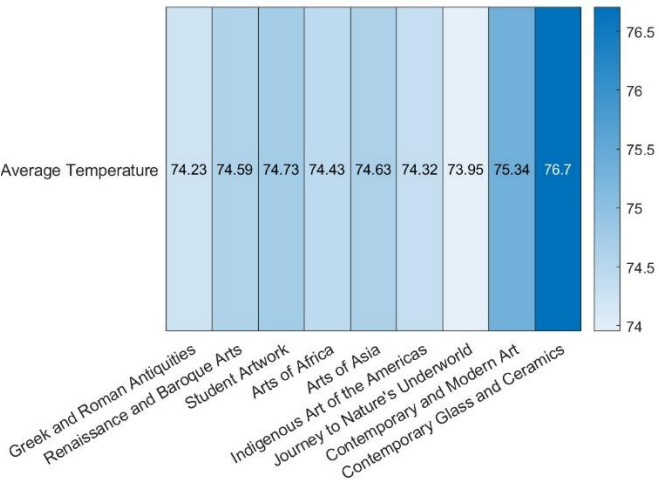
FIGURE 7: AVERAGE TEMPERATURE BY EXHIBIT (°F)

Figure 7 signifies the temperature increase in the “Contemporary and Modern Art” and “Contemporary Glass and Ceramics” exhibits. On the other hand, Figure 8 reveals that the highest humidity is in the “Greek and Roman Antiquities” with 57.5% and “Renaissance and Baroque Arts” with 58.67% which is greater than the average of 55.2%

Where the temperature was found to be lower in Figure 7, is the point of greatest humidity in Figure 8. This led to testing to examine whether the deviation in temperature and humidity was

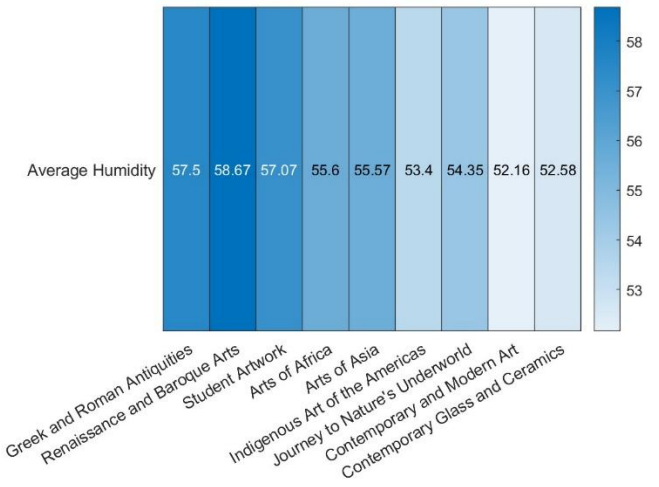
FIGURE 8: AVERAGE HUMIDITY BY EXHIBIT (%)

likely due to material composition and exhibit architecture as to what may have caused the abnormal humidities in various exhibits as shown in Figure 8 and Figure 10. These are rooted in the material science of the artwork for example the findings show the greatest humidity in the building occurred at Renaissance and Baroque arts where it was later found that almost all the pieces are either created on wood or use oil paint. Increased humidity levels should be addressed. The reason for humidity could be the wood, which has hygroscopic properties to absorb and retain moisture. This ability may also be reversed in scenarios when the air is dry the hygroscopic materials are capable of releasing moisture into the surrounding area [2]. Which in turn leads to a higher presented humidity compared to other exhibits since the wooden pieces play a heavy role in humidity control of that exhibit. However, the cross-linking potential of the oil paint attempts to oppose this dynamic. Oil paint when applied properly is capable of full cross-linking [3]. Due to oil's hydrophobic properties cross-linking makes a solid layer that can significantly reduce the amount and speed of moisture being absorbed and released [4]. This only occurs in ideal settings, the base that the oil is applied to also needs to withstand climate changes. Wood is prone to swelling shrinking and warping caused by fast changes in weathering events. The structural changes in the wooden bases commonly lead to cracks in the paint applied to them [2, 5]. In the Renaissance and Baroque arts section all the pieces have suffered from cracking. Cracking breaks the cross-linking creating channels for the moisture to flow between the wood and surrounding air. And so, the cracking of the oil paint on the wooden bases is what caused the higher humidity since the wood takes control of the humidity. This trend continued in the Journey to Nature's Underworld exhibit. However, this presented a special case scenario and that stems from the architecture perspective where the volume of this room is nearly 3 times the size of the Renaissance and Baroque section specifically with higher ceilings and no doors to separate the exhibits allowing for more dispersion of humidity decreasing concentration and providing the DHT22 with lower comparison readings throughout. Furthermore, the lowest recorded humidities occurred in the Contemporary exhibits in which roots from a combination of artwork material and architectural design that allows for lower humidity. In these exhibits none of the pieces featured the use of oil paint or wooden canvas paired with open concept exhibits with lofty ceilings spreading the water vapor in the air. To prevent any bias checks were also done on the leftover exhibits such as the Arts of Asia and Africa where observations show nearly every piece is enclosed by acrylic which causes the artwork to not affect the humidity in the same manner as the oil and wood. Furthermore, the acrylic enclosure has negligible effects on the humidity proven by their ideal humidities being 30-50% [2]. Another perspective to consider is the country of origin for art. This exemplifies the conditions the piece had to undergo when it was being created and therefore leading to a potential increase or decrease in humidity absorption in the surrounding areas [5]. The Renaissance and Baroque arts all feature European origins such as Italy and Spain. Naturally, these locations have different climate settings from Miami, FL.

Practical solutions for the museum would be to separate the wooden base pieces into separate areas of the museum. Nonetheless, this contradicts the organization of the exhibits and the featured pieces and so there needs to be a tradeoff either allowing the potential damage to the art through humidity fluctuations or to preserve the art and space out some of the collections focusing on the distancing of the wooden bases.
