2019 Tampa Bay Water Quality Assessments

A Tampa Bay Estuary Program Initiative to Maintain and Restore the Bay's Seagrass Resources

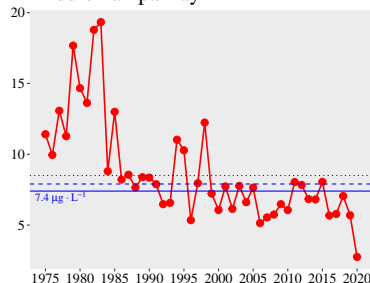
Figure 3: Historic chlorophyll-a annual averages for the four bay segments.

Water quality (chlorophyll-a and light penetration) remained supportive of seagrass in Hillsborough Bay (HB), Middle Tampa Bay (MTB), and Lower Tampa Bay (LTB)(Table 1, Figure 3). The nuisance algae, *Pyrodinium bahamense*, was again reported in Old Tampa Bay (OTB) during May - September 2019, contributing to a large magnitude chlorophyll-a exceedance that has persisted for a long duration (5yrs). However, it should be noted that effective light penetration was still observed to be supportive of seagrass in all bay segments, including OTB (Table 1).

— Annual Mean — Management Target — +1 se (small exceedance) — +2 se (large exceedance)
