# 2019 Tampa Bay Water Quality Assessments

A Tampa Bay Estuary Program Initiative to Maintain and Restore the Bay's Seagrass Resources

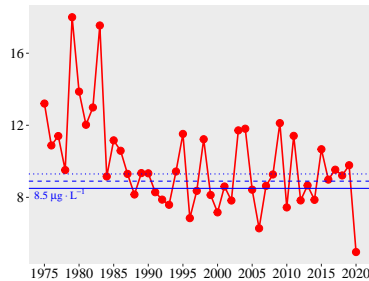
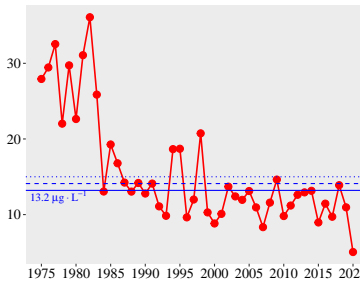
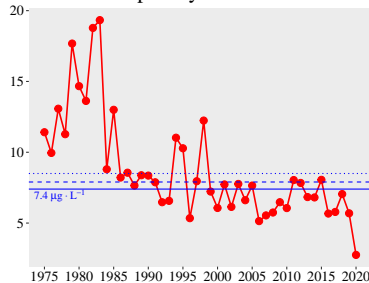
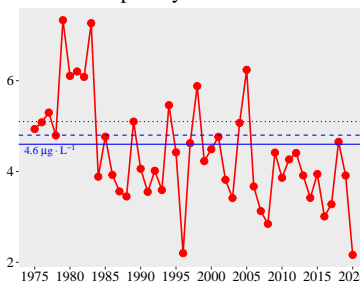
Figure 3: Historic chlorophyll-a annual averages for the four bay segments.

— Annual Mean — Management Target — +1 se (small exceedance) — +2 se (large exceedance)

Water quality (chlorophyll-a and light penetration) remained supportive of seagrass in Hillsborough Bay (HB), Middle Tampa Bay (MTB), and Lower Tampa Bay (LTB)(Table 1, Figure 3). The nuisance algae, *Pyrodinium bahamense*, was again reported in Old Tampa Bay (OTB) during May - September 2019, contributing to a large magnitude chlorophyll-a exceedance that has persisted for a long duration (5yrs). However, it should be noted that effective light penetration was still observed to be supportive of seagrass in all bay segments, including OTB (Table 1).
