2019 Tampa Bay Water Quality Assessments

A Tampa Bay Estuary Program Initiative to Maintain and Restore the Bay's Seagrass Resources

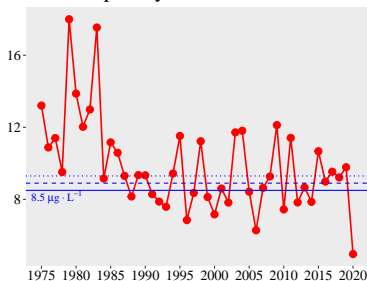
Figure 3: Historic chlorophyll-a annual averages for the four bay segments.

Water quality (chlorophyll-a and light penetration) remained supportive of seagrass in Hillsborough Bay (HB), Middle Tampa Bay (MTB), and Lower Tampa Bay (LTB)(Table 1, Figure 3). The nuisance alga, *Pyrodinium bahamense*, was again reported in Old Tampa Bay (OTB) during May - September 2019, contributing to a large magnitude chlorophyll-a exceedance that has persisted for a long duration (5yrs). However, it should be noted that effective light penetration was still observed to be supportive of seagrass in all bay segments, including OTB (Table 1).

— Annual Mean — Management Target - - +1 se (small exceedance) - - +2 se (large exceedance)
