2019 Tampa Bay Water Quality Assessments

A Tampa Bay Estuary Program Initiative to Maintain and Restore the Bay's Seagrass Resources

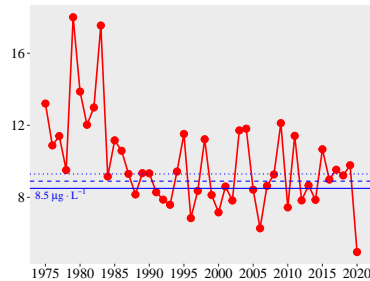
— Annual Mean — Management Target — +1 se (small exceedance) — +2 se (large exceedance)

Figure 3: Historic chlorophyll-a annual averages for the four bay segments.

Water quality (chlorophyll-a and light penetration) remained supportive of seagrass in Hillsborough Bay (HB), Middle Tampa Bay (MTB), and Lower Tampa Bay (LTB)(Table 1, Figure 3). The nuisance alga, *Pyrodinium bahamense*, was again reported in Old Tampa Bay (OTB) during May - September 2019, contributing to a large magnitude chlorophyll-a exceedance that has persisted for a long duration (5yrs). However, it should be noted that effective light penetration was still observed to be supportive of seagrass in all bay segments, including OTB (Table 1).
