# 2019 Tampa Bay Water Quality Assessments

A Tampa Bay Estuary Program Initiative to Maintain and Restore the Bay's Seagrass Resources

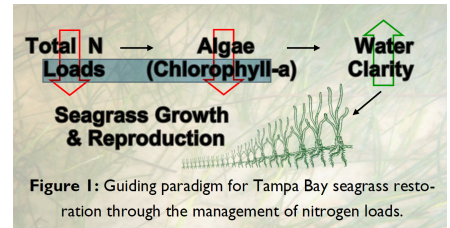
Light availability to seagrass is the guiding paradigm for TBEP's Nitrogen Management Strategy. Because excessive nitrogen loads to the bay generally lead to increased algae blooms (higher chlorophyll-a levels) (Figure 1) and reduce light penetration to seagrass, an evaluation method was developed to assess whether load reduction strategies are achieving desired water quality results (i.e. reduced chlorophyll-a concentrations and increased water clarity).
