2019 Tampa Bay Water Quality Assessments

A Tampa Bay Estuary Program Initiative to Maintain and Restore the Bay's Seagrass Resources

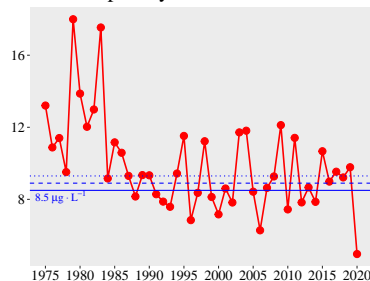
Figure 3: Historic chlorophyll-a annual averages for the four bay segments.

— Annual Mean — Management Target — +1 se (small exceedance) — +2 se (large exceedance)

Old Tampa Bay

Hillsborough Bay

Middle Tampa Bay

Lower Tampa Bay

Water quality (chlorophyll-a and light penetration) remained supportive of seagrass in Hillsborough Bay (HB), Middle Tampa Bay (MTB), and Lower Tampa Bay (LTB)(Table 1, Figure 3). The nuisance alga, *Pyrodinium bahamense*, was again reported in Old Tampa Bay (OTB) during May - September 2019, contributing to a large magnitude chlorophyll-a exceedance that has persisted for a long duration (5yrs). However, it should be noted that effective light penetration was still observed to be supportive of seagrass in all bay segments, including OTB (Table 1).
