# 2019 Tampa Bay Water Quality Assessments

A Tampa Bay Estuary Program Initiative to Maintain and Restore the Bay's Seagrass Resources

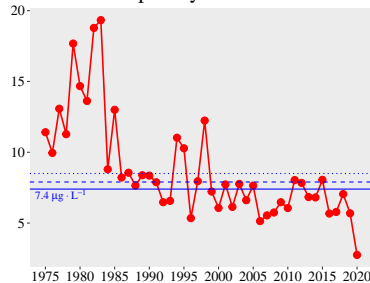
Figure 3: Historic chlorophyll-a annual averages for the four bay segments.

Water quality (chlorophyll-a and light penetration) remained supportive of seagrass in Hillsborough Bay (HB), Middle Tampa Bay (MTB), and Lower Tampa Bay (LTB)(Table 1, Figure 3). The nuisance algae, *Pyrodinium bahamense*, was again reported in Old Tampa Bay (OTB) during May - September 2019, contributing to a large magnitude chlorophyll-a exceedance that has persisted for a long duration (5yrs). However, it should be noted that effective light penetration was still observed to be supportive of seagrass in all bay segments, including OTB (Table 1).

— Annual Mean — Management Target - - +1 se (small exceedance) - - +2 se (large exceedance)
