2019 Tampa Bay Water Quality Assessments

A Tampa Bay Estuary Program Initiative to Maintain and Restore the Bay's Seagrass Resources

2020 Decision Matrix Results

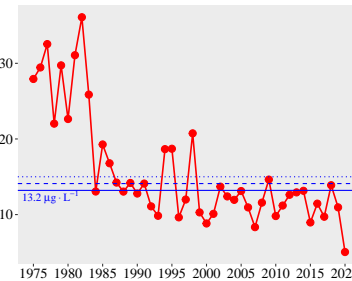
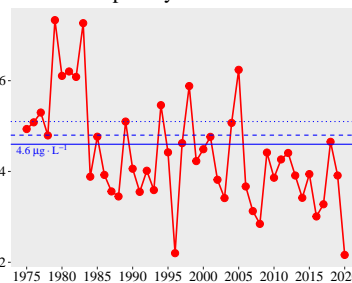
Figure 3: Historic chlorophyll-a annual averages for the four bay segments.

— Annual Mean — Management Target — +1 se (small exceedance) — +2 se (large exceedance)

Old Tampa Bay

Hillsborough Bay

Middle Tampa Bay

Lower Tampa Bay

Water quality (chlorophyll-a and light penetration) remained supportive of seagrass in Hillsborough Bay (HB), Middle Tampa Bay (MTB), and Lower Tampa Bay (LTB)(Table 1, Figure 3). The nuisance algae, *Pyrodinium bahamense*, was again reported in Old Tampa Bay (OTB) during May - September 2019, contributing to a large magnitude chlorophyll-a exceedance that has persisted for a long duration (5yrs). However, it should be noted that effective light penetration was still observed to be supportive of seagrass in all bay segments, including OTB (Table 1).
