2019 Tampa Bay Water Quality Assessments

A Tampa Bay Estuary Program Initiative to Maintain and Restore the Bay's Seagrass Resources

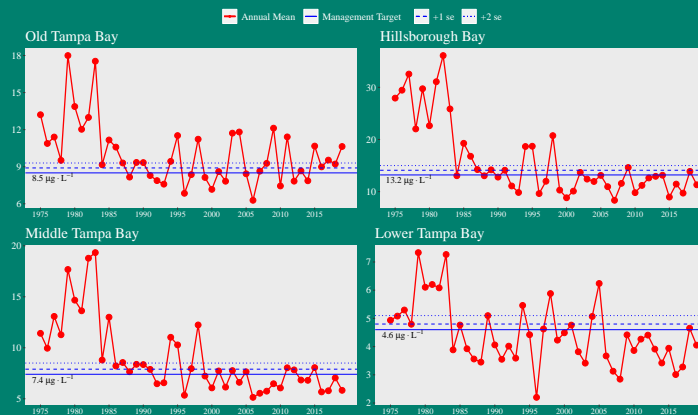
Figure 3: Historic chlorophyll-a annual averages for the four bay segments.

Water quality (chlorophyll-a and light penetration) remained supportive of seagrass in Hillsborough Bay (HB), Middle Tampa Bay (MTB), and Lower Tampa Bay (LTB) (Table 1, Figure 3). The nuisance alga, *Pyrodinium bahamense*, was again reported in Old Tampa Bay (OTB) during the Summer and Fall 2019, contributing to a small magnitude chlorophyll-a exceedance. In all bay segments, separate algal bloom events contributed to individual stations exceeding the bay segment chlorophyll-a targets (Figure 4). However, effective light penetration was supportive of seagrass in all bay segments (Table 1).
