# 2019 Tampa Bay Water Quality Assessments

A Tampa Bay Estuary Program Initiative to Maintain and Restore the Bay's Seagrass Resources

# Progress Towards Meeting Regulatory Goals

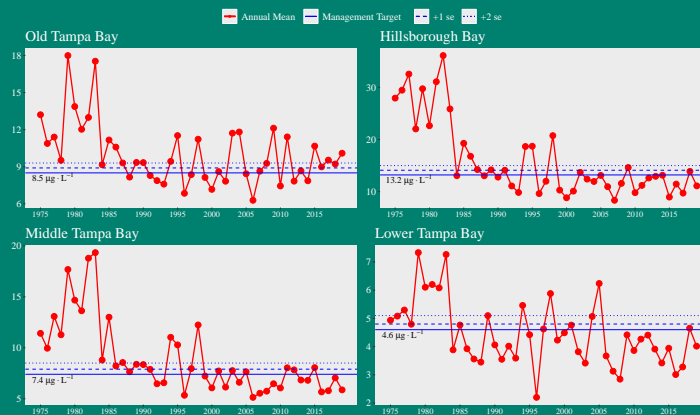
Figure 3: Historic chlorophyll-a annual averages for the four bay segments.

Water quality (chlorophyll-a and light penetration) remained supportive of seagrass in Hillsborough Bay (HB), Middle Tampa Bay (MTB), and Lower Tampa Bay (LTB) (Table 1, Figure 3). The nuisance alga, *Pyrodinium bahamense*, was again reported in Old Tampa Bay (OTB) during the Summer and Fall 2019, contributing to a large magnitude chlorophyll-a exceedance. In other bay segments, separate algal bloom events contributed to individual stations exceeding the bay segment chlorophyll-a targets (Figure 4). However, effective light penetration was supportive of seagrass in all bay segments (Table 1).

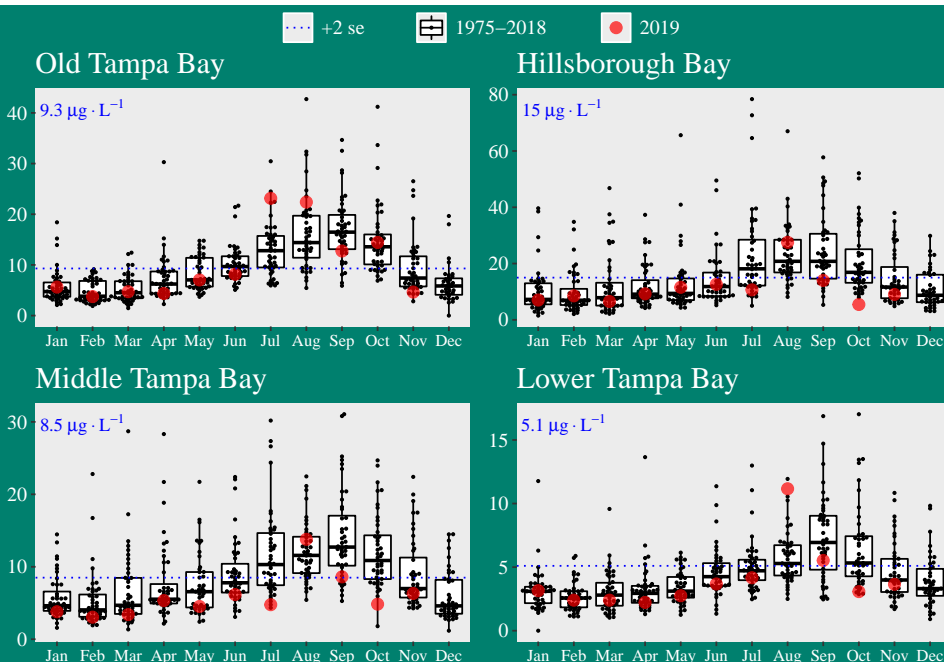
Figure 6: Chlorophyll-a monthly averages from 1975-2018 for the four bay segments. The monthly averages for 2019 are shown in red. Historic chlorophyll-a annual averages for the four bay segments.

Chlorophyll-a concentrations were evaluated within the bay on a monthly basis during 'r maxyr' and compared to prior years' levels (Figure 6). Elevated concentrations in Old Tampa Bay and Lower Tampa Bay were primarily due to *Pyrodinium bahamense* and *Karenia brevis* blooms, respectively. Hillsborough Bay also showed elevated concentrations during two months in 2018 - the fall event coincided with blooms of the nonharmful alga, *Tripos hircus*.

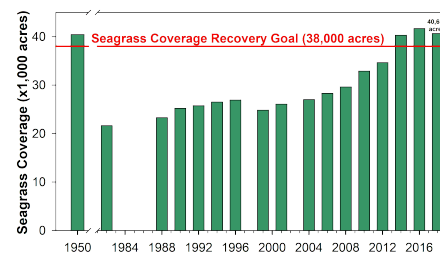
Figure 7: Historic seagrass acreage estimates for Tampa Bay from 1950-2018 (Source: TBEP & SWFWMD)

Tampa Bay's total seagrass coverage remains above the recovery goal, though a slight decrease was observed from 2016 to 2018. The 2018 baywide coverage was estimated at 40,652 acres (Figure 7). As in 2016, coverage remains above the target (38,000 acres) and the estimated historic coverage of the 1950s (40,420 acres). The next SWFWMD coverage estimates will be developed from aerial photographs acquired over the winter 2019-20 period, following the extensive red tide event observed throughout 2018 (note: the 2018 coverage estimate was developed prior this event). More information can be found in TBEP technical publication #08-16 and #09-17.
