2019 Tampa Bay Water Quality Assessments

A Tampa Bay Estuary Program Initiative to Maintain and Restore the Bay's Seagrass Resources

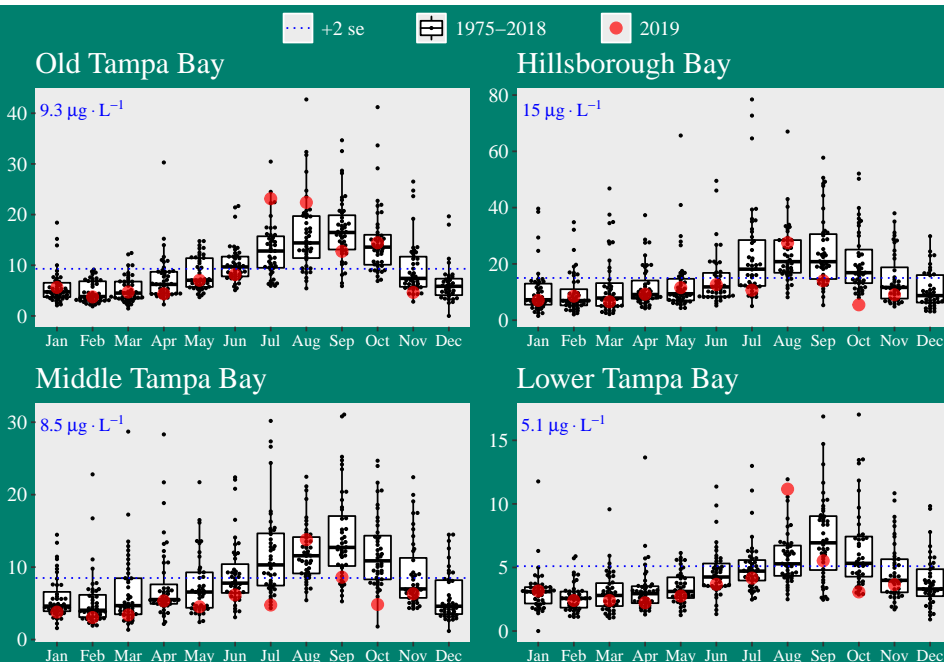
Figure 6: Chlorophyll-a monthly averages from 1975-2018 for the four bay segments. The monthly averages for 2019 are shown in red. Historic chlorophyll-a annual averages for the four bay segments.

Chlorophyll-a concentrations were evaluated within the bay on a monthly basis during 2019 and compared to prior years' levels (Figure 6). Elevated concentrations in Old Tampa Bay and Lower Tampa Bay were primarily due to *Pyrodinium bahamense* and *Karenia brevis* blooms, respectively. Hillsborough Bay also showed elevated concentrations during two months in 2018 - the fall event coincided with blooms of the nonharmful alga, *Tripos hircus*.
