2019 Tampa Bay Water Quality Assessments

A Tampa Bay Estuary Program Initiative to Maintain and Restore the Bay's Seagrass Resources

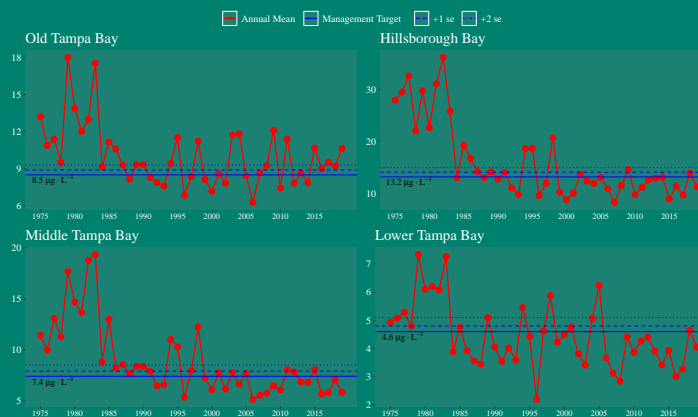
Figure 3: Historic chlorophyll-a annual averages for the four bay segments.

Water quality (chlorophyll-a and light penetration) remained supportive of seagrass in Hillsborough Bay (HB), Middle Tampa Bay (MTB), and Lower Tampa Bay (LTB)(Table 1, Figure 3). The nuisance alga, *Pyrodinium bahamense*, was again reported in Old Tampa Bay (OTB) during the Summer and Fall 2019, contributing to a small magnitude chlorophyll-a exceedance. In all bay segments, separate algal bloom events contributed to individual stations exceeding the bay segment chlorophyll-a targets (Figure 4). However, effective light penetration was supportive of seagrass in all bay segments (Table 1).
