# 2019 Tampa Bay Water Quality Assessments

A Tampa Bay Estuary Program Initiative to Maintain and Restore the Bay's Seagrass Resources

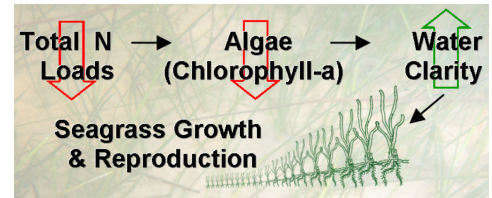
Figure 2: Seagrass restoration with N management.

Light availability to seagrass is the guiding paradigm for TBEP's Nitrogen Management Strategy. Because excessive nitrogen loads to the bay generally lead to increased algae blooms (higher chlorophyll-a levels) (Figure 2) and reduce light penetration to seagrass, an evaluation method was developed to assess whether load reduction strategies are achieving desired water quality results (i.e. reduced chlorophyll-a concentrations and increased water clarity).
