# **Precautionary Measures Addressing Potential Geological/Geotechnical Failure:**

## **A Case Study of the Lord Shiva Statue Construction**

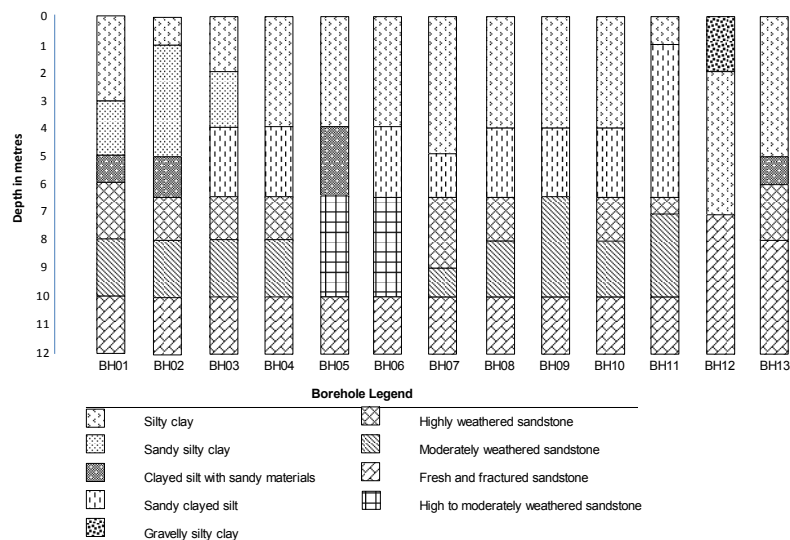
Generally, soil strata are represented by occasional gravel together with clayey silt and silty clay with presence of sand layer up to 6.0 m. Below this depth grey coloured to dark grey coloured, medium-grained, highly weathered micaceous sandstone followed by fractured and fresh micaceous sandstone when the rotary drilling were conducted up to 12.0 m. The same rock type of Kulikhani Formation is represented by all borehole logs at depths varying between 6.5 m to 7.0 m respectively (Fig. 3).

Fig. 3. Results of borehole logs at Kalpeshwordham, 108 feet Lord Shiva statue project premises.

The corrected SPT N-values are ranged from 9.90 to 20.90 for BH13 and 22 for BH04 as the maximum values, and their corresponding allowable bearing capacity are ranged from 40.69 kPa to 76.69 kPa for BH13 and 90.23 kPa for BH04 using Meyerhof (1956). The estimated allowable bearing capacity has been measured at the depth of 1.5 m to 4.5 m which is quite lower and increased gradually up to 4.5 m for predicted foundation width of from 0.5 m.

Although the bearing capacities are increased below the depth of 4.5 m, the foundation for 108 feet tall Lord Shiva statue is not adequate up to the depth of 6.0 m on account of execution of receiving lower field SPT values along with presence of silty clay to clayey silt soil layers together with the presence of occasional gravels and considerable sands.

The DCPT value below 4.5 m is suddenly increased due to presence of stiff completely weathered rock, the raft foundation at this layer would be not sufficient due to the proposed heavy structure owing to presence of weak micaceous minerals present in rock strata.

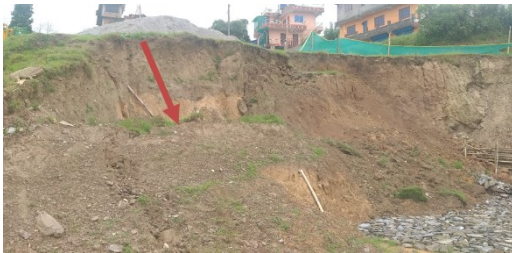
The current site condition reveals that the vertical excavation to a depth of 7.0 meters to meet the plinth level for the Lord Shiva statue foundation was conducted without proper consultation with geo-engineers and structural engineers, leading to immediate slope failures. The designed plinth level, determined by structural analyses, was not adequately supported during excavation, causing the sides of the excavation to collapse. Figures 6 and 7 illustrate the aftermath of this non-engineered vertical box cut, highlighting significant cracks, wall collapses, and displaced materials. These failures underscore the necessity of adhering to standard excavation practices and involving geo-engineering expertise to prevent such issues.

Figure 6 shows the displaced material indicated by an arrow, resulting from the non-engineered excavation at the site. Numerous tension cracks have appeared on the top of the slope adjacent to the box cut, which seem to be progressing. Figure 7 depicts the wide and deep tension cracks

**Fig. 6.** Slope failure of the box cut with the presence of clear demarcation of displaced mass indicated by an arrow.

Considering the geomorphological distribution, geological sub-surface strata, borehole log, ERT log, and visual inspection of the vertical cut, it is evident that the site for constructing the 108-foot tall Lord Shiva statue is situated in a locally disturbed area. While the geotechnical investigation and bearing capacity evaluation based on SPT (Table 3) suggest that a raft foundation could be designed, the presence of weathered to fractured rock and possible lineaments, as indicated by geomorphological observations and S-type microfolds (Fig. 8), raises concerns about settlement issues. These factors underscore the need for detailed analysis and modeling. Therefore, it is crucial to consider a combined raft and pile foundation to minimize vertical and horizontal settlement and prevent potential foundation failure due to weak layers.

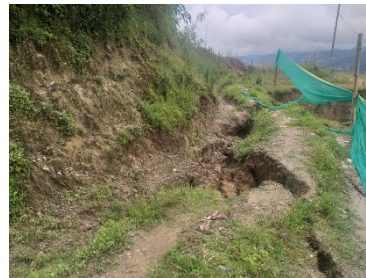
visible at the ground surface, indicating significant instability in the earthworks. These unstable conditions necessitate careful consideration and engineering to ensure the stability of the statue's foundation. Proper geotechnical measures and adherence to standard excavation practices are crucial to address these issues and safely support the superstructure of the statue.

**Fig. 7.** Wide tension crack appeared on the top of the box cut.

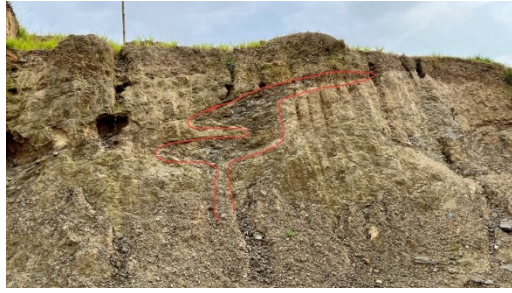
Additionally, the vertical cut exposed highly fractured rocks on the wall surface, contradicting the results of the exploratory core drilling conducted at 13 sites. Figure 8 illustrates the s-type micro fold starting from the ground surface in the box cut, and Fig. 9 shows geomorphological disturbances, marked by yellow lines, in a Google Earth photo, which align with the ERT results shown in Figs. 4 and 5. This discrepancy suggests potential inaccuracies in the drilling results, possibly due to improper core collection and inadequate initial geological studies. Consequently, these issues complicate the foundation design process based on borehole samples, SPT, and DCPT data.

**Fig. 8.** S-type microfold marked by red line present on the vertical cut.

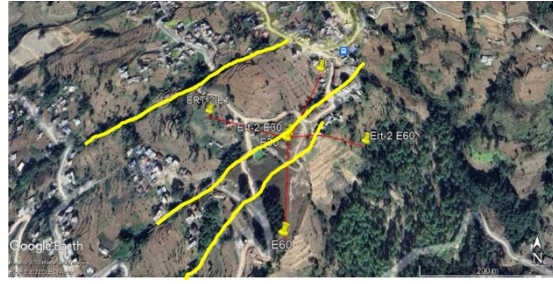
**Fig. 9.** Straight lineament/local fault line shown by yellow lines.
