TESTING DOCUMENT

Project: Final DPM Project

Document Version: 1.0

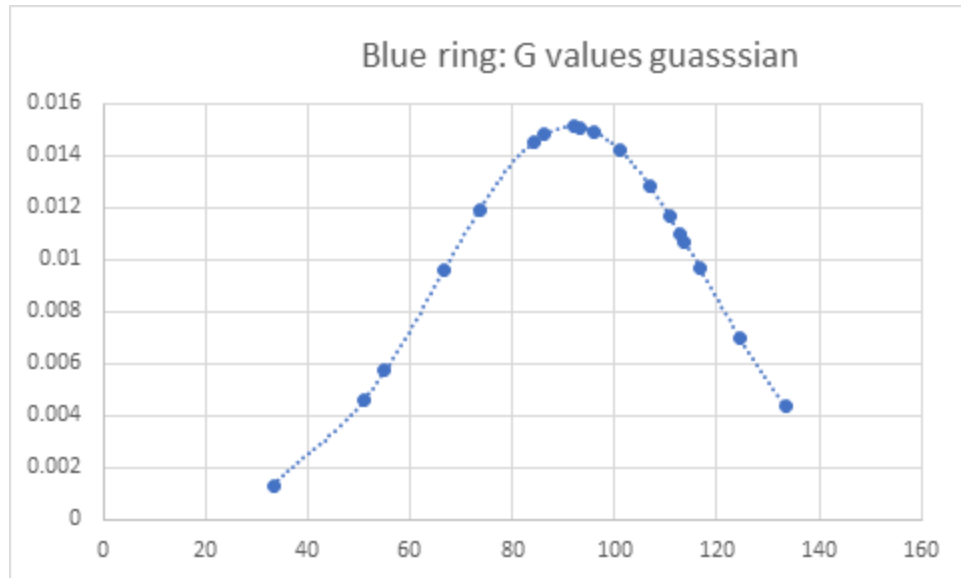
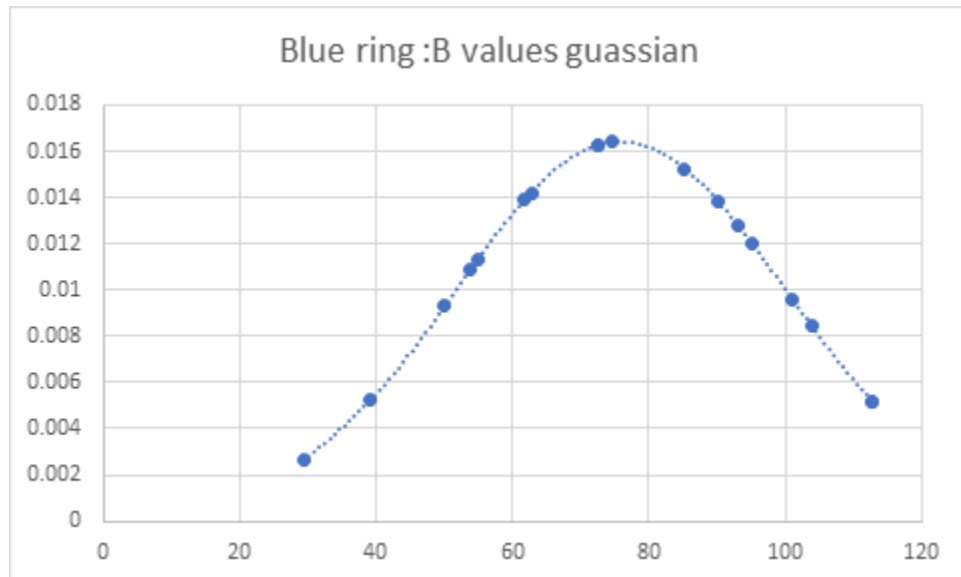
For the blue ring:

Test Report: The test was performed 18 times for each of the 4 rings. The mean and standard deviation was calculated using the following formulas:

The tables and graphs below show the results:

Conclusion: The test results shows that we can use the RGB values to detect the color of the ring accurately.

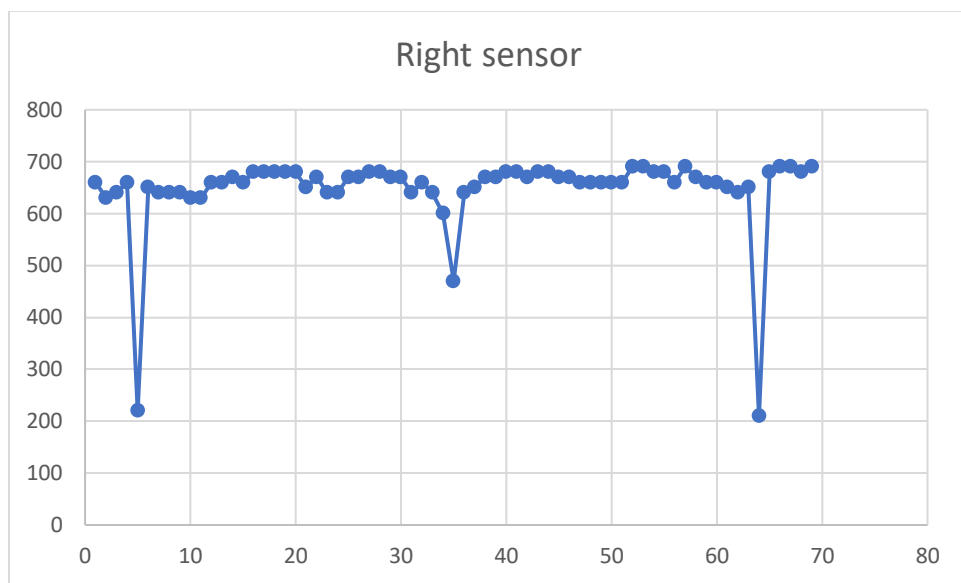
Test Report: The robot went over 3 lines and the graphs below show the results.

The dips in the graph are when the sensor detects the lines.

Conclusion: A differential of 100 would allow the light sensor to accurately detect lines
