# AN-24 Accident at Nizhneangarsk, Russia

On Thursday 27 June 2019 an AN-24 of Angara Airlines, flight number 2G-200, flying from Ulan-Ude Airport was destroyed whilst landing at Nizhneangarsk Airport. Reportedly, the left engine had failed in flight.

This is an analysis of these videos that gives a picture of the speed, position and acceleration forces experienced by the aircraft.

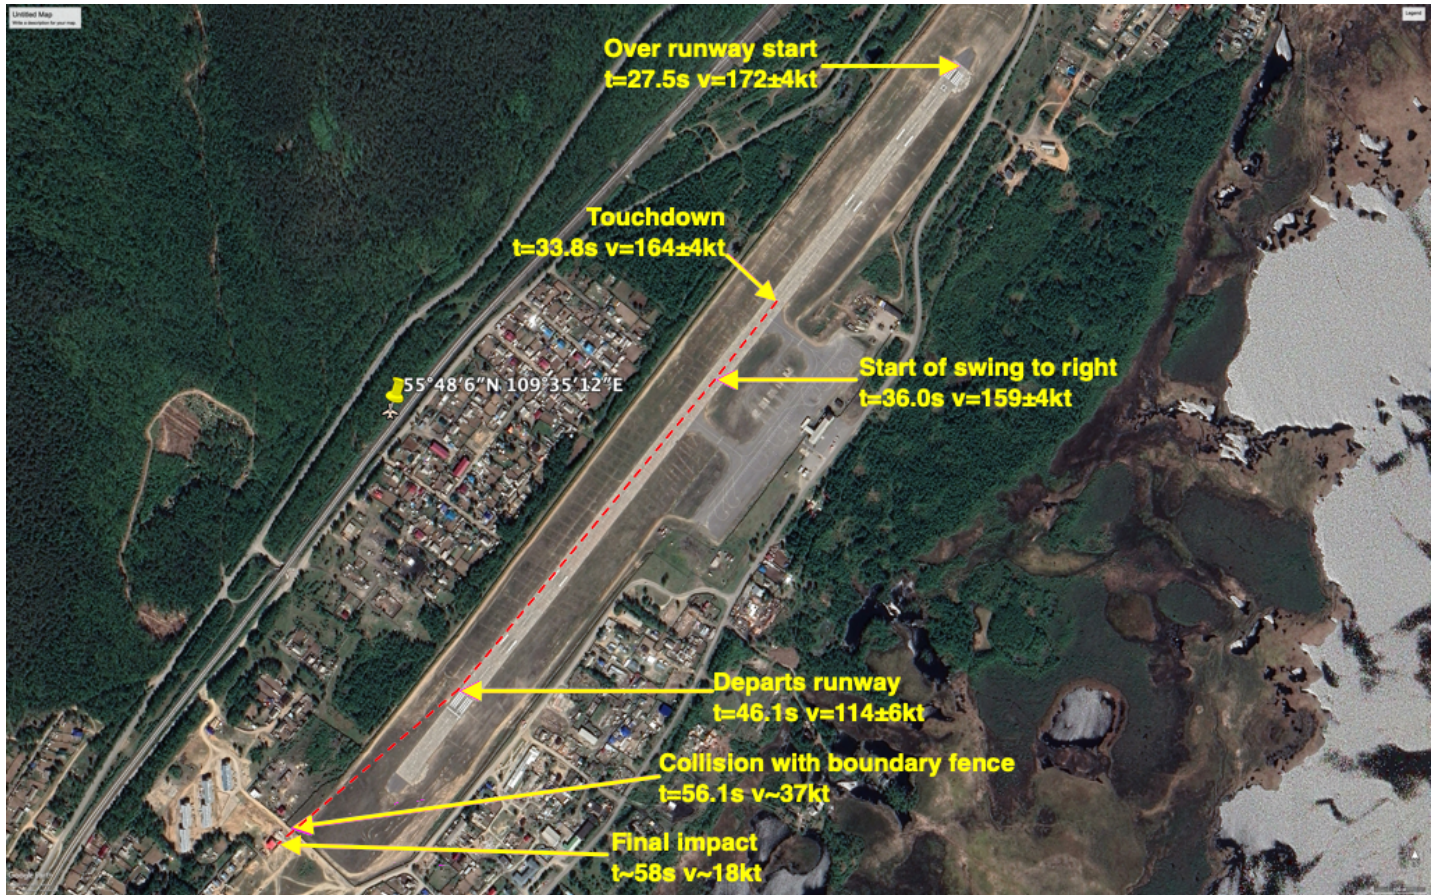
The annotated image below shows the estimated ground path of the aircraft in dotted red with significant events in yellow:

- At the start of the video A the aircraft is on the extended centreline of Nizhneangarsk runway 23 (length 1653 m) at a distance of  $2482 \pm 98$  m from the start of the runway. Ground speed is  $82.8 \pm 2.0$  m/s, ( $161 \pm 4$  knots).

- At  $t=56.1$  there is an impact with the boundary fence 1853m from the start of the runway. This collapses the starboard undercarriage (and probably the port one as well). Impact speed is around 19 m/s (37 knots).

- The aircraft would have slid to a stop roughly 45m later unfortunately there was a building 36m from the boundary fence which is the site of the final impact. Time is about  $t=58.0$  and speed is somewhat less than 9 m/s (18 knots).

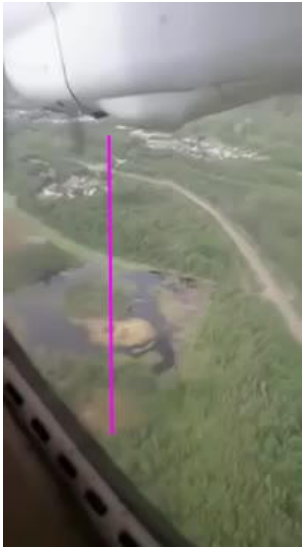
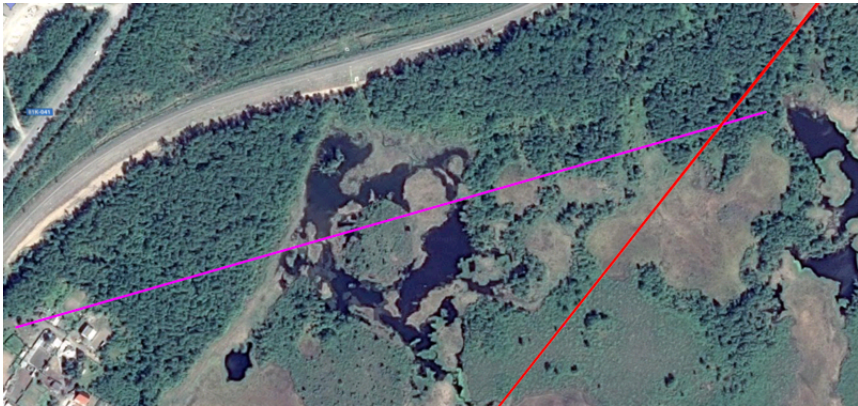
Camera View	Aerial View

Here are two examples. Frame 1 ( $t=0s$ ) shows the line up of the edge of a settlement with a dark smudge on a sandy part of an island. The magenta line shows the estimated ground line the aircraft is flying across, the red line is the extended centreline of runway 23:

This puts the aircraft  $2490 \pm 98\text{m}$  from the start of runway 23.

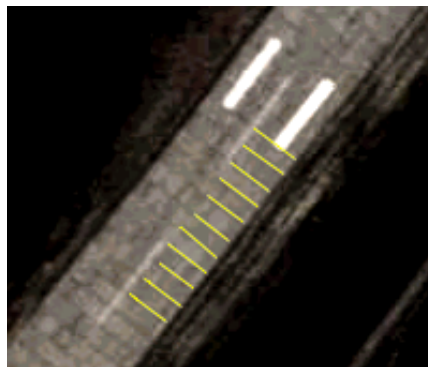
Standardised slabs used for roads and runways in Siberia measure 6m x 1.8m (data from the author's engineering file). For confirmation here is an enhanced aerial image of the runway at Nizhneangarsk where the south side of the runway has been annotated, rather crudely, with yellow lines at the edge of each slab (the slabs are laid with their long side in the runway direction).

Measurement of this imagery shows that these 10 slabs are 98 pixels long which, at 0.617 m/pixel for this image, gives a slab length of 6.05m. The value of 6m for slab length is used hereon.

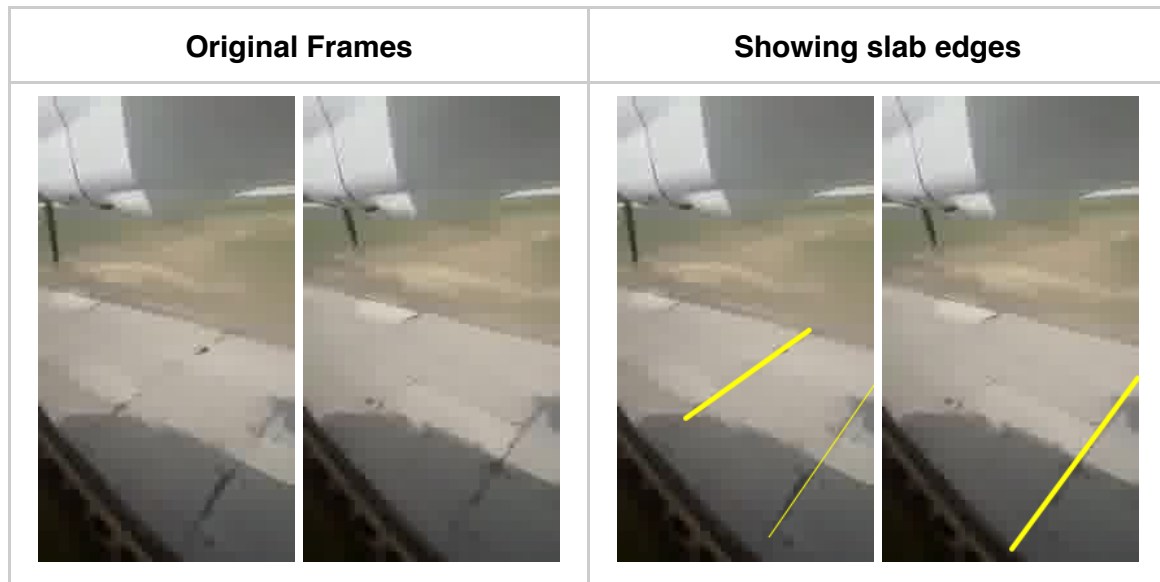
These slab edges can be seen quite clearly on video 'A', as an example here are two frames [841 and 843] which are 1/15 second apart (at 30 fps). On the left are the original frames, on the right the edges of the slabs are identified with yellow lines.

The broad yellow line on the first image is the same part of the runway as the broad line on the second image. The near match of the right hand line in the first frame with the line in the second frame indicates that the aircraft has traveled almost exactly 6m in that 1/15th second. The light patch on the right of the concrete, and the lightish patch in the grass confirms this sequence.

This gives a ground speed of 90 m/s (175 knots). The error term is how confident the slab match is, in general this assumed to be 10% of a slab, so 0.6m in this example thus  $\pm 9$  m/s ( $\pm 18$  knots). If a succession of slabs can be counted the error is proportionally reduced. This is a speed measurement and can be integrated for distance or differentiated for acceleration.

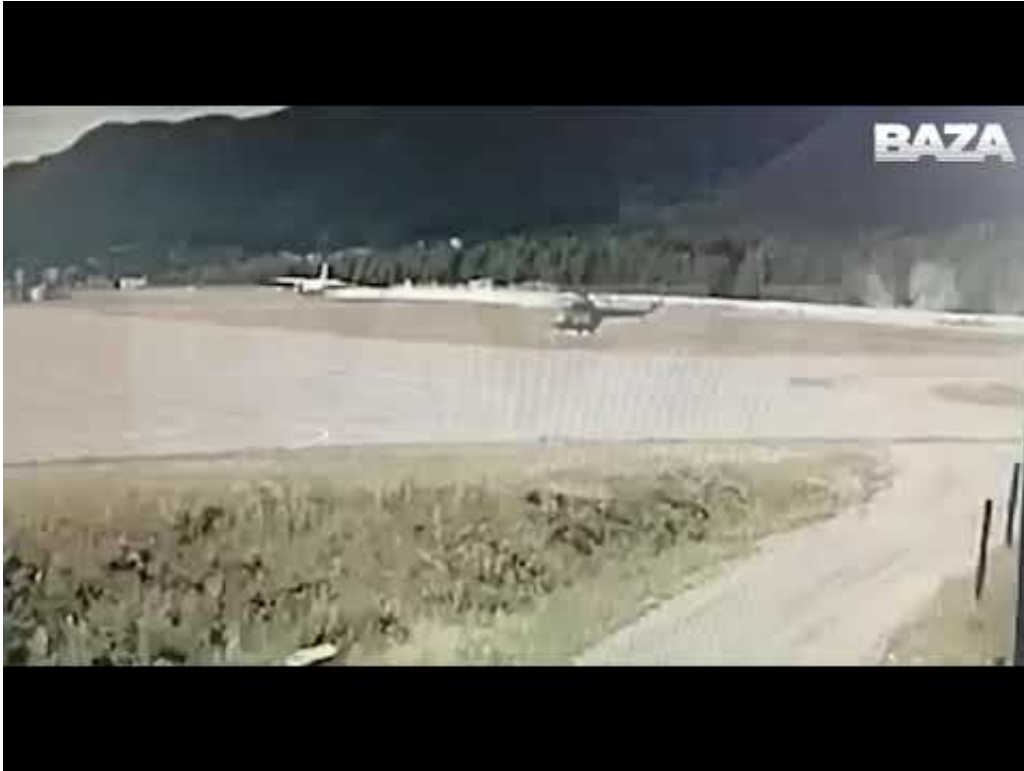
A second video was posted on YouTube that showed images from a security camera overlooking the airport, here referred to as video 'B'. The camera is facing roughly south west and was recorded at 25 frames per second.

The distinctive foreground means the camera position is fairly easily identified on aerial imagery from Google Earth at a position  $x=491\text{m}$  down runway 23 and  $y=-161\text{m}$  to the left of the runway centreline.

- A Mi-2 helicopter near the centre of the frame. The length and height of this can also be used to help calibrate the camera.
- Towards the right of the frame is a pale smudge where tarmac meets grass.
- Slightly left of centre is a bright roofed house beyond the tree-line.
- There are some structures on the extreme left of the frame.
- The red building identified as the scene of the final impact can be determined by the base of the column of smoke that starts at around frame 850.

Comparing the relative frame positions of these with the actual bearings gives a camera resolution of  $21.6 \pm 1.9$  (pixels/degree), this assumes a linear field. For a video that is 640 pixels wide this corresponds to an equivalent focal length for a 35mm camera of  $68 \pm 6\text{mm}$ . This also means that the centreline of the camera is pointing at a bearing of  $238.7 \pm 2.1$  degrees.

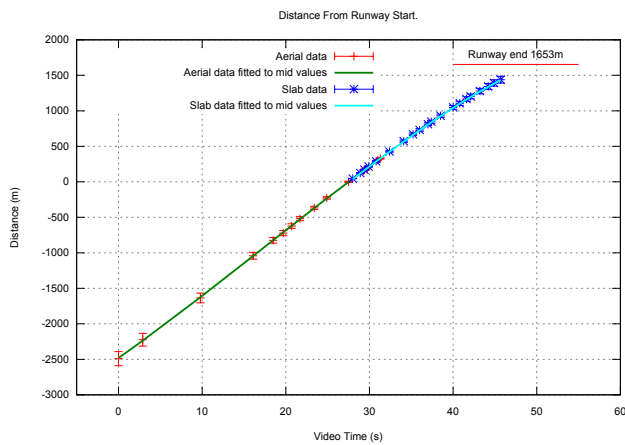
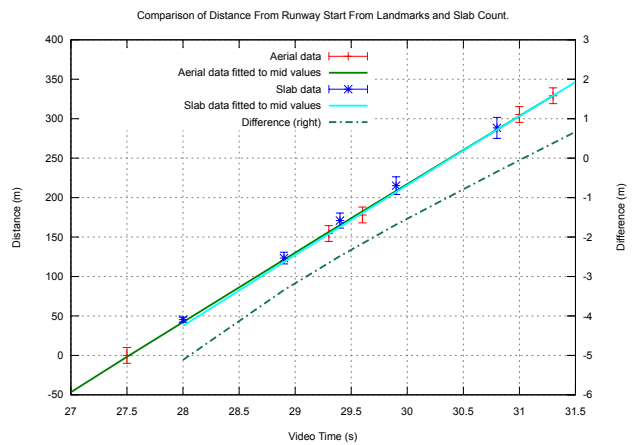
Here is a plot of distance from the start of runway 23 over time from video A, the mid points are fitted to a third order polynomial. The right hand graph shows the comparison where the two measurements overlap:

The difference between the two techniques is 5m or less.

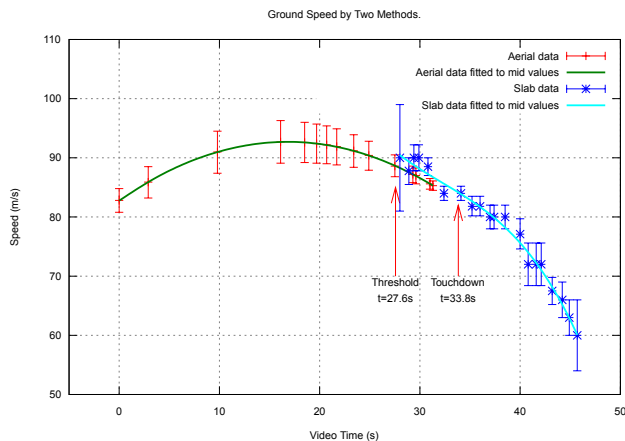
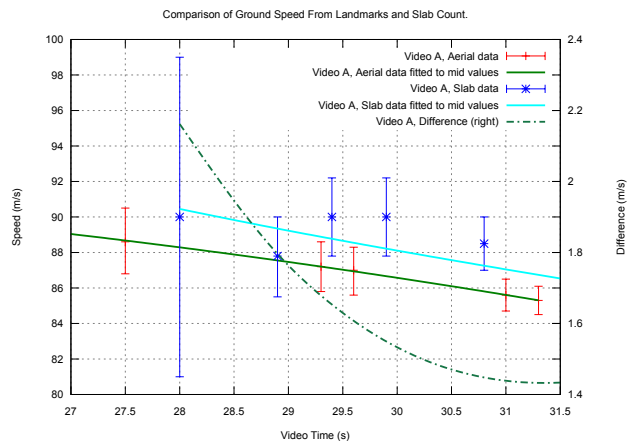
Here is the ground speed by the two techniques. The right hand graph shows the comparison where the two measurements overlap:

The difference is 1.4 to 2.2 m/s over this interval with the fitted data which is just about within the error terms of each if centred on the respective fitted data.

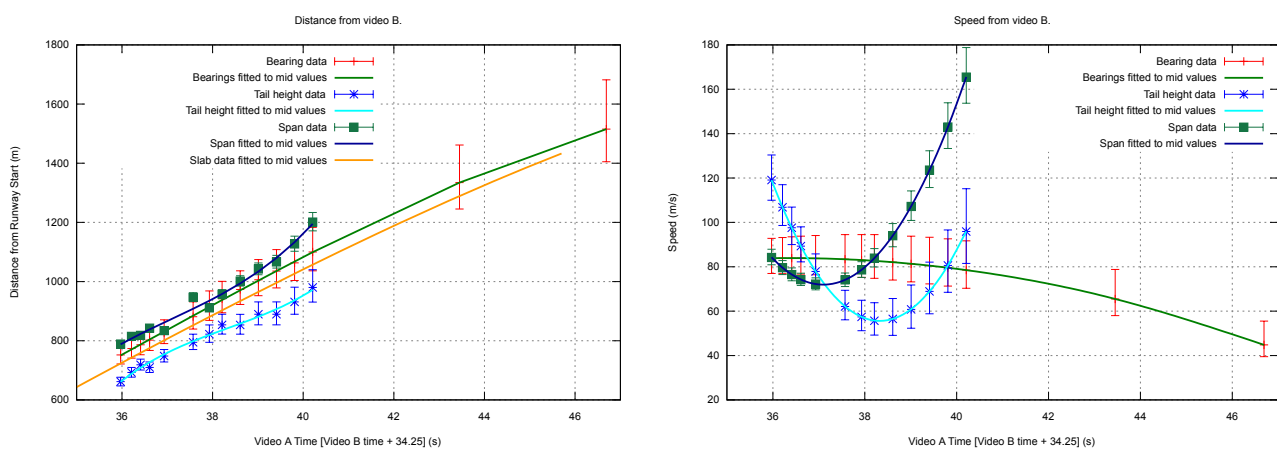
The calculated distance down the runway by these three methods agree rather roughly in magnitude as shown below on the left (the distance data from the slab measurements is also shown for comparison). However when differentiated to obtain ground speed the results are implausible except for the bearing data, as seen on the right.

The poor results from this analysis could be for many reasons; the low resolution of the video, measurement error, non-linear camera field and so on. Even the bearing data does not make sense giving a de-acceleration of around  $-5\text{m/s}$ , if this were true the aircraft would have stopped well before the boundary fence which was not the case. The following graph compares the ground speed from the slab speed data of video A to the bearing data of video B:

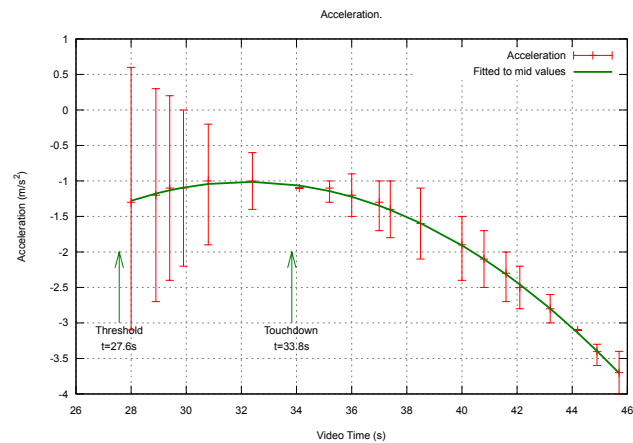
The ground speed if the aircraft computed from video A can be differentiated to give the longitudinal acceleration:

There are no visible discontinuities of sudden changes of acceleration such as might be caused by a tyre burst or running of the runway. Possibly this is because of the smoothing caused by the curve fitting process.
