# AN-24 Accident at Nizhneangarsk, Russia

On Thursday 27 June 2019 an AN-24 of Angara Airlines, flight number 2G200, flying from Ulan-Ude Airport (UUD/UIUU), Russia was destroyed whilst landing at Nizhneangarsk Airport (UIUN), Russia. Reportedly, the left engine had failed in flight. A video of the landing taken by a passenger sitting on the right hand side under the wing was posted online.

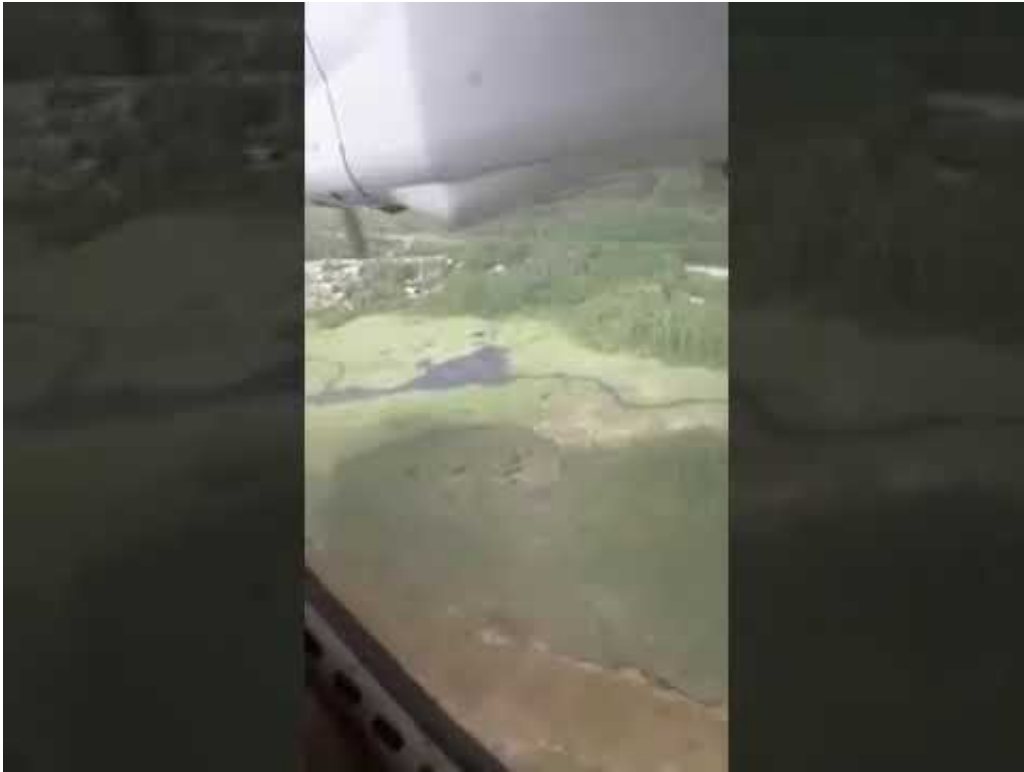
The aircraft approaches at what seems like high speed after touchdown it veers off the runway to the right eventually colliding with a series of obstructions.

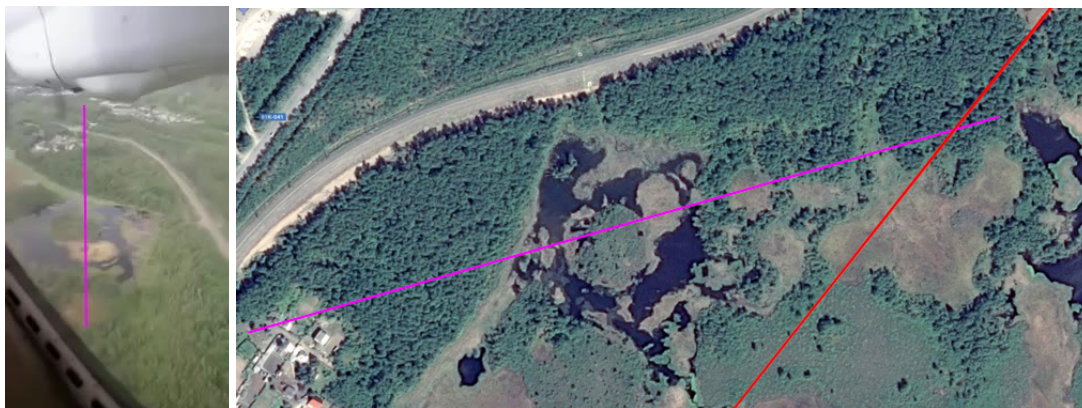
Here are two examples. Frame 1 ( $t=0$ s) shows the line up of the edge of a settlement with a dark smudge on a sandy part of an island. The magenta line shows the estimated ground line the aircraft is flying across, the red line is the extended centreline of runway 22:

This puts the aircraft  $2490 \pm 98\text{m}$  from the start of runway 22.

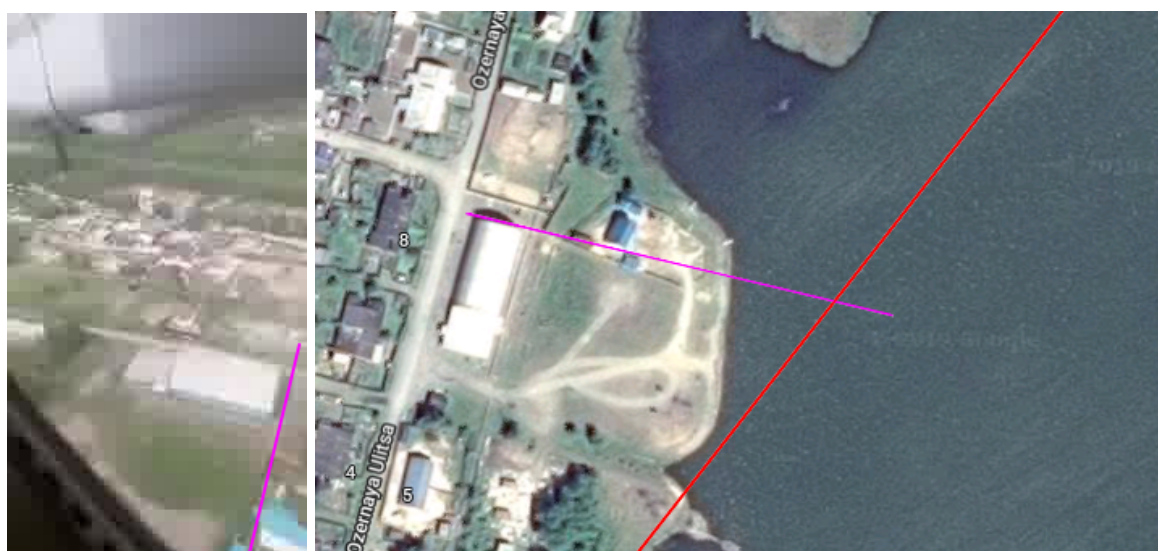
The second example is frame 483 ( $t=16.0\text{s}$ ) where a two distinctive buildings are lined up:

This puts the aircraft at  $1041 \pm 49\text{m}$  from the start of runway 22.

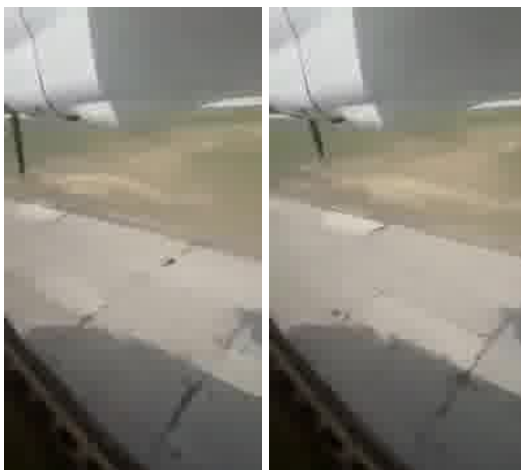
These slab edges can be seen quite clearly on the video. As an example here are two frames [841 and 843] and they are 1/15 second apart (at 30 fps).

The broad line on the left image is the same part of the runway as the line on the right image. So the near match of the right hand line in the left frame with the line in the second frame indicates that the aircraft has traveled almost exactly 6m in that 1/15th second. This gives a ground speed of 90 m/s (175 knots).

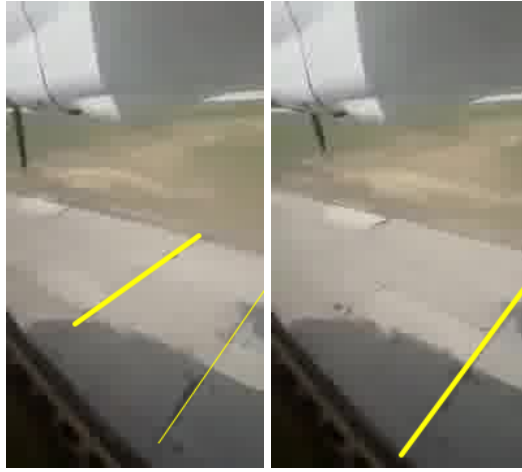
For clarity the edges of the slabs are identified with yellow lines:

The light patch on the right of the concrete, and the lightish patch in the grass that confirms this sequence.
