Room Inspection Report

Room Summary

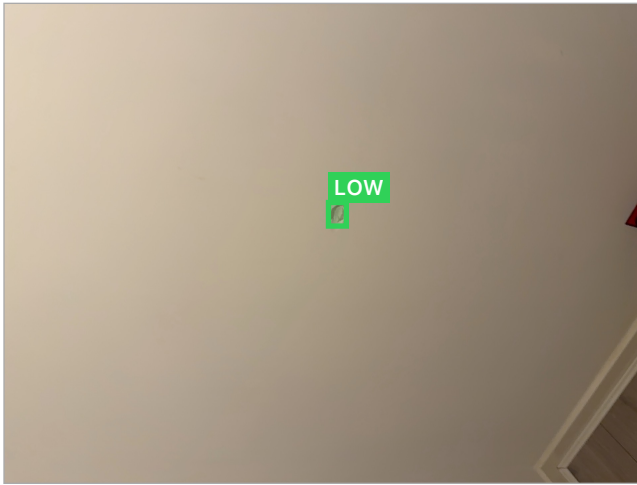
1. Hole - Wall

Size: 3.1 cm × 4.1 cm (12.8 cm²)

Small indentation or hole in the drywall surface, likely caused by a minor impact.

Recommendation: Patch the area with a small amount of spackle or drywall joint compound, sand until flush with the wall once dry, and then repaint with matching paint.
