UNIVERSITY COLLEGE CORK

WIND ENERGY

Kilgarvan Wind Farm Visit 28-10-2015

November 5, 2015

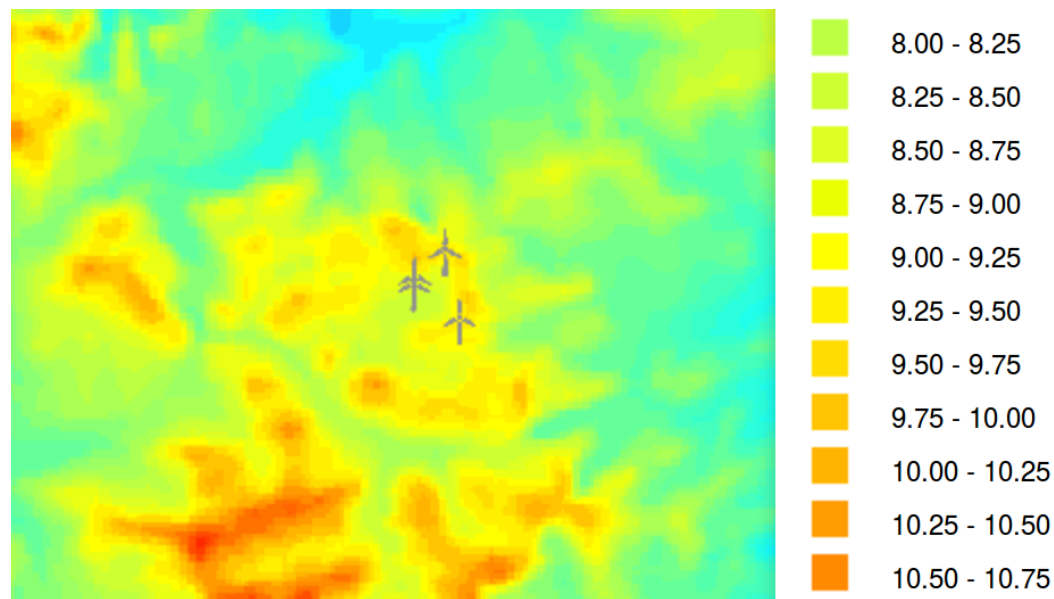
Figure 1: Wind speed at 75m - SEAI Wind Atlas - Kilgarvan Area

According to the SEAI Wind Atlas [3], the area has average wind speeds at 75m height of 8 - 10 m/s.

The terrain can be described as complex, mountainous terrain - there are large depressions and hills in the area. This will affect the vertical wind profile, power output of turbines and choice of turbine design. Depending on wind direction, the terrain effects will differ. The turbines are sited on the south western hillside. If the winds from the prevailing south west direction, the wind will experience a

speed up effect due to acceleration over the hill. If the wind is blowing from a northerly or easterly direction, the turbines will be in the lee of the hills and will experience lower wind speeds and more turbulent conditions.

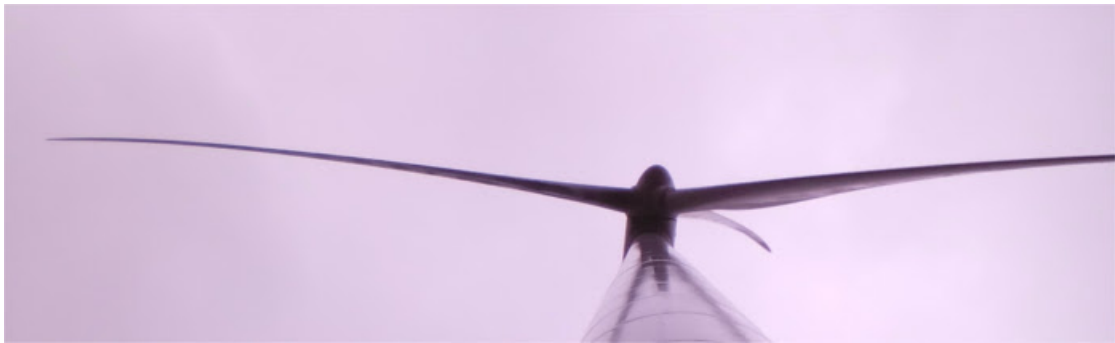
The blades on the Vestas machines appear to be swept back significantly. The Nordex blades appear straighter. There was a noticeable twist along the length of the blades. This twist is designed in to accommodate the difference in apparent wind speed along the blades. Figure 3 shows Vestas rotor. Note the swept back blades and twist of the blades.

Figure 2: Vestas V90 Rotor

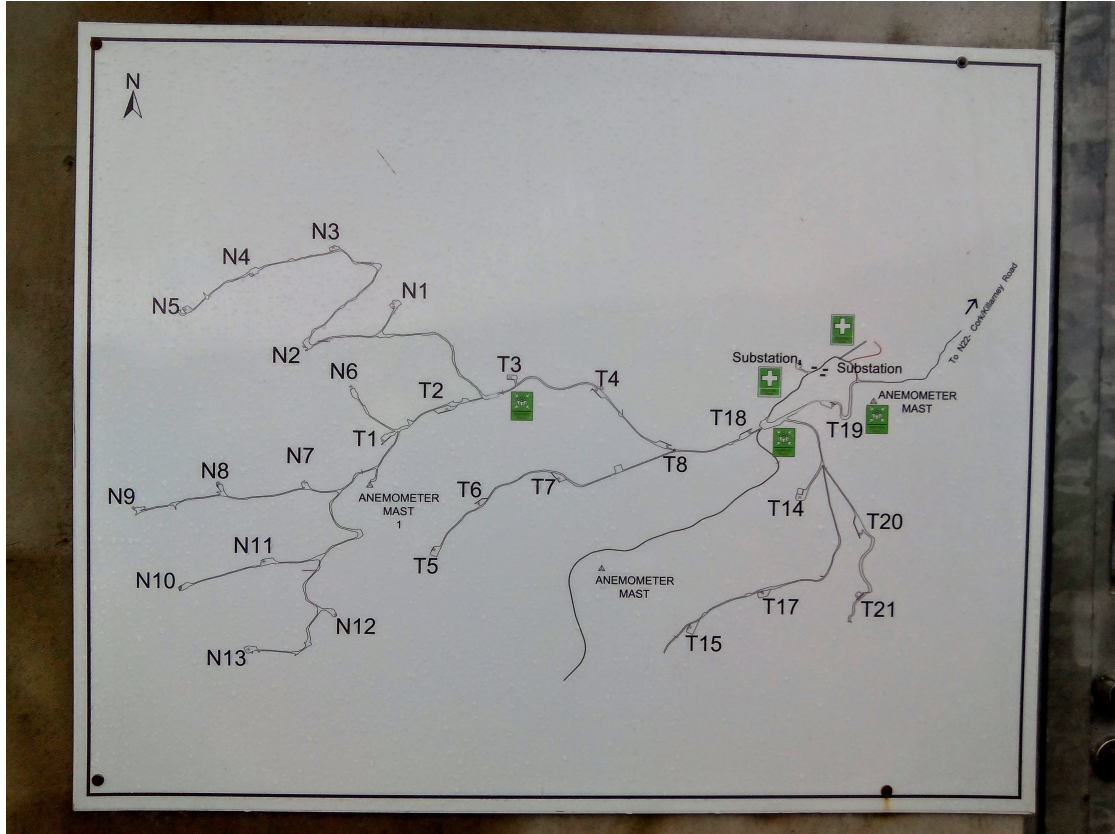
Some machines are in better sites than others. Some machines are located in depressions, or shadowed by the hillside if the wind is blowing in a particular direction. The power output of the turbines can vary significantly depending on their location. The best performing machine is a Vestas machine on the top of the

hill. The worst performing machines are Nordex machines at the bottom of the hill. The worst performing machines can generate as little as 40% of the power as the best performers. This is expected and is taken into account at the design stage.

Figure 3: Farm Layout - N indicates Nordex, T indicates Vestas
