# In-Stream Monitoring During an Ice-Melt Event

*Pete Marchetto, Soil and Water Lab, B&EE*

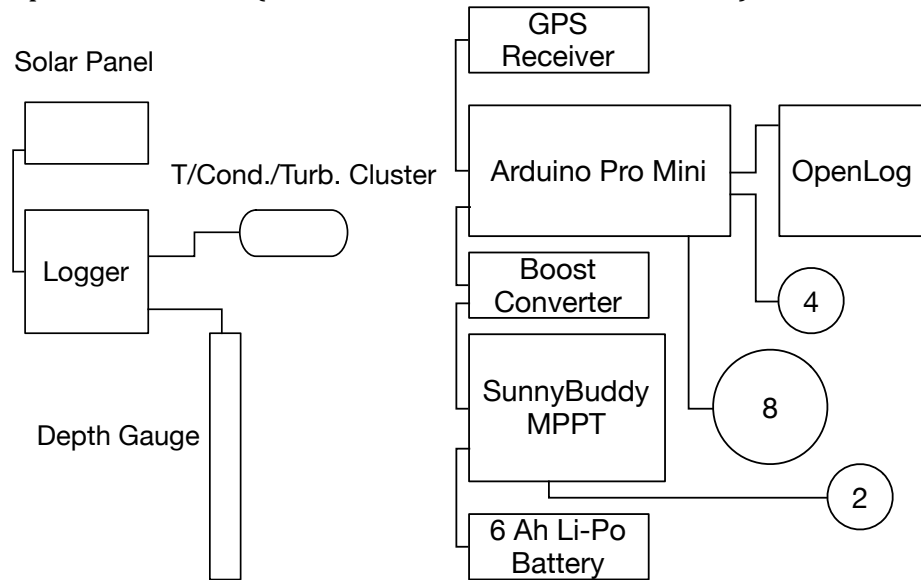
*Fig. 2: Block diagram of logger system (left), and logger internals (right). Circles represent ports, with numbers of conductors inside. The 2-port is connected to the solar panel, while the 4-port is connected to the depth gauge, and the 8-port is connected to the sensor cluster.*

The gauging station was constructed of four major parts: a depth sensor, a sensor cluster for temperature, conductivity, and turbidity, a solar panel, and the logger box itself, as seen in Fig. 2. The logger itself is constructed from an Arduino Pro Mini Microcontroller, OpenLog  $\mu$ SD card logger, Boost Converter, SunnyBuddy solar charger, and 6 Ah Li-Po battery stack (all from SparkFun Electronics, Niwot, CO, USA), as well as a GP-635T GPS receiver (ADH Technology, Taipei, Taiwan). The

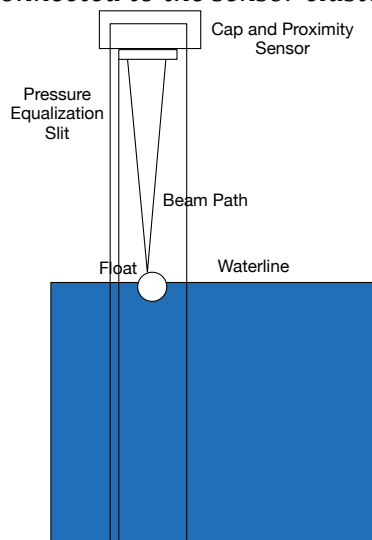
*Fig. 3: Depth gauge consisting of pipe, cap, float, and optical proximity sensor.*

depth gauge, as seen in Fig. 3, is constructed from a 1 m piece of 2" PVC pipe which has been slit down one side and spray painted flat black inside, a blind endcap, and a GP2Y0A02YK0F proximity sensor (Sharp, Camas, WA, USA), with a standard 40 mm diameter white ping pong ball as a float. Finally, the sensor cluster, as seen in Fig. 4, consists of a turbidity sensor made from a full-spectrum white LED and a CdS photoresistor waterproofed and placed 1 cm apart, a conductivity sensor made from two pieces of 0.5 mm graphite pencil lead placed 5 mm apart, and an LM50 full-range temperature sensor (Texas Instruments, Dallas, TX, USA).

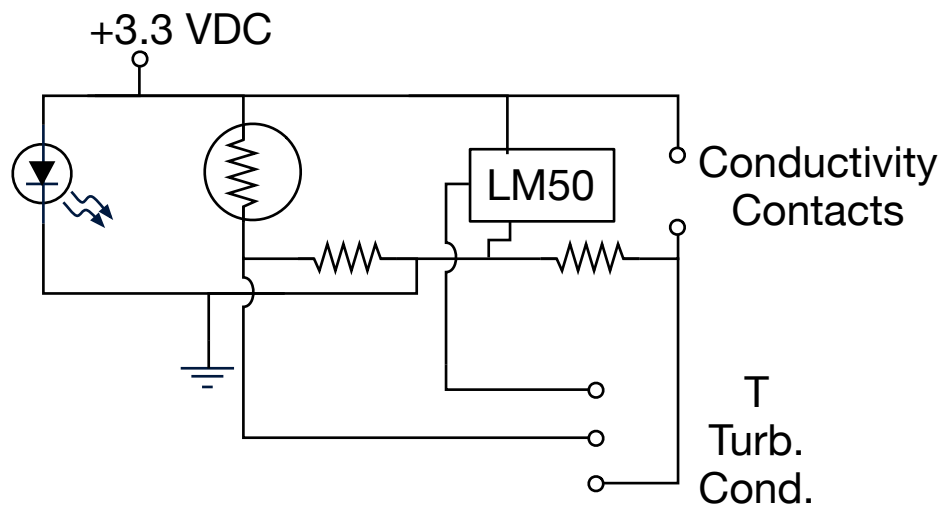
*Fig. 4: Sensor cluster schematic with light gate turbidity sensor, LM50 temperature sensor, and graphite conductivity contacts.*

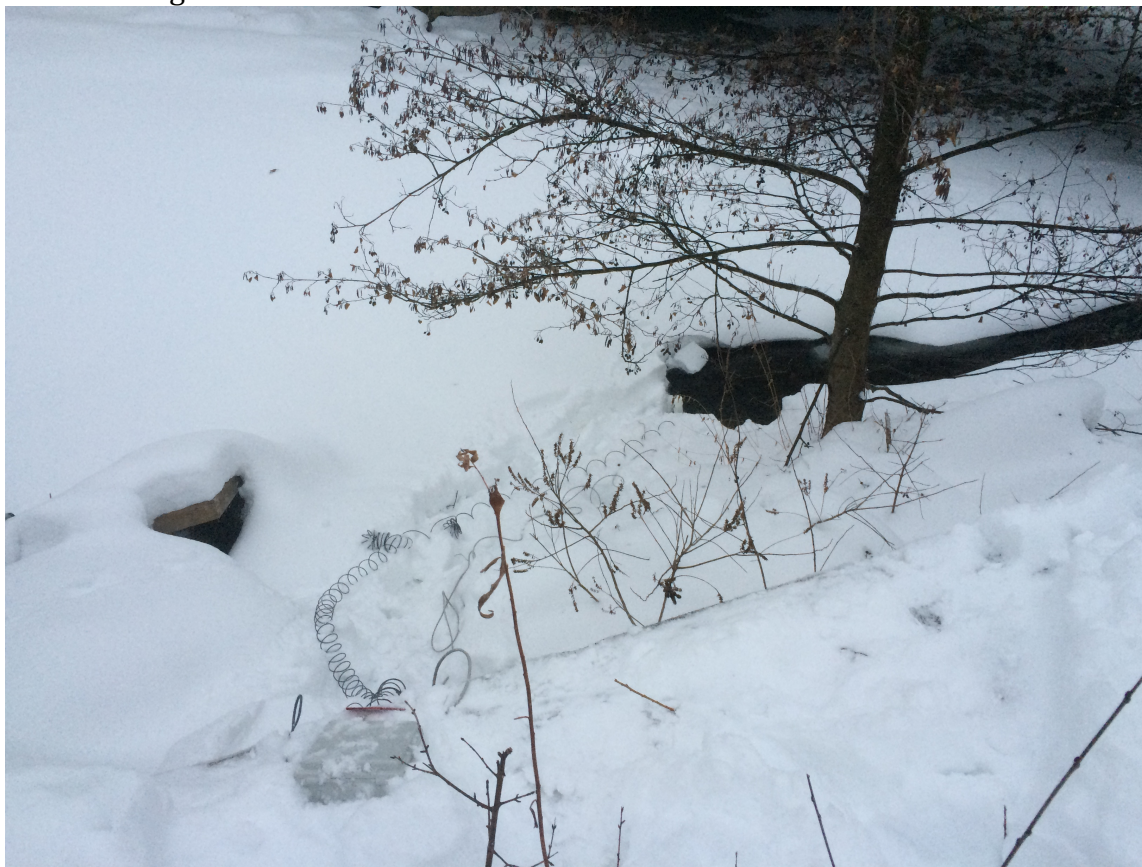
*Fig. 5: Logger and sensor emplacement. The logger is at the lower left of the picture, while the sensors are at the ice-water interface at the end of the coiled wire near the center of the picture, under the tree.*

The logger was emplaced on top of a retaining wall above Cascadilla Creek, while the two sensors were run down into the stream along the ice-water division, as seen in Fig. 5.

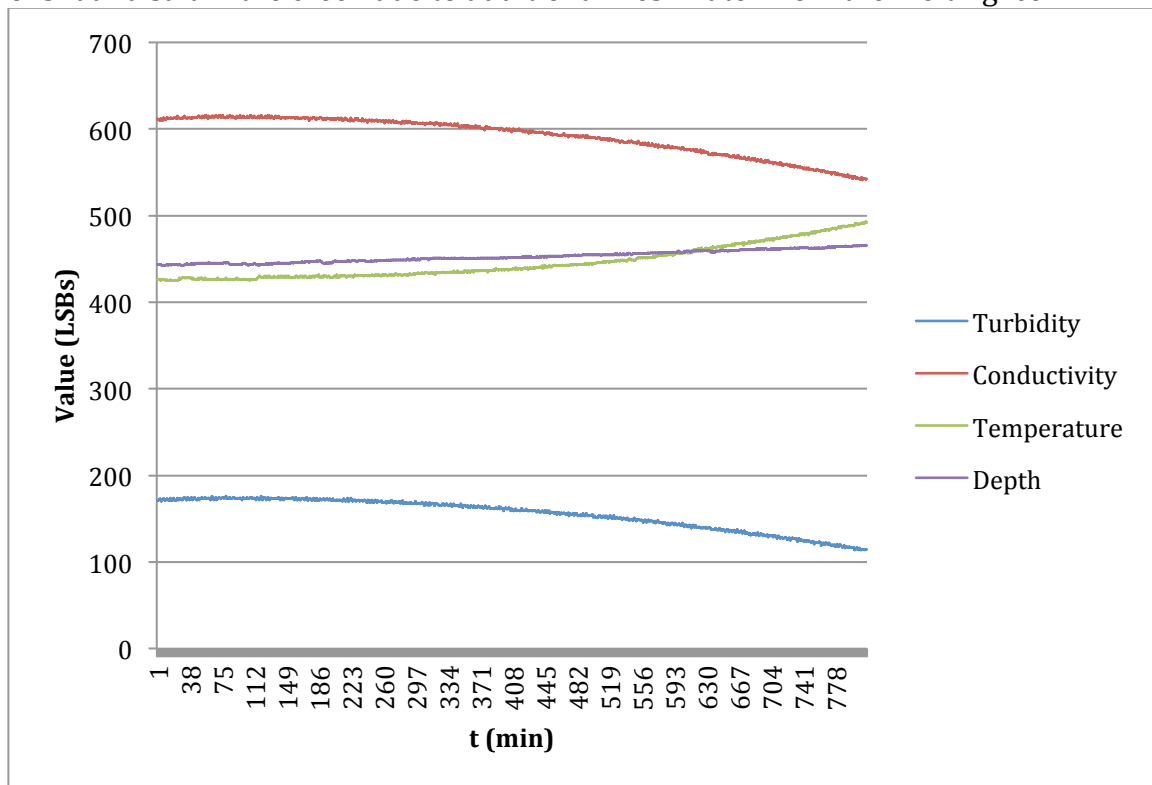
*Fig. 6: Time series of turbidity, conductivity, temperature, and depth during an ice melt event. Values are in Least Significant Bits, with a sensitivity of 4.88 mV/LSB.*

A considerable amount of data was retrieved later. The time series of interest, during an ice melt event, can be seen in Fig. 6 below. The actual values have not been calibrated with real units, but the trends stand out. During this event, the temperature came up from the freezing point to allow ice to melt. The depth then increased due to additional liquid water in the flow channel. Finally, the conductivity and turbidity both began to decrease, presumably because of dilution of silt and salt in the creek due to additional freshwater from the melting ice.

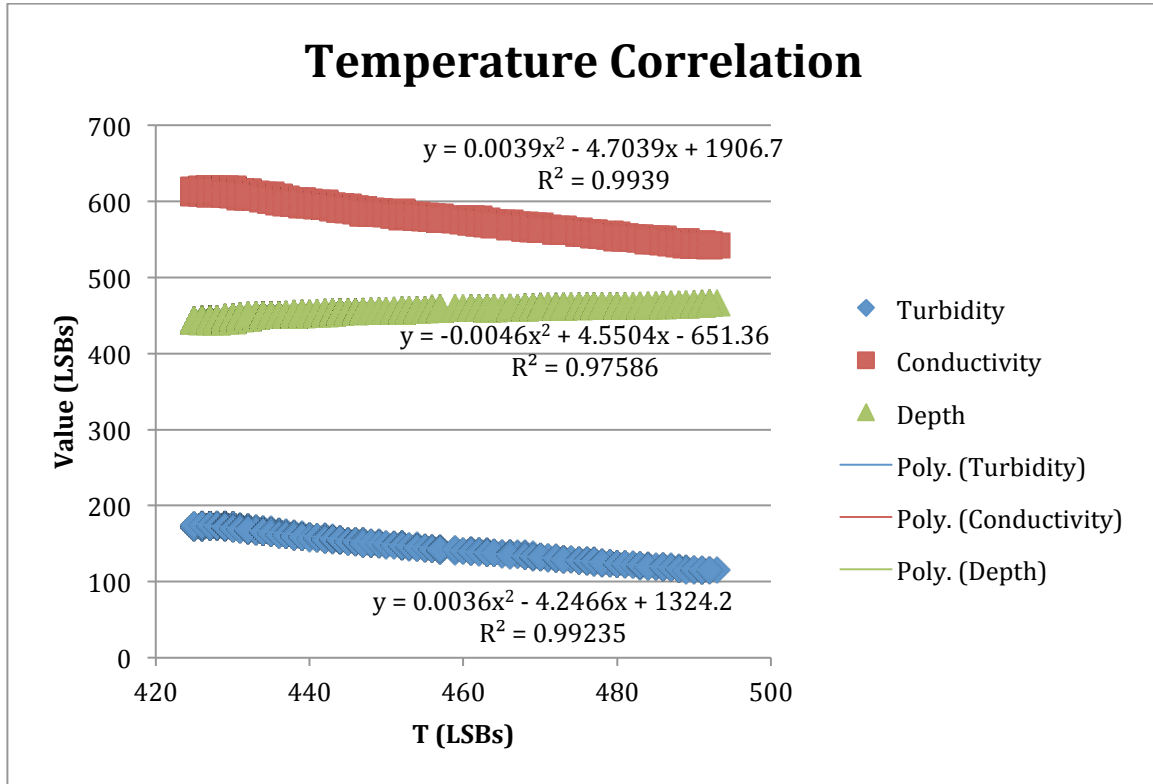
*Fig. 7: Temperature correlation of turbidity, conductivity, and depth. As above, the sensitivity is 4.88 mV/LSB.*

A further correlation analysis was done on the three dependent variables, as seen in Fig. 7 below. Temperature was given priority as an independent variable, as it is intrinsic to the environment. The graph in Fig. 7 clearly shows that temperature then correlated very well ( $R^2 \geq 97.5\%$ ) with the other three measured variables, giving even more evidence to the hypothesis of this being an ice melt event.
