# Elevation Map of Edenville Dam Before and After Flooding

Patrick Hullman - April 1 2025

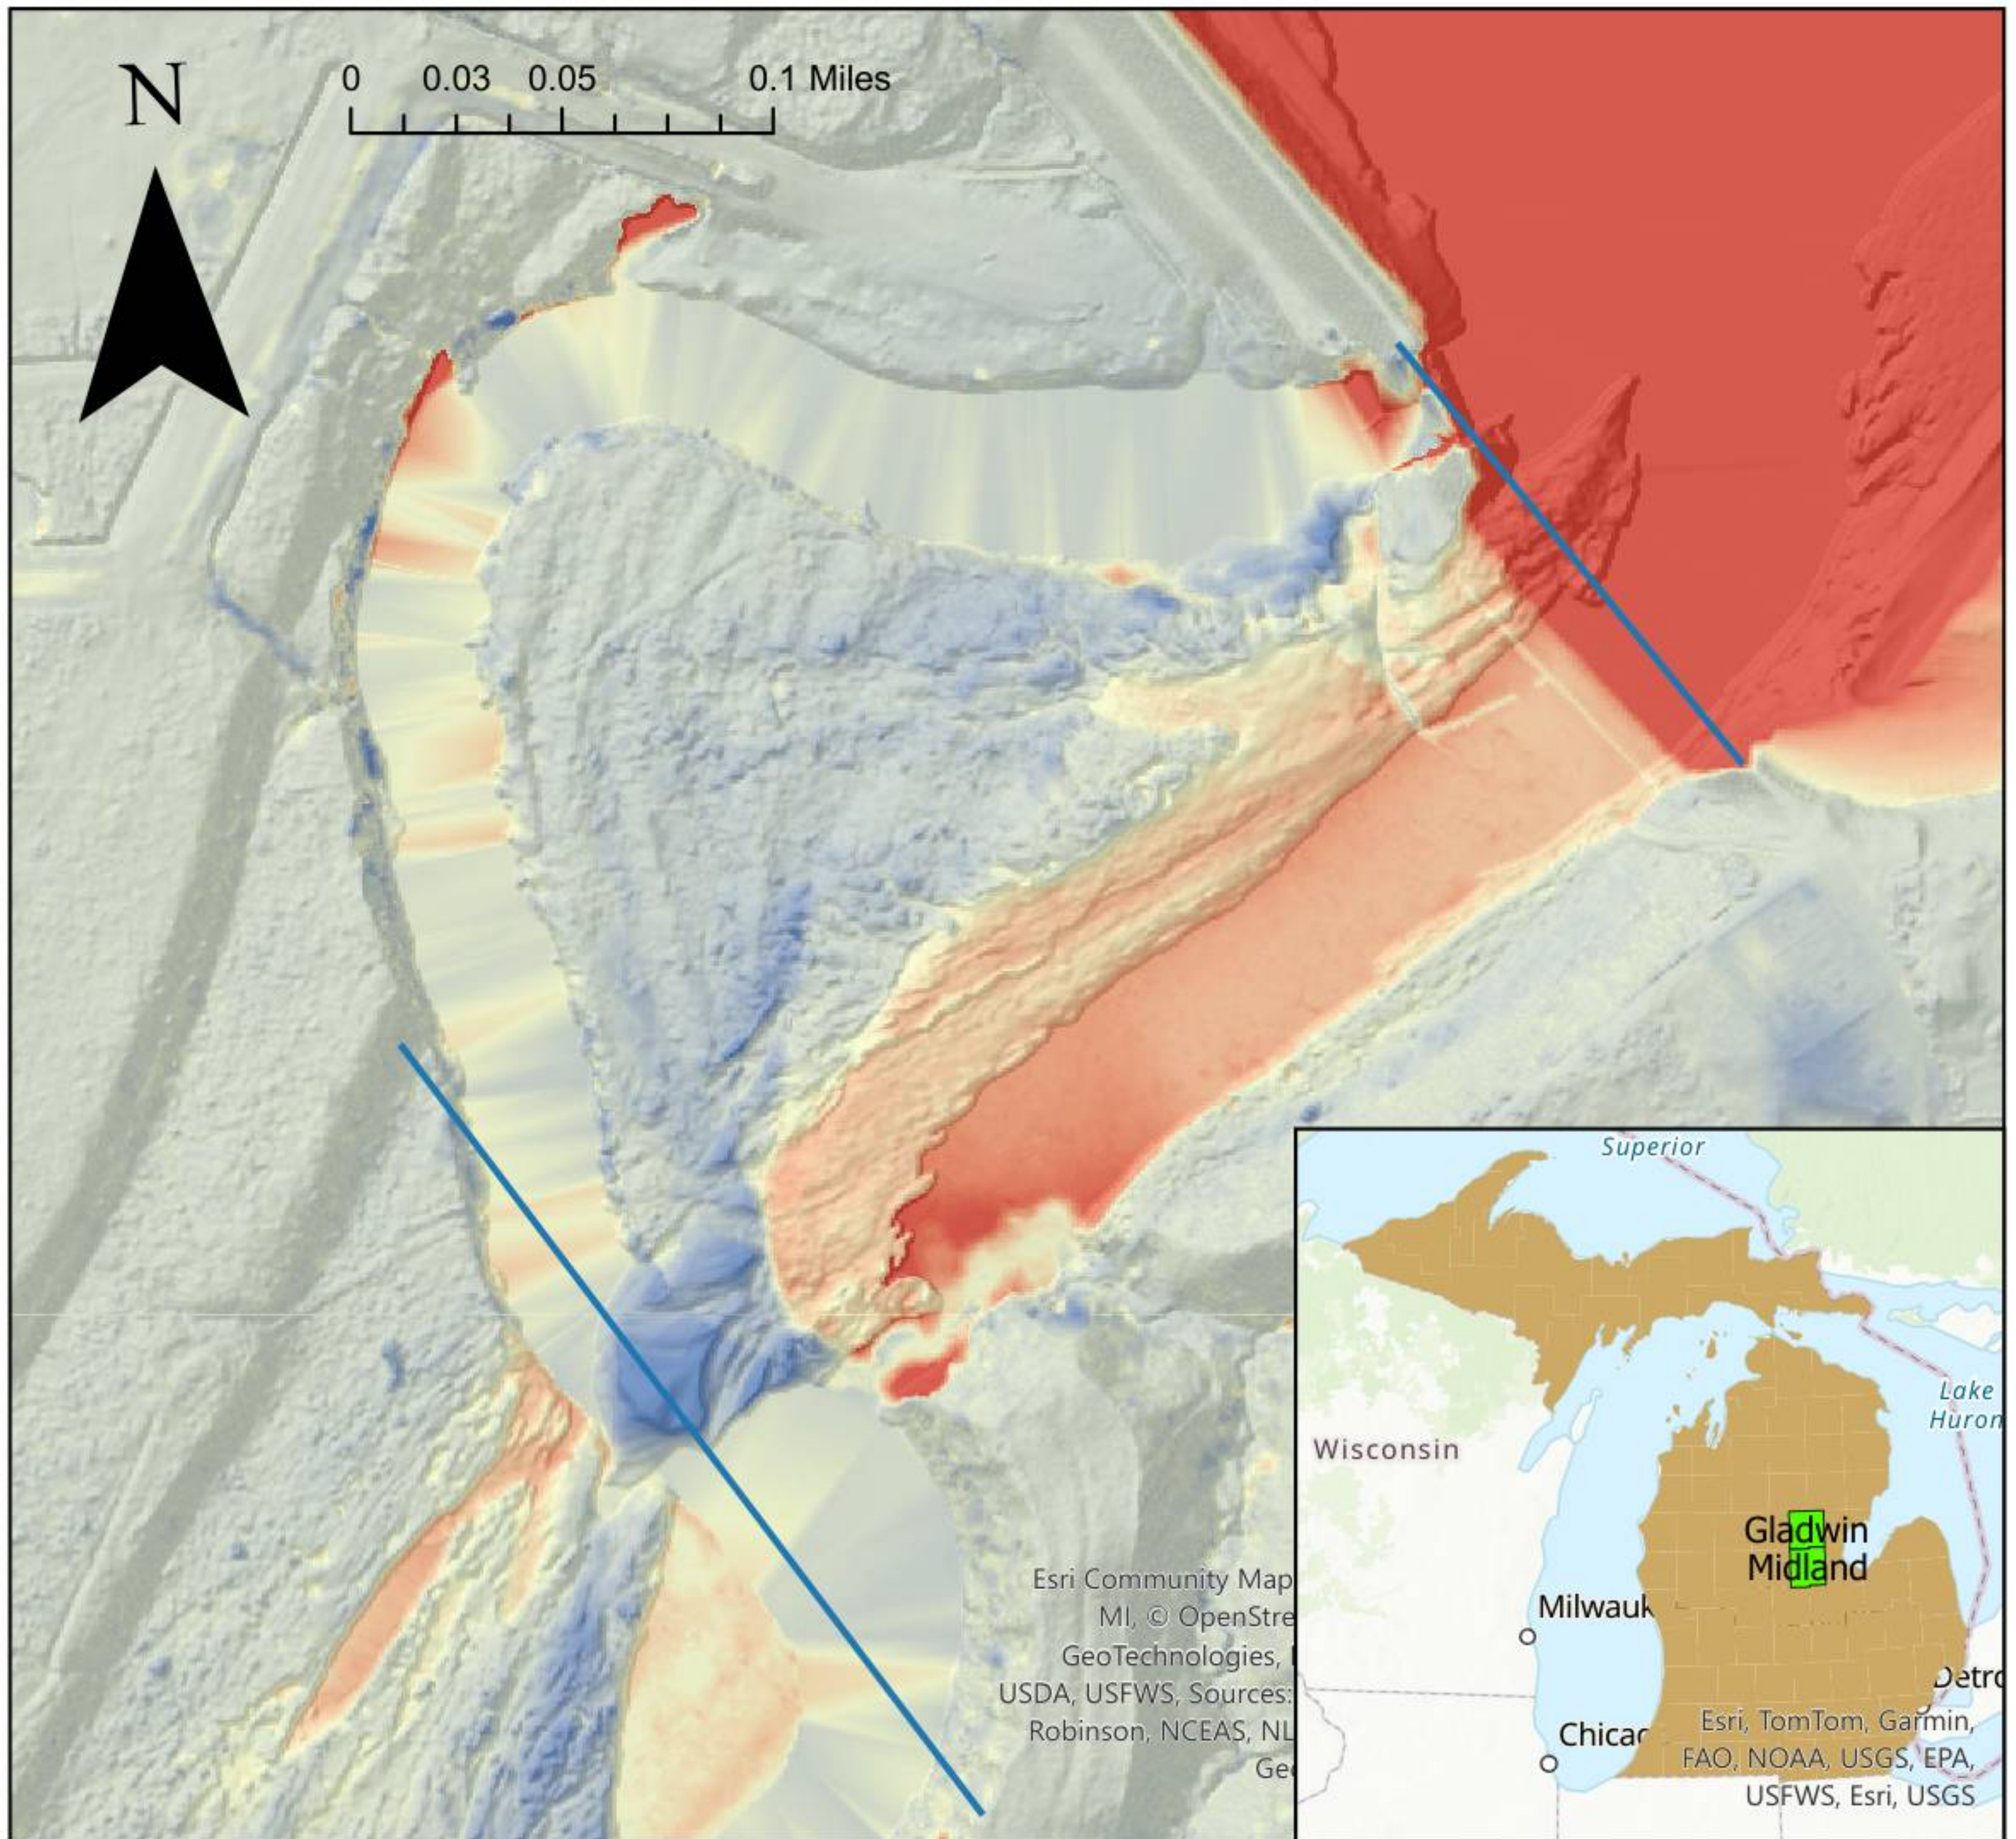
This shows the elevation difference in elevation of the local area before and after the Edenville Dam collapse. The dam collapse impacted Gladwin and Midland counties. The map shows a dramatic decrease in elevation of the area where the dam used to be (Top right line on the map), and an increase in elevation downriver towards what used to be the mouth of the river that the dam emptied into. This is likely due to water level dropping dramatically near the dam, and the water level rising downriver once the dam collapsed. Also it's likely some sediment near the dam was carried by the water and deposited downstream once the dam collapsed.
