TASKCARD

A/C TYPE	Effectivity	DESCRIPTION	WORK ORDER NO.	
		A320 FAMILY - WEEKLY CHECK		
A/C REG.	A/C MSN.	ACCESS	TASKCARD NO.	
			A32-052000-99-3-IDN	
A/C TSN.	A/C CSN.		THRESHOLD	INTERVAL
:			0	0
OPERATOR	PLACE	ZONE	TASK	REVISION
			DET	10
START DATE	FINISH DATE	NOTE	ATA	SKILL
		<input type="checkbox"/> ETOPS <input type="checkbox"/> RVSM <input type="checkbox"/> RNP10 <input type="checkbox"/> RII <input type="checkbox"/> CDCCL	05-20

WORK ORDER NO.	A/C REG.	A/C MSN.	A/C Effectivity	OPERATOR	TASK CARD NO.
					A32-052000-99-3-IDN

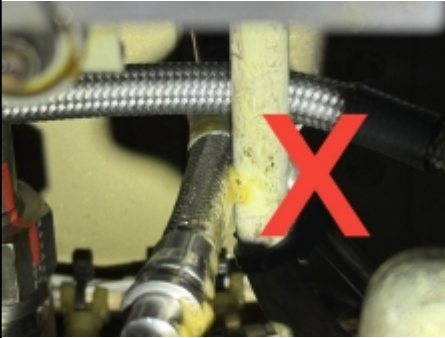
ACCOMPLISHMENT			
NO.	INSTRUCTION	PERFORMED BY	INSPECTED BY
7	<p>ON A/C FSN 001-050, 051-100, 101-150, 151-200, 201-250 (AMM 05-21-20-200-002)</p> <p>1.3 NOSE LANDING GEAR WELL</p> <p>Do a general visual inspection of the nose gear well as far as visible, including:</p> <p>Components: Installation, hydraulic fluid leakage, Checked</p> <p>Doors: Structure, hinges, up-lock assy and operating Checked mechanism,</p> <p>Gear assy: Structure, attachment. Checked</p>	A/P	
8	<p>ON A/C FSN 001-050, 051-100, 101-150, 151-200, 201-250 (AMM05-25-70-200-001)</p> <p>1.4 MAIN LANDING GEAR BAY</p> <p>Do a general visual inspection of the LH and RH main landing gear bay as far as visible, including:</p> <ul style="list-style-type: none"> - Components: Installation, hydraulic fluid leakage, Checked - Gear assy: Structure, attachment. Checked <p>(pos# 11, 16 see diagram at appendix)</p> <p>CAUTION:MAKE SURE THE HYDRAULIC LINE NOT INTERSECT EACH OTHER, DUE TO WILL CAUSE HYDRAULIC LEAKAGE</p> <p>EXAMPLE IMPROPER POSITION</p>

<p>EXAMPLE PROPER POSITION</p>	A/P

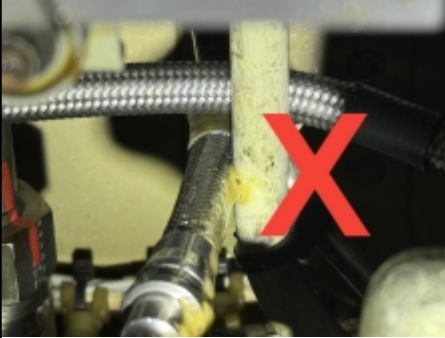
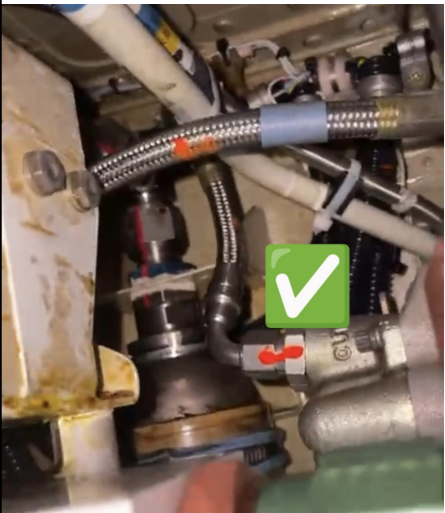
ACCOMPLISHMENT			
NO.	INSTRUCTION	PERFORMED BY	INSPECTED BY
	value "P" minus 217.56 psi (15.00 bar) ACTION REQUIRED ** ON A/C FSN 001-041, 104-104 - If the value on the brake accumulator pressure-gage (2585GM) is less than value "P" minus 20 bar ACTION REQUIRED (290 psi) ** ON A/C FSN 042-299 Adjust the nitrogen pressure as necessaryRef. AMM TASK 12-14-32-614-002.		
10	ON A/C FSN 001-050, 051-100, 101-150, 151-200, 201-250 (AMM 32-40-00-210-801) 1.5 WHEELS AND BRAKES (MP TASK 324000-16-1) General visual inspection of ML/G brake units Checked (pos# 11, 16 see diagram at appendix)	A/P	
11	ON A/C FSN 001-050, 051-100, 101-150, 151-200, 201-250 (AMM 12-22-32-640-001-A) 1.6 LUBRICATION OF MAIN LANDING GEAR DOORS (AOT A32N006-14) Perform LH and RH MLG door actuator PN 114122014 Serviced greasing NOTE: Ensure greasing of both eye end bearings is accomplished	A/P	
12	ON A/C FSN 001-050, 051-100, 101-150, 151-200, 201-250 (AMM 05-21-40-200-003) 1.7 MAIN GEAR WELL - HYDRAULIC COMPARTMENT Do a general visual inspection of the LH and RH main landing gear well and hydraulic compartment as far as visible, including: - Components: Installation, hydraulic fluid leakage, Checked - Doors: Structure, hinges, up-lock assy and operating Checked mechanism. NOTE : The checklist in A320-EA-29-1293 must be filled. CAUTION:MAKE SURE THE HYDRAULIC LINE NOT INTERSECT EACH OTHER, DUE TO WILL CAUSE HYDRAULIC LEAKAGE EXAMPLE IMPROPER POSITION	A/P

EXAMPLE PROPER POSITION

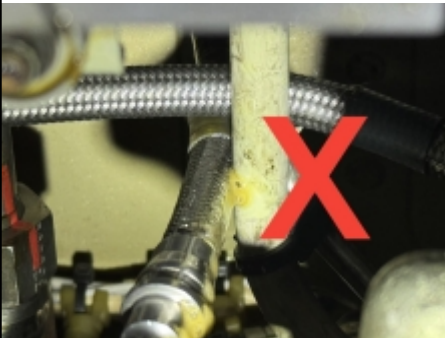
ACCOMPLISHMENT			
NO.	INSTRUCTION	PERFORMED BY	INSPECTED BY
14	<p>ON A/C FSN 001-050, 051-100, 101-150, 151-200, 201-250 (AMM 29-10-00-864-003-A) (AMM 29-24-00-864-001-A) (AMM 29-24-00-864-002-A)</p> <p>1.9 DEPRESSURIZE BLUE AND YELLOW HYDRAULIC SYSTEM</p> <p>Depressurize the Blue And Yellow Hydraulic System Serviced</p> <p>(AMM 29-11-49-200-010-A) IAE Engine (AMM 29-13-49-200-010-A) IAE Engine (AMM 29-11-49-210-002-A)CFM engine (AMM 29-13-49-210-001-A) CFM engine</p> <p>1.9.1 HYDRAULIC HOSES AND TUBES OF ENGINES</p> <p>Do visual inspection of the hydraulic hoses and tubes of Engine #1 and Engine #2.</p> <p>Inspected</p> <p>Please write down the results :</p> <p>.....</p> <p>.....</p> <p>.....</p> <p>.....</p> <p>Note:</p> <ul style="list-style-type: none"> - make sure there is no leakage on the tube, hose, fitting and union - make sure clamp on the proper position, if no proper please fix it base on the AMM <p>CAUTION:MAKE SURE THE HYDRAULIC LINE NOT INTERSECT EACH OTHER, DUE TO WILL CAUSE HYDRAULIC LEAKAGE</p> <p>EXAMPLE IMPROPER POSITION</p>

<p>EXAMPLE PROPER POSITION</p>	A/P
