## **SEISMIC RESPONSE OF BRIDGES LOCATED IN CHRISTCHURCH, NEW ZEALAND**

Christopher Manco, University of Delaware, [cmanco@udel.edu](mailto:cmanco@udel.edu)

REU Institution: University of Auckland, New Zealand

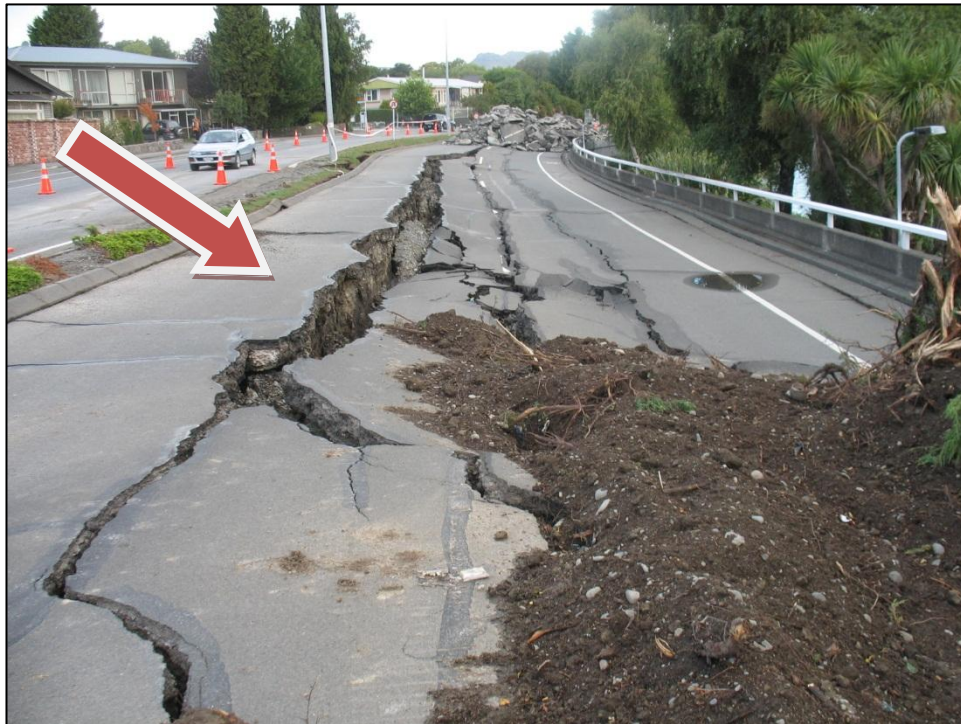
Liquefaction by itself causes no harm but when it is accompanied by some form of displacement it can lead to severe damage to the built environment. Engineers study this phenomenon so that they can understand its behavior and develop solutions that will prevent liquefaction from significantly damaging our infrastructure. They have learned that it can take on many forms. For example, lateral spreading is the movement of large sections of soil as a result of liquefaction (Committee on Soil Dynamics of Geotechnical Engineering Division [CSDGED], 1978). It generally develops on slopes and moves toward a free surface such as a river (See Fig. 2). These displacements can range up to several meters, forming large cracks in the ground. Buildings and bridges built on or across the failures are known to experience displacement or rotation in their foundations. Depending on the severity, this may lead to the collapse or buckling of these structures.

Figure 2: Road damage due to lateral spreading along the Avon River, New Zealand

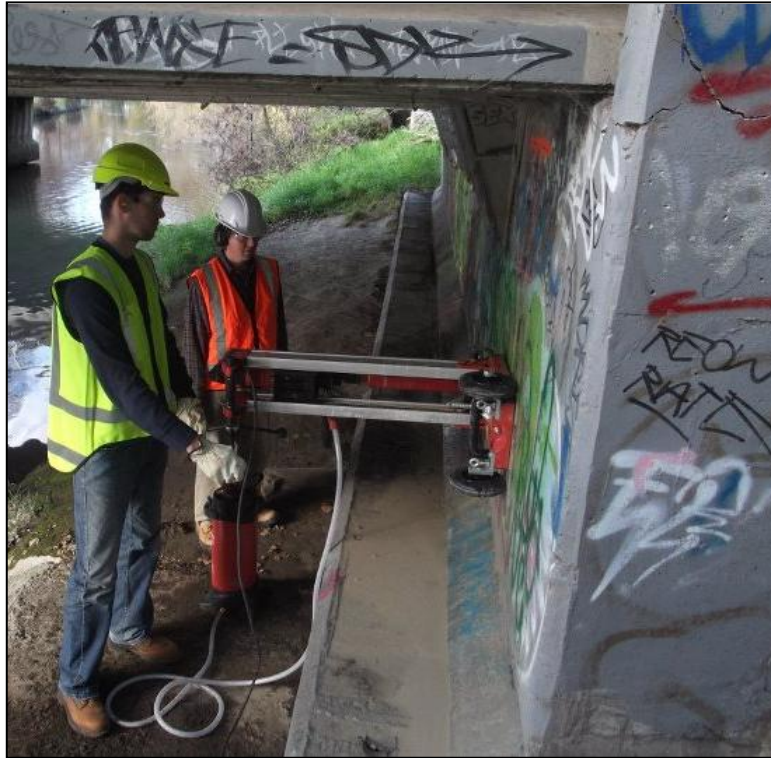
Upon arriving at the site of each bridge, a brief examination of the structure would take place in order to determine the best area to collect a sample. A Hilti PS 35 Rebar Detector was used to locate the rebar positioned within the concrete. Next, the coring system was set and attached to the abutment of the bridge. The equipment that was used included the Hilti DD 130 Diamond Coring System and the Kipor IG3000X/E Generator. Three concrete samples were then taken from the abutment. Figure 5 shows how the sample collecting was completed. Two tests were immediately performed on the samples. A silver nitrate and phenol thalein test determined how much chloride and carbon penetrated the concrete, respectively. Both tests are performed by spraying a small amount solution on the samples. Depending on the color that appears, one can determine how much of the elements have entered the concrete. Assessments such as these are necessary because large amounts of these elements found in concrete can significantly compromise its strength. A fourth hole was drilled into the abutment to expose the rebar of the structure. A hardness test was then performed on the reinforcement. This experiment requires the use of an indenter and Birnell microscope. The indenter makes a small indent on the surface of the rebar and the microscope measures the diameter of the hole. With the measurement of the diameter, the strength of the rebar can be determined. This examination was conducted to see if deep cracks in the bridge allowed water to damage the reinforcement.

Figure 5: Collecting a concrete sample from Fitzgerald Avenue Bridge

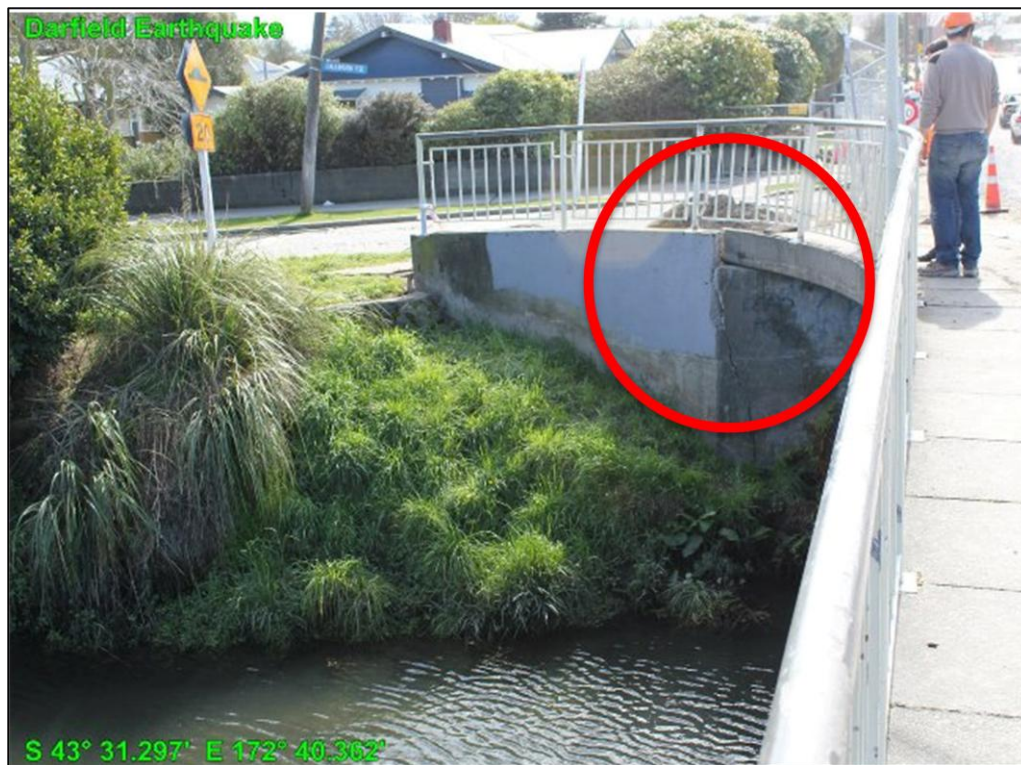
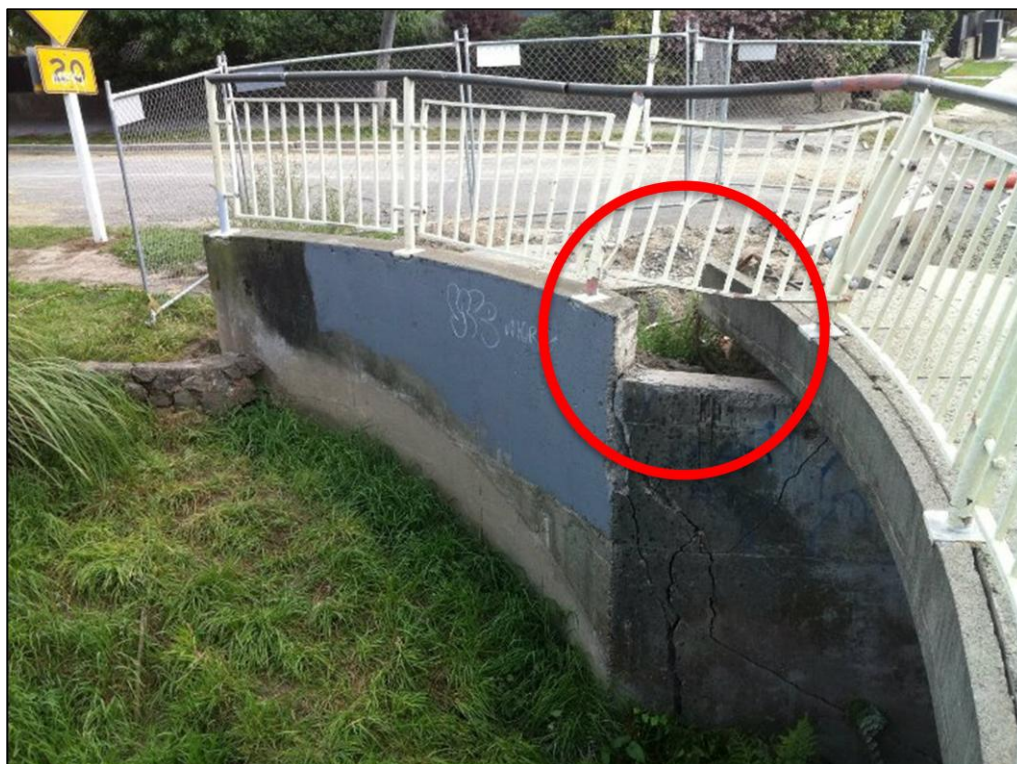
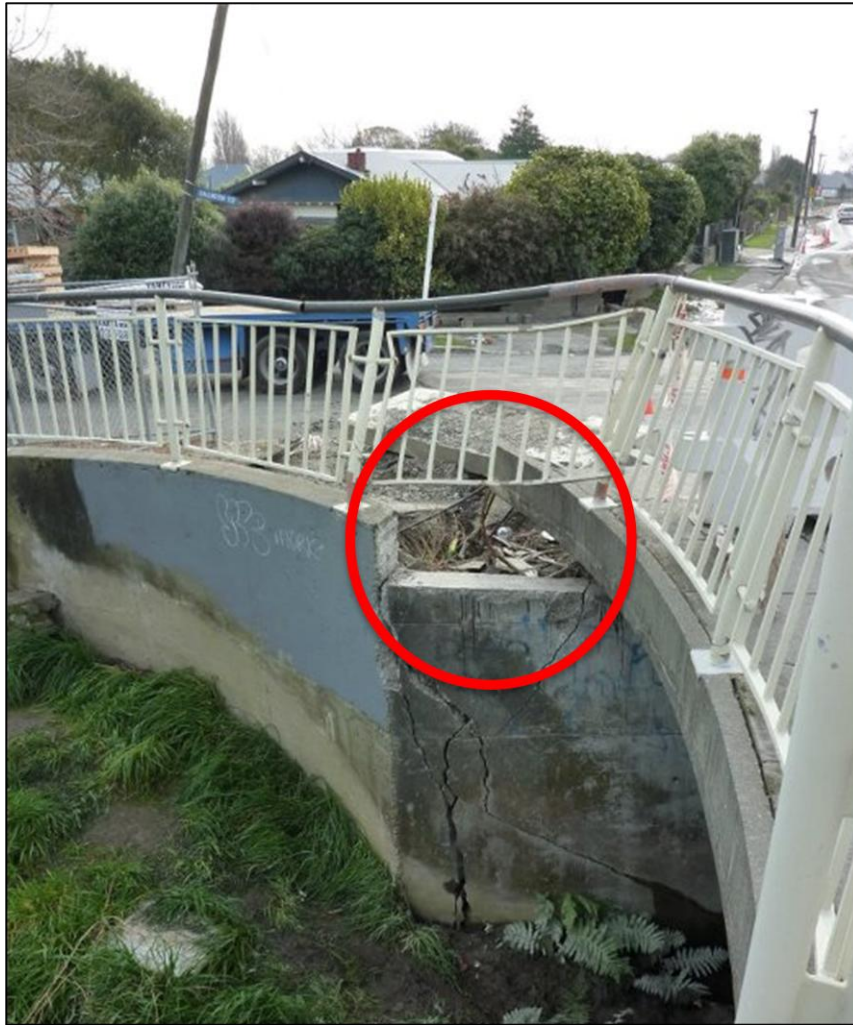
The final part of the research program dealt with recording the damage progression of the bridges. Since the 04/09/10 Darfield earthquake, Dr. Wotherspoon has recorded changes in bridge damage over the past few months by taking pictures. All the photos were compiled, organized, and clearly labeled to show the damage progression of each bridge. An example of this can be found in Figure 6. This figure shows the damage progression of Gayhurst Road Bridge, north abutment wing wall/bridge deck connection. While completing this portion of the project it was sometimes difficult to determine what section of the bridge was being viewed in the pictures. In order to correct this, indicators within the background of the photos were used to determine the bridge section and its geographical location (i.e. North Abutment, West Side).

Figure 6a: September 20<sup>th</sup> 2010

Figure 6b: March 1<sup>st</sup> 2011

Figure 6c: June 17<sup>th</sup> 2011
