REPAIR AND CONSERVATION OF REINFORCED CONCRETE

David Farrell and Kevin Davies

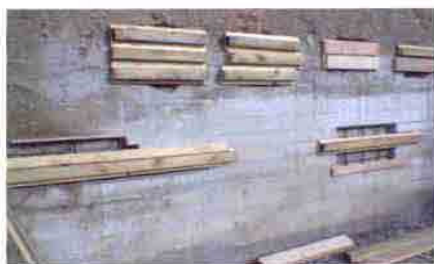
Figures 2 & 3 Breakout and repairs using formwork (Photo: Francis Doherty) and (below) the finished work

Examples of patch repairs on 1930s concrete undertaken for English Heritage are shown in figures 2 and 3. The repair sites were marked out and a 25mm diameter core drill was used to mark the corners. This provided relief at these points and reduced the risk of the arrisses spalling. The depth of the cut-outs was specified as a minimum of 40mm but many areas were taken down to 75mm. This, together with an undercut of 2–4mm on the edges to create a dovetail, helped to lock the repair patches into the existing concrete more securely. Steel reinforcements with previously low cover were either replaced at a greater depth or hammered back into the concrete. The corroded bars were wire brushed to remove the loose corrosion product and not coated. The new high alkalinity concrete will effectively re-passivate the corroded steel. Boards, to match the height of impressions in the original concrete, were fixed across the repair sites and cotton wool was used to seal the interfaces. The repair concrete was sequentially poured in for each board and on the top board a 'letterbox' was added to allow it to be filled. The repairs were then externally vibrated to achieve complete filling of the voids.

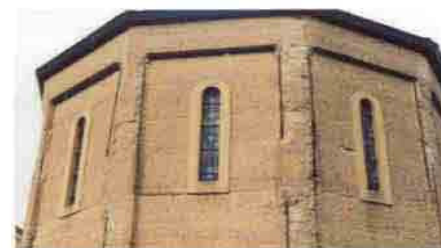
One example of this approach is illustrated by the treatment of concrete decay and reinforcement corrosion on the external columns of the chancel at the parish church of St John and St Mary Magdalene in Goldthorpe (figure 4). The concrete of this 1914 church had been badly damaged by a combination of carbonation and attack from sulphurous fumes from the nearby Sheffield steelworks in the early part of the 20th century. This church was

Figures 4 & 5 Concrete decay and reinforcement damage to the full length columns at Goldthorpe and (below) the finished work

extensively repaired in 2001/2 using traditional concrete repairs and replacement. English Heritage requested a near perfect colour and finish match to the original yellowed texture and ruled out masking the repair with paint, which is the more usual treatment for concrete repairs. The match was achieved by varying the sand and cement content and, in all, involved 30 trial mixes to achieve the best colour and texture for specific parts of the church. The final mix was a 1:2:4 ratio of cement, sand and coarse aggregate with a 0.4 water/cement ratio. Yellow dye and a water-proofing additive were also used. A photograph of the completed chancel is shown in figure 5. The shutters were struck after only 12 hours and laitance (the weakly bound surface residue of cement and fine particles) was removed by brushing to

expose the aggregate. The variable 'day joints' which were formed when the concrete was first cast were faithfully recreated in the repairs to match the original.

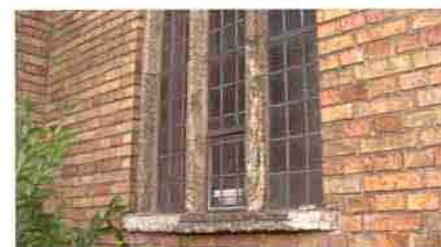
Figures 6 & 7 Concrete mullions at Scunthorpe Church and (below) a repaired window

A photograph of corrosion-induced damage to concrete mullions at St Hugh's, Scunthorpe is shown in figure 6. Again, the RC had been subject to carbonation and chemical attack by sulphurous fumes, in this case from the coking plants that surrounded the town in the middle of the 20th century. Mullions may be either repaired in situ or alternatively, re-cast off site and the sections replaced. An example of repaired mullions is shown in figure 7.

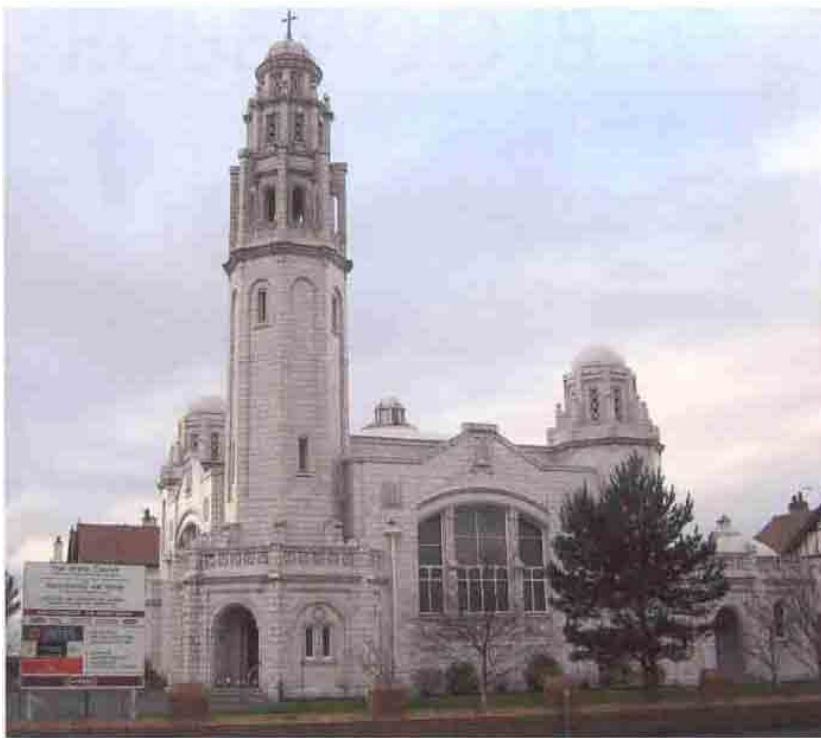
Figure 8 The White Church, Lytham St Annes (Photo: Phil Stringer)

Significant repairs were carried out using polymer-based materials at The White Church, Lytham St Annes in 2004 (see figure 8). The church was constructed in 1903 using mainly stone and brick, but it also contained some of the oldest known RC still in everyday use. The RC comprising the beams and floors within the tower had been subject to corrosion by a combination of carbonation and chloride attack (see figure 9). The church is situated close to the sea and the marine air is used to ventilate the inside of the tower.

considered for this project but these would have involved the complete breakout and loss of the existing (historic) concrete floors. The use of modern concrete repairs, on the other hand, would enable breakout and removal to be limited to the most significantly damaged concrete of the deck soffits and slabs. Pre-bagged, proprietary repair materials were therefore chosen as they were deemed able to provide the strength and corrosion resistant qualities required. A photograph of the RC beams after the loose concrete had been removed and the bars cleaned and primed is shown in figure 10.

The repair materials were applied to the floors by hand to a thickness of 50–80mm and reinforced with a stainless steel mesh on the underside of the floors. The beams were worked on half a beam at a time. First, formwork was erected around them to form the original profile, then the formwork was filled with water both to wet the original concrete and to wet the boards. After several hours soaking, the polymer-modified repair material was poured in. External vibration was used to remove air voids and the concrete was left to cure for three days. Finally, an anti-carbonation coating was applied over the repaired concrete to slow down future deterioration.

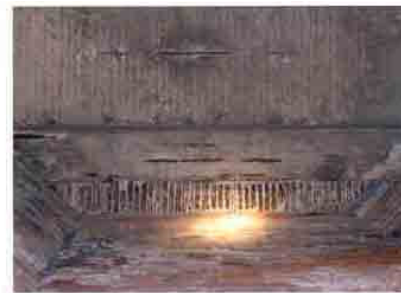
Figures 9 & 10 Corroding reinforced concrete beams and floor in the tower of The White Church and (below) the steel reinforcement after removal of the concrete and the application of a primer
