Crack growth monitoring on industrial plant using established electrical resistance 'Scanner' technology

D.M. Farrell and B.J. Robbins
Rowan Technologies Ltd
216 Church Road, Urmston, Manchester, UK.
Tel: (44) 161 748 3644, E-mail: mail@rowantechnologies.co.uk

J. Stallings, S. Cardoso and W. Bakker
Electric Power Research Institute
3420 Hillview Avenue, Palo Alto, CA, USA

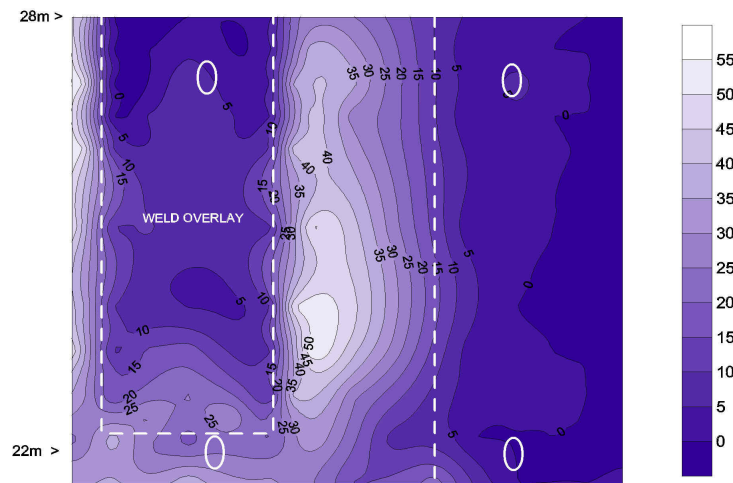
Figure 1: Typical corrosion rate map (measured in nm/hr) of a boiler wall showing excessive corrosion of the bare steel tube but minimal corrosion of the Inconel 625 weld overlay

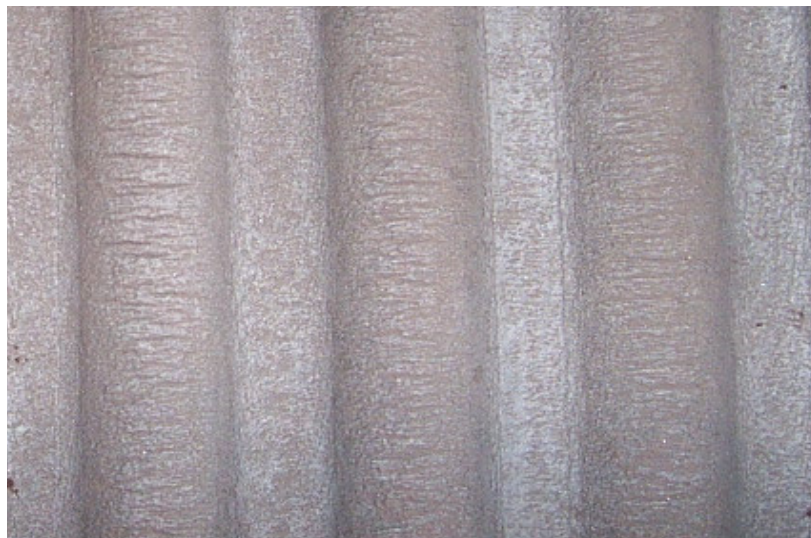
Figure 2: Image of circumferential cracking on boiler tubes

Due to a number of changes that have been made to accommodate environmental concerns, including low NO_x burners and over-fired air (OFA) systems, many of these supercritical units are now finding circumferential cracking of their weld overlaid boiler tubes in the furnace zone. The Electric Power Research Institute (EPRI) instigated a Program on Technology Innovation to find ways of detecting and measuring the cracking and to investigate the reasons for it. Rowan Technologies was asked to increase the sensitivity of its scanner technology to detect and quantify the cracking, carry out a modelling study using finite element analysis and then to use the improved scanner technology on a boiler subject to cracking. The plant selected for the site trial was a super-critical coal-fired boiler operated by Pennsylvania Power and Light in the USA; circumferential cracking of weld-overlaid tubes is an ongoing problem in this boiler, Figure 2.

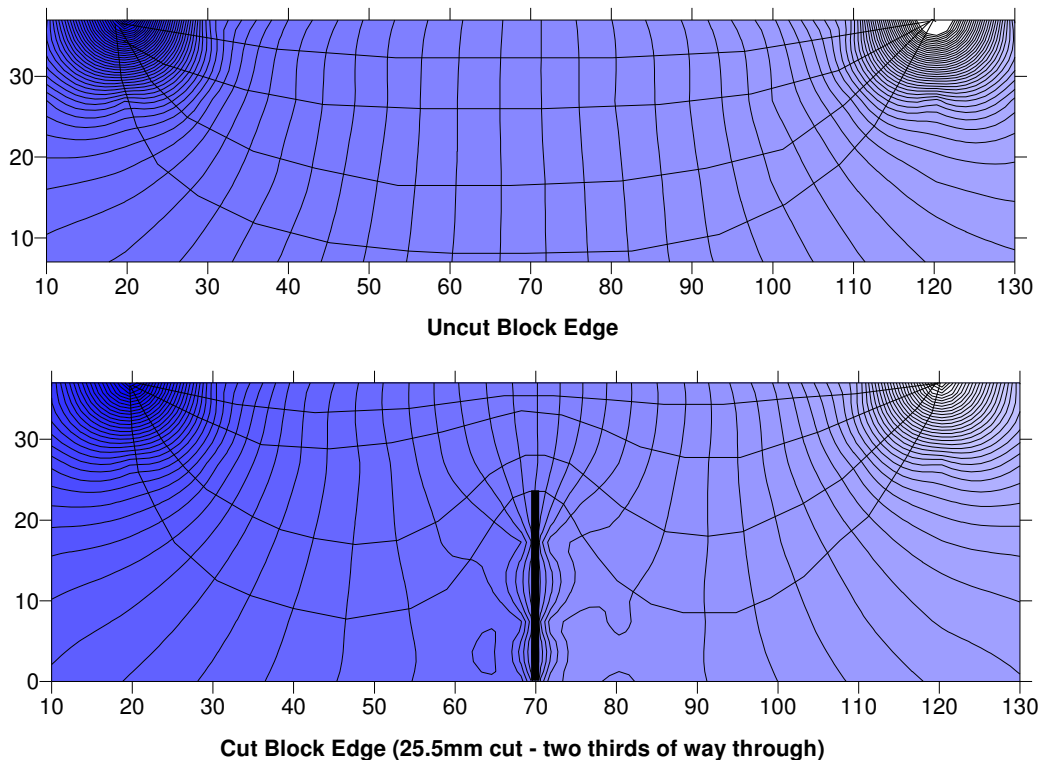
Notes
Current Travels Perpendicular to Field Lines
Current Density Proportional to Field Line Separation

Figure 3: Measured field lines – with and without crack

A simple laboratory-based demonstration of the influence of a 25.5mm deep crack which affected the flow of current through a 38mm thick block of steel is shown in Figure 3. The current density is seen to be highest around the crack tip where the potential gradient is at its highest. A graph of the increase in electrical resistance as a function of the crack depth is shown in Figure 4. Note – as the crack deepens the increase in resistance accelerates and approaches infinity when it is almost through. As the crack gets deeper then its rate of propagation becomes easier to quantify.

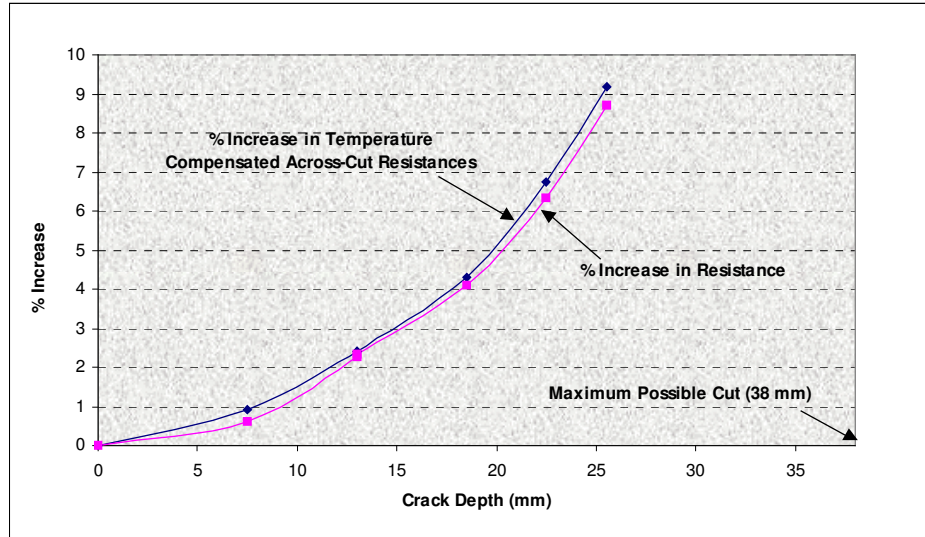
Figure 4: Typical increase in electrical resistance with increasing depth of crack for a 38mm thick steel wall

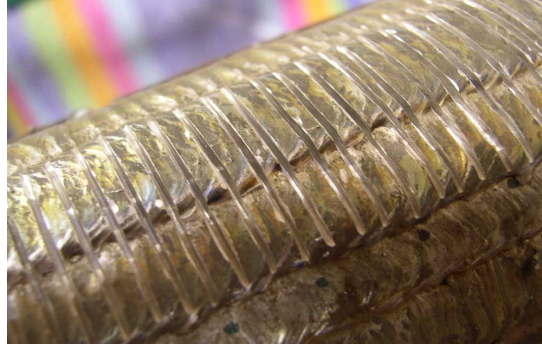
Figure 6: Example of artificial cracks cut into the weld overlay. Note – the cracks were shaped as penny slots (deeper in the middle) to simulate real cracks

The model was extended to 3-dimensions and sections of Inconel 625 weld-overlaid boiler tubing were obtained to carryout comparative laboratory simulations. Artificial cracks were cut into the weld overlay tubes at differing depths (ranging from 0.125mm to 1.5mm using a small diamond wheel to simulate those found on boiler tubes, Figure 6. The close relationship between the results from the model and the laboratory simulation tests is shown in Figure 7.

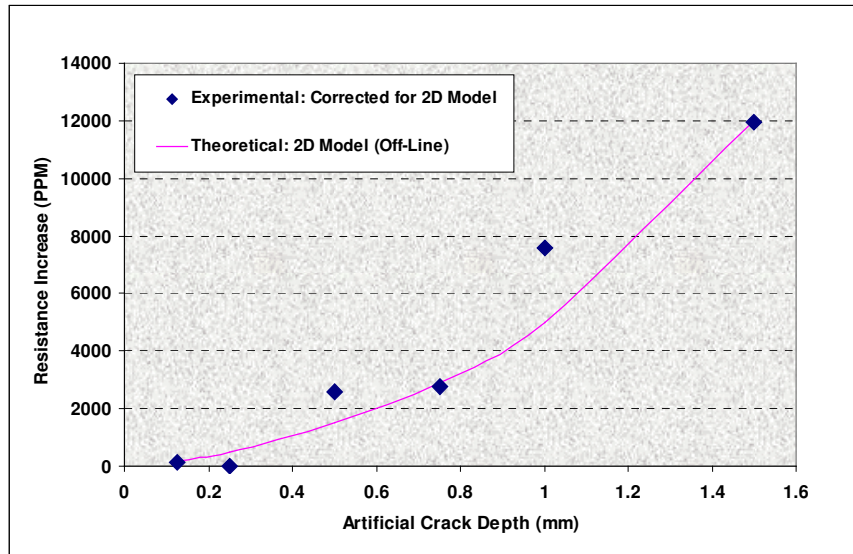
Figure 7: A graph of increase in electrical resistance with crack depth at a crack spacing of 8 per inch

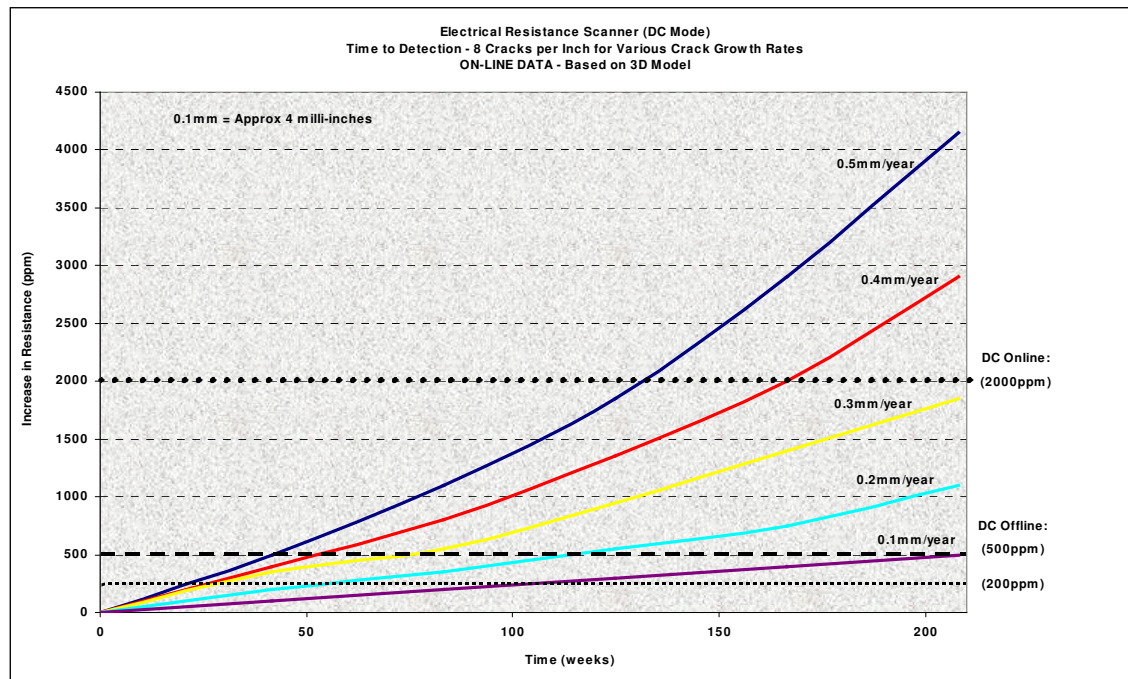
Figure 8: Time to detection for crack growth for a boiler when on-line with a DC system. Note – resistance increases have been reduced by a factor of 4 to account for the crack length being only a quarter way around the fireside segment

Finally, 3-dimensional models were developed which related different crack depth and crack spacing to the increase in electrical resistance. A typical ‘time to detection’ graph for circumferential cracking on boiler tubes at various crack depths and 8 cracks/inch is shown in Figure 8. The sensitivity of the combined scanner and electrode arrangement was known, both for on-line and off-line assessment. Although the electronics used in the scanner are sensitive to 200ppm (when combined with the welded electrodes and without unmeasurable temperature variation), when the boiler is on-line this increases to 2000ppm. Using off-line data (which minimises temperature effects) the sensitivity is around 500ppm. For a 0.5mm deep crack this

would take around 130 weeks to reliably quantify for the on-line data and around 48 weeks for off-line data.

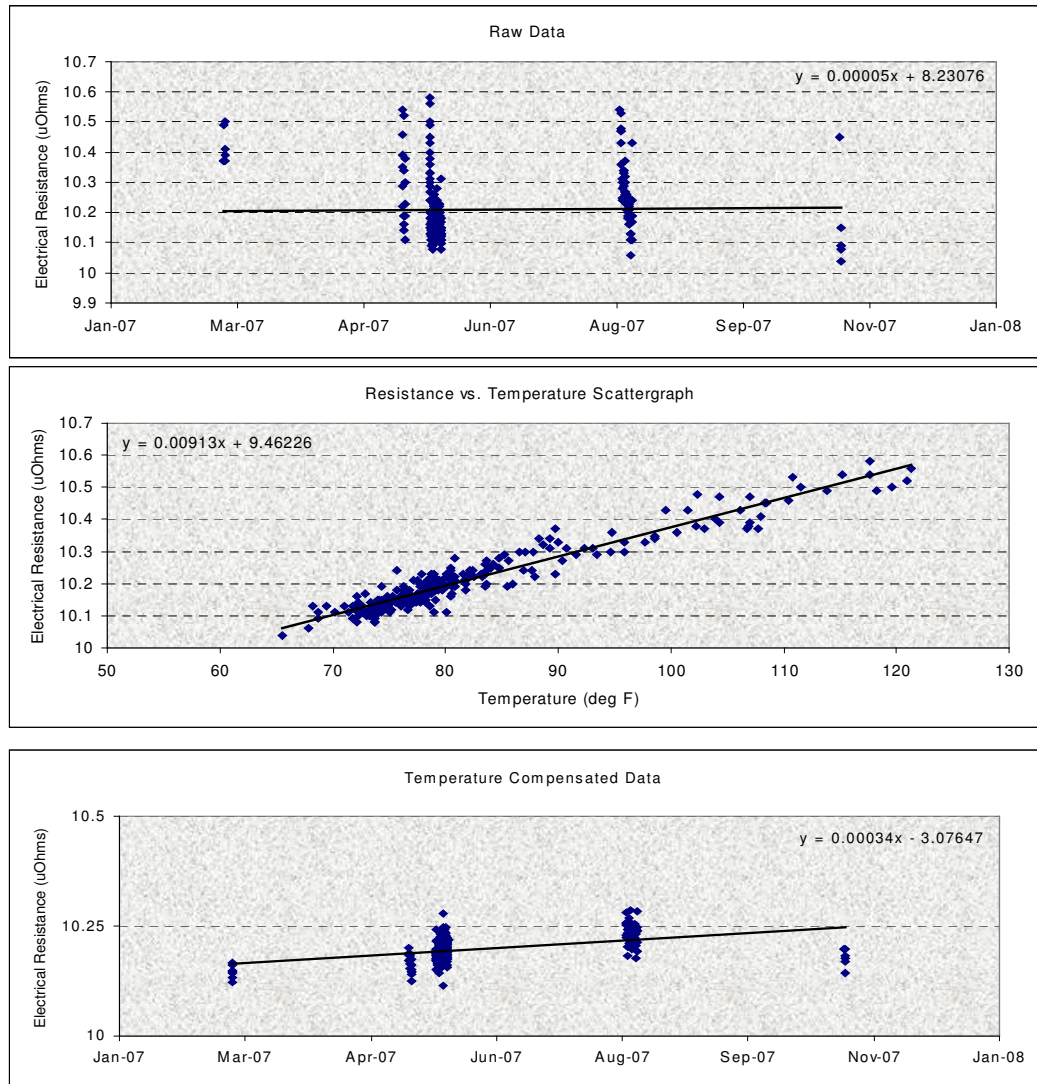
Figure 9: Typical analysis of electrical resistance data – the raw data is temperature compensated to produce the real electrical resistance

The system was commissioned in January 2007 and the results to December 2007 indicate that a few areas of the walls may be subject to crack initiation and growth. The most consistent data was for the off-line periods and using individually temperature compensated data. An example of the off-line electrical resistance data is shown in Figure 9. The raw data (without temperature compensation) is shown in the top trace. The data (resistance vs. temperature) is next plotted to produce a 'scattergraph'; the gradient of which is the temperature coefficient of resistance for the particular alloy (or in this case weld-overlaid construction) in this temperature range. This method is preferable to determining the constant from laboratory work as it also takes into account the geometry and other factors (such as the weld overlaid construction), which will contribute to variations in electrical resistance. This coefficient is then used to temperature compensate the raw resistance data. The temperature compensated data showed a small increase in electrical resistance which

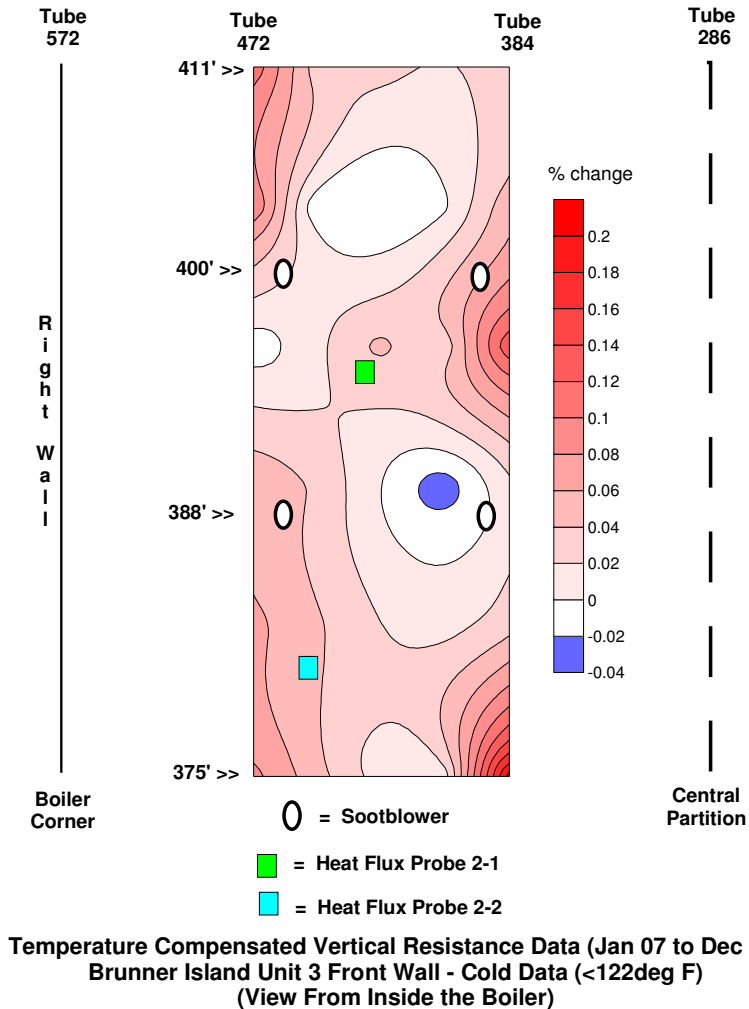
Figure 10: Temperature compensated vertical resistance data

may be associated with crack growth. An example 2D map of the test area on the front wall, giving the change in electrical resistance, is shown in Figure 10. From the initial laboratory-based simulation of circumferential cracking⁽³⁾ and using a density of 16 cracks/inch, this equates to a maximum depth (on the right side of the test area) of between 0.25 to 0.5mm (9 to 18 milli-inches) on the fireside crown of the weld-overlaid tubes. This is close to the detection limit of the scanner. Further monitoring is currently being carried out to quantify the rate of crack growth on this boiler.

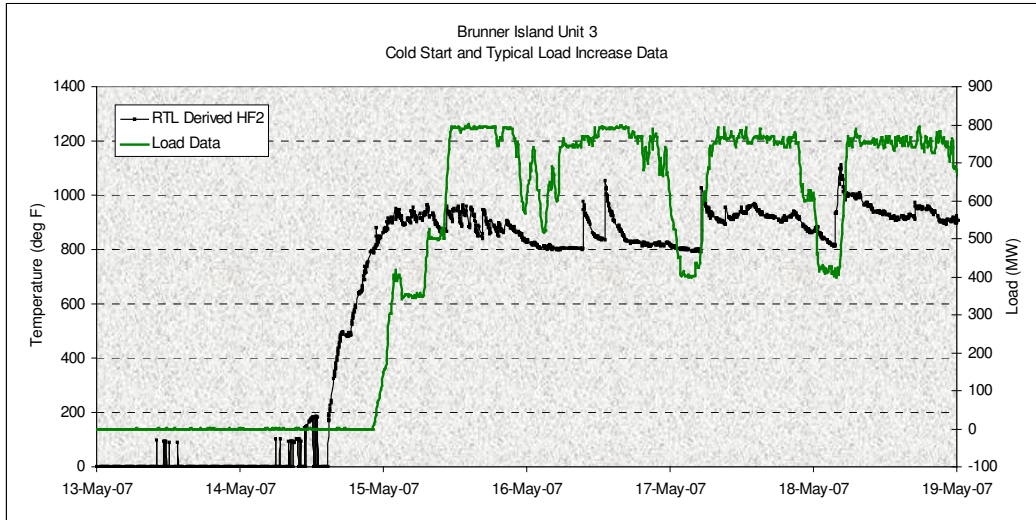
Figure 11: Thermal data from Brunner Island Unit 3, front wall

Typical thermal data from the scanner (at one location only) is shown in Figure 11. This shows four thermal spikes relating to the fireside temperature of the tube, two of which correlate with increases in boiler load and two of which occur at full load. A 2D map of the front wall test area during one of these thermal spikes is shown in Figure 12. This shows the highest membrane temperatures around the middle of the test area. These thermal events, which will contribute towards the stress resulting in fatigue cracking are occurring on the fireside and are due to operational factors, such as slag shedding, flame impingement or increased radiation from the fireball⁽⁴⁾.

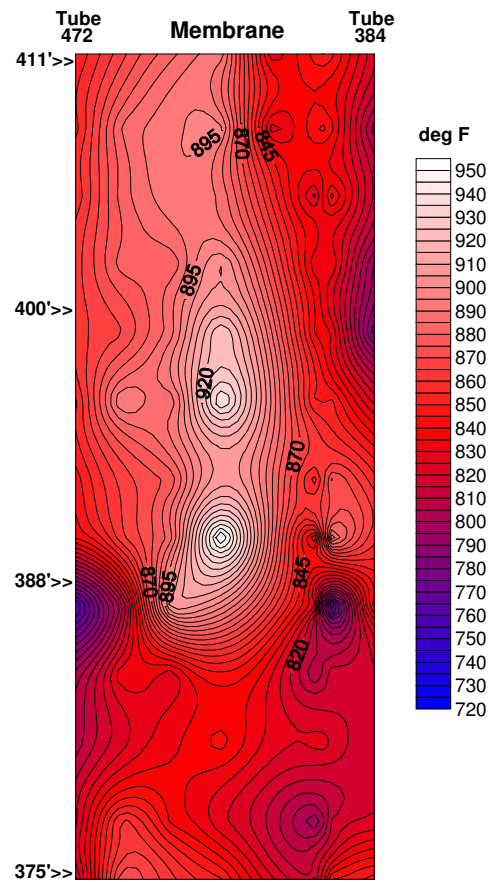
Figure 12: 2D thermal map of Brunner Island Unit 3, front wall after start of second thermal event
