Cathodic Protection of Tie Bars and Ring Beams in Church Towers

Christopher Hunt and David Farrell

**Rowan Technologies Ltd, 216 Church Road, Urmston, Manchester
M41 9DX, Tel: 0161-748-3644, Email: mail@rowantechnologies.co.uk**

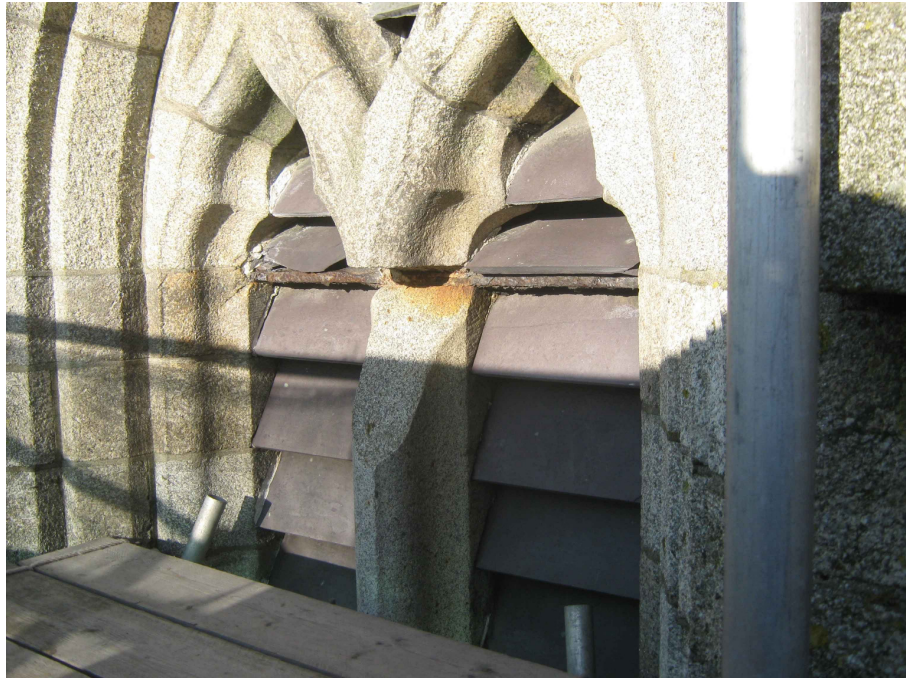
Figure 1 Large tie bars embedded in the inner masonry and passing through the mullions, resulting in fracture of the granite, St Aidan's Cathedral, Enniscorthy.

An example of corroding iron tie bars, which are connected together to form a ring beam within a church tower, is shown in Figure 1. This shows spalling of the central mullion due to ongoing corrosion. Ring beams were originally incorporated into the towers to resist the masonry buckling outwards and to strengthen the walls to resist wind loading. Normally they are embedded within the external masonry to maximise support to the tower, but sometimes they are embedded within the internal masonry if the thickness of the wall changes due to windows or louvres being present.

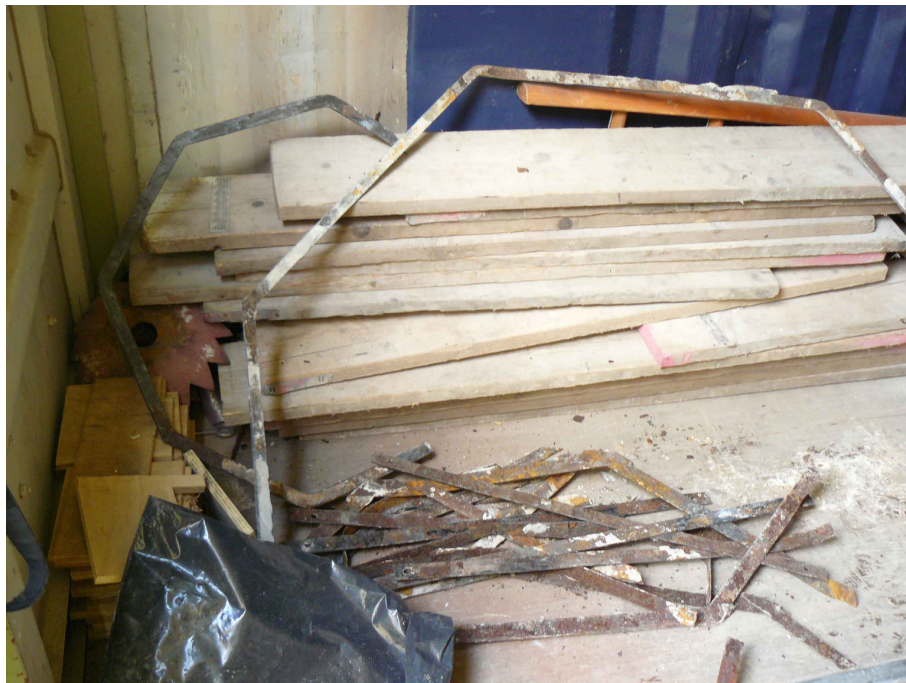
Figure 2 Corroding wrought iron fitments, which were readily removed from the tower, St Mary's church, Balderstone.

The conventional remedy has usually involved surgery to remove the iron fittings, Figure 2. They may sometimes be replaced with non-corroding phosphor bronze or stainless steel, or even left without replacement, prior to repair to the stonework. Conventional treatments can sometimes be highly invasive involving large-scale opening up to expose and treat affected components or even demolition to replace the iron. Cathodic protection offers an alternative, non-intrusive approach to the treatment of rusting iron buried in masonry and stone.

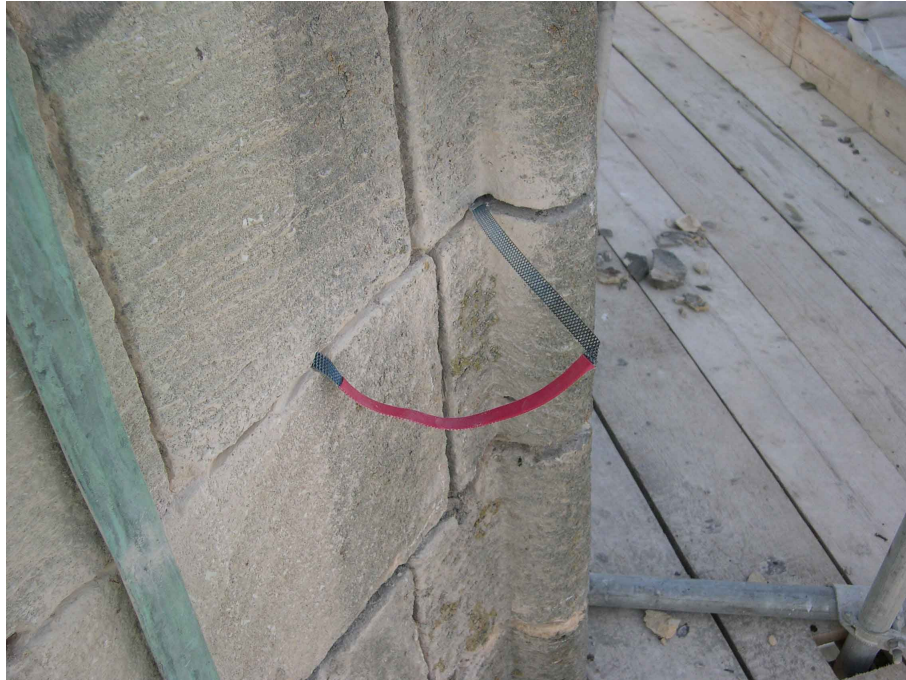
Figure 3 Anode ribbon being installed externally above and below the wrought iron to provide cathodic protection, St Mary's church, Kiddlington.

The 'positive' side of the CP circuit is formed by the anode ribbon, which should be installed equidistantly above and below the tie bars or ring beam. If the ring beams are fitted externally then the anode ribbon should also be fitted in the external joints, Figure 3. This has the added benefit in that the external faces of the stones normally have higher moisture contents, as compared to the inner faces, and their electrical resistance will therefore be lower, requiring a decreased driving potential. Sometimes the ring beams are mounted internally and this may require internal scaffolding, or possibly working with rope access specialists to install the system, Figure 4.

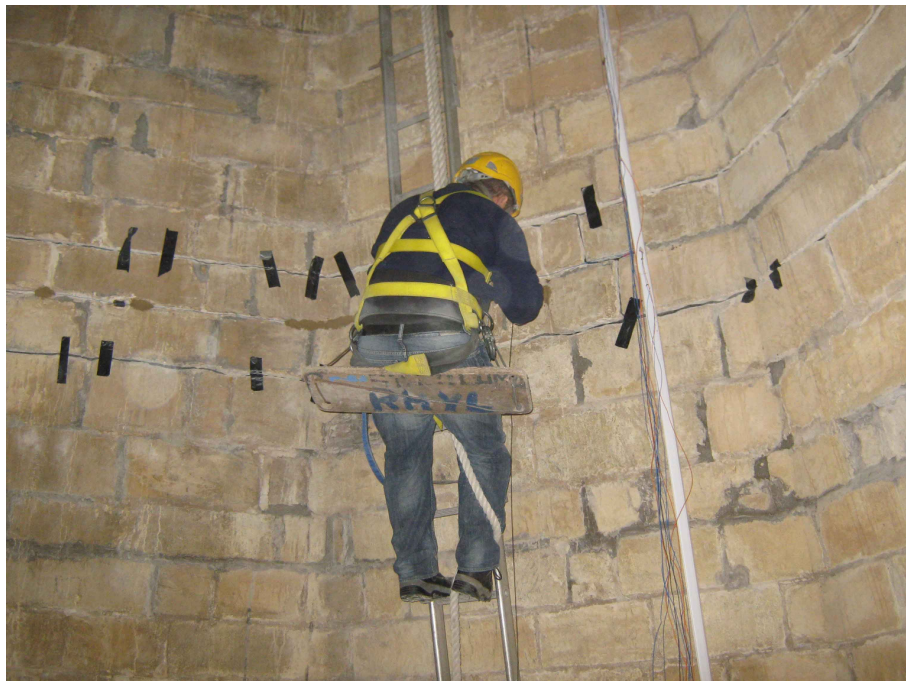
Figure 4 Anode ribbon being installed internally either side of the ring beams using rope access, St Aldheimes church, Doultling.
