Practical Aspects of Cathodic Protection for the Conservation of Iron and Steel in Heritage Buildings

David Farrell and Kevin Davies

**Rowan Technologies Ltd, 216 Church Road, Urmston, Manchester
M41 9DX, Tel: 0161-748-3644, Email: mail@rowantechnologies.co.uk**

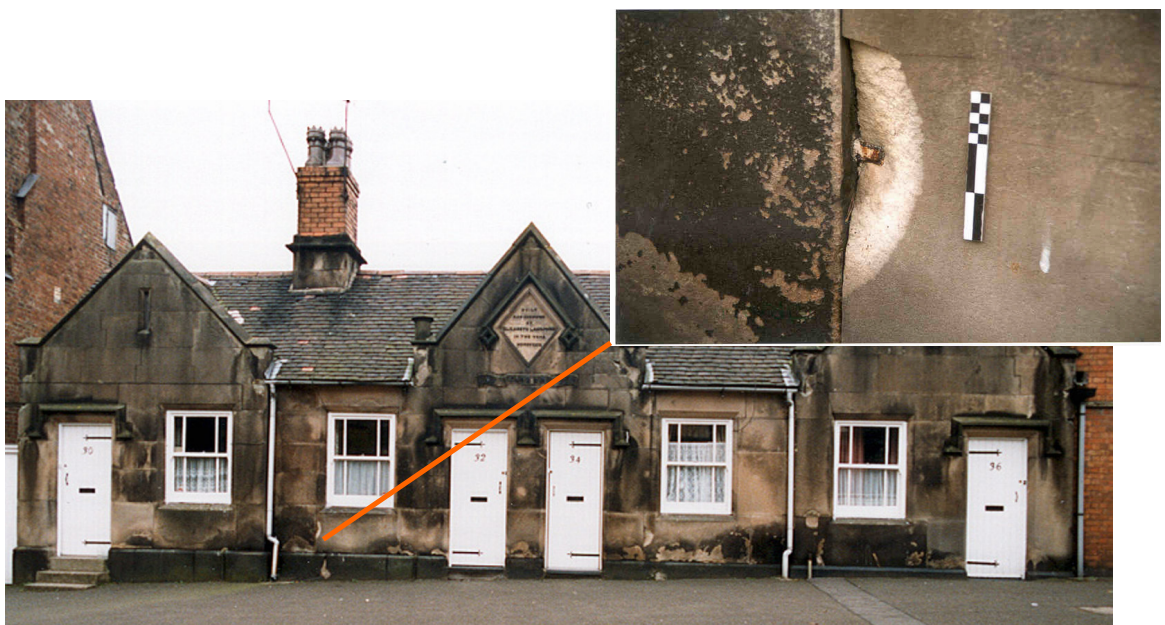
Figure 2: View of the Almshouses—showing typical damage from the cramps

An SACP system was installed in 1999 to protect rusting cramps in the stone façade of four Grade II listed almshouses in Whitchurch, Shropshire, Figure 2. This was the first known application of its kind in the UK. The stones formed an interlocking frontage with iron cramps fitted between adjacent blocks. Water ingress beneath the eaves and window sills had permeated into the stonework joints and had allowed the iron cramps to corrode. The expanding corrosion products had introduced internal stresses into the stonework which had resulted in cracking and spalling to some of the stones.

To provide the cathodic protection, six 2.3kg magnesium anodes were buried in the pavement in front of the cottages and these were connected directly through to the cramps in a ‘ring circuit’ arrangement. Electrical connections were made to the cramps using a ‘keyhole surgery’ technique to minimise damage to the stones; the titanium connection wires were sunk into the mortar joints and the current from the sacrificial anodes was conducted through the stone façade thus completing the CP’s electrical circuit. This allowed the cramps to be polarised from an external source and thus protected from further corrosion.

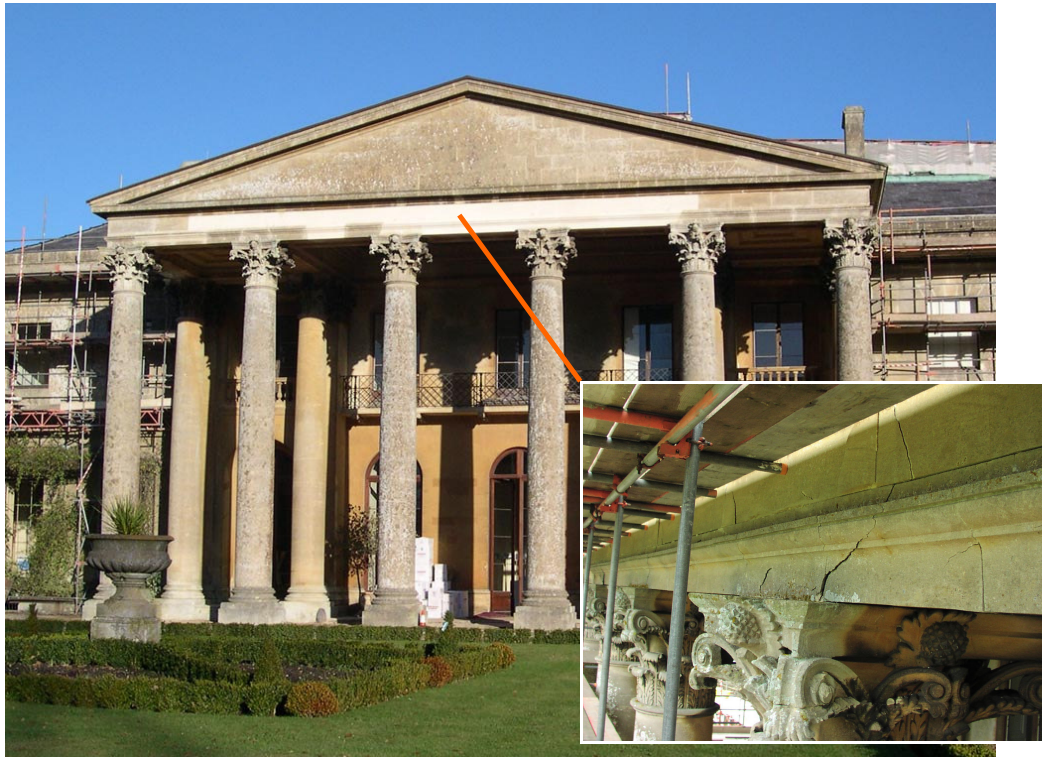
Figure 3: View of the Restored Portico at Dodington House – showing the damage that had occurred to the original stonework

The portico of this large country house (circa 1840s) had suffered significant damage from water ingress, corrosion of the embedded cramps and spalling of the large blocks of Bath stone, Figure 3. In late 2003, many of the damaged stones were replaced and stainless steel cramps used to secure the new blocks together. The remaining cramps (in excess of 100) were protected using an ICCP system. The large cramps (around 50mm square and up to 1.5m in length) were buried deep in the stonework (typically 120 to 250mm) and surrounded by lead. The lead surrounds were incomplete and the exposed iron had corroded, Figure 4. The corrosion face had progressed down the lead/iron interface and had forced the lead off the surface, resulting in the entire cramps now being subject to corrosion.

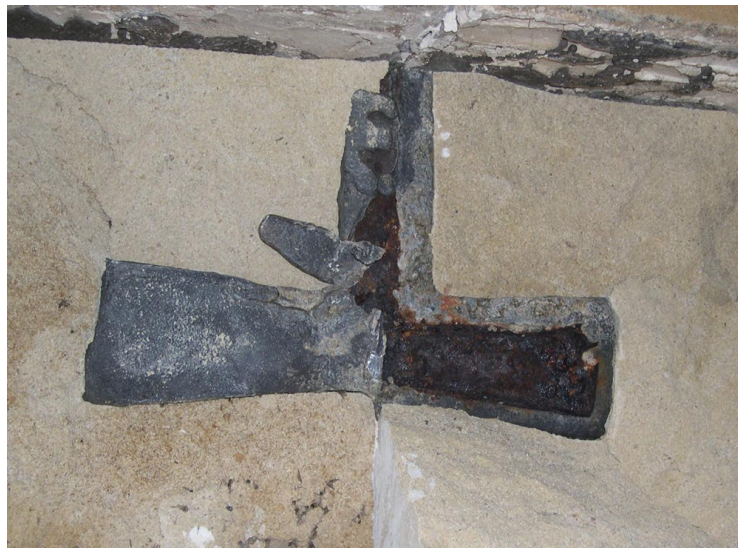
Figure 4: View of a Ledged Cramp—showing incomplete lead coating

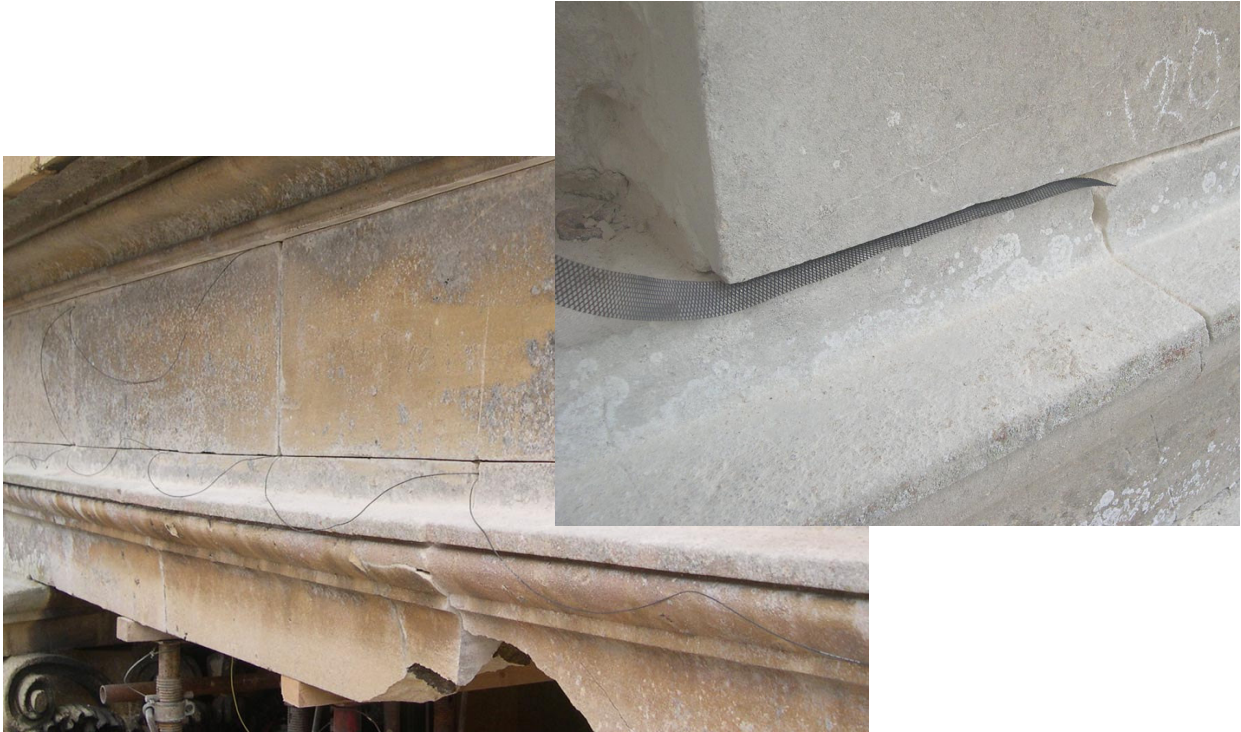
Figure 5: Dodington House: Daisy Chaining the Iron Cramps and Insertion of the MMO Coated Titanium Anode Mesh

Keyhole surgery was used to locate and make electrical connections to each cramp and these were daisy-chained to form the negative (cathodic) side of the circuit. The wires were sunk into the mortar joints, Figure 5. A mixed metal oxide (MMO) coated titanium ribbon (12mm wide) was also embedded into the mortar joints, prior to re-pointing, to provide the anodic side of the circuit, Figure 5. To enable the protection levels to the iron cramps to be monitored and controlled, reference electrodes were also installed within the stonework. These measure the effect of the electrical currents from the CP system on the embedded iron fittings.

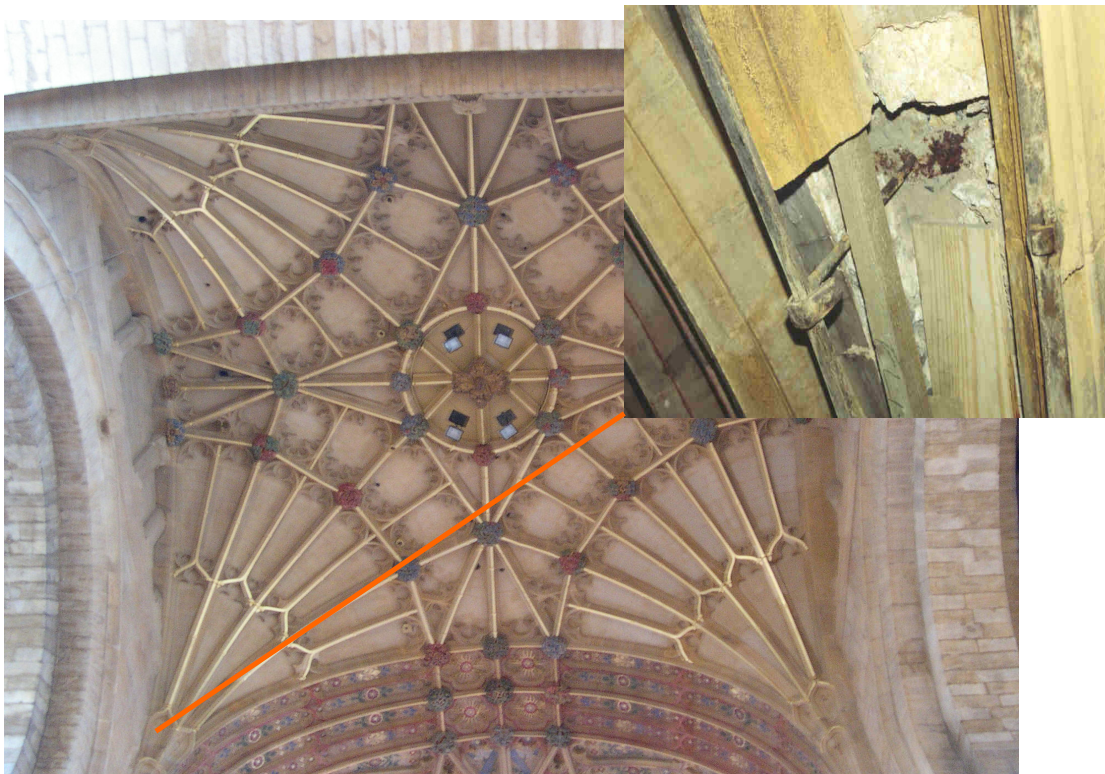
Figure 6: Sherborne Abbey—View of the Fan Vault showing Damage to the Stonework caused by Corrosion of the Iron Reinforcements

Sherborne Abbey boasts the earliest fan vault to be built in England (circa 1425). The tower vault had been subject to subsidence over the centuries and the Victorians had introduced a wrought iron reinforcement system covering the bottom and top faces of the ribs around 1840. Moisture ingress from the north and south walls had caused the iron reinforcement to corrode, Figure 6. This ultimately led to spalling of some of the stones resulting in the tower being cordoned off in 2000.

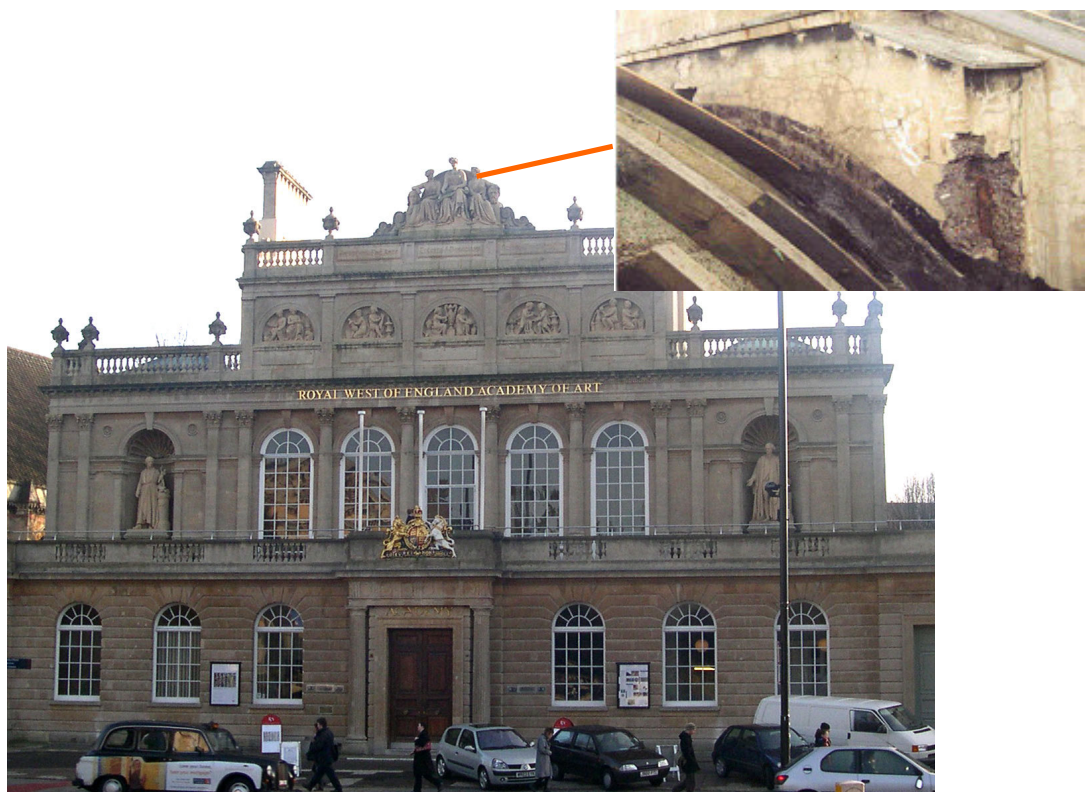
Figure 8: Royal West of England Academy - showing damage to the back of the pediment

This 1858 building, situated in Bristol, was refurbished extensively in 2001, Figure 8. The pediment, dating from 1913, was constructed of clinker concrete with a render finish and used 'I' beams within the central construction to provide support. Clinker, from power stations, contains significant quantities of chlorides and these, in combination with water ingress through the render, resulted in corrosion of the steel beams and cracking of the concrete.
