EDGBASTON STADIUM BIRMINGHAM, UK PROJECT ANALYSIS

SITUATION

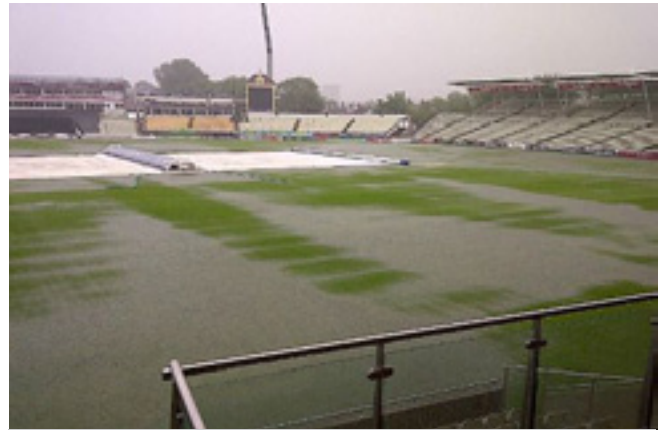
MAIN FIELD, MAY 30TH, NO EGRP®

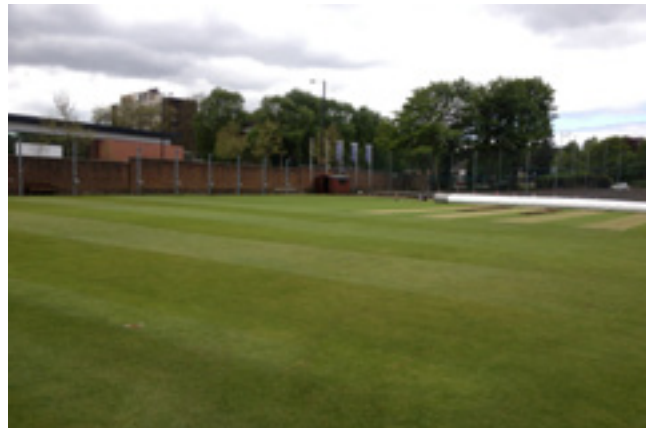
PRACTICE FIELD, MAY 30TH, WITH EGRP®

The EGRP® system was installed in May 2013 on the main practice area, only one month prior to the ICC Trophy the biggest Cricket tournament in the world. The practice area had NO drainage system and is surrounded by two parking lots. On May 30th There was a 1/2 inch of heavy rain, which, previously would have flooded the field and left it unplayable for days. However, with the EGRP® system in place, in less than two hours the ground was completely dry and solid under foot and practice resumed whilst a nearby practice field (with NO EGRP® installation) remained out of action.

In terms of the performance of the EGRP System, any doubts I had about the system working, have been completely dispelled. We had two heavy rain spells in May where 12mm of rain fell in the day and in June where there was 15mm of rain in half hour; both of these occasions flooded the area and normally would have rendered the ground unplayable the following day. On both instances the standing water and flooding was gone within hours and the ground was completely dry. This was an excellent result and enabled the teams scheduled to practice to use the facility the next day.
