Audit Report of “Stockwell Street Facility of
University of Greenwich” according to
ISO 27002:2022

CyberSAFE

Date: 22nd March, 2024

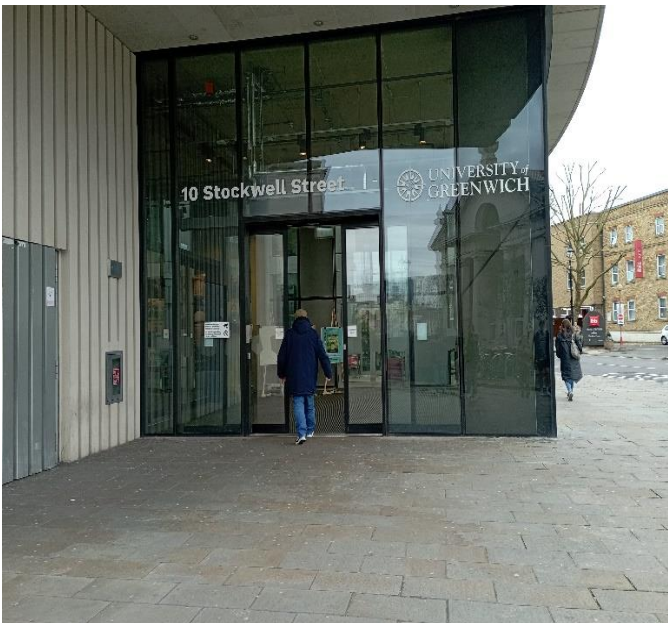
Figure 1: Main Entry into Stockwell Street Facility

- **As seen in Figure 1**, We observed the main entry of the Stockwell Street facility which is equipped with an automatic door that operates using sensors, allowing it to open upon the arrival of a person.
- Next to Stockwell Street, there is a narrow road leading towards the University of Greenwich campus as in **Figure 2**. This door is only open in Business hours and also Information label is placed on the door describing owner of the area and warning regarding operational hours.

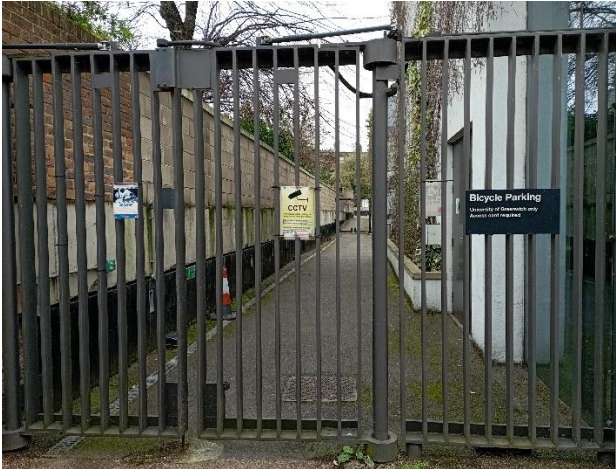
Figure 3: Rear area with bicycle parking facilities.

- we checked out the back area of the building shown in **Figure 3**. There are two entrances, both monitored by cameras. Access through gate requires an electronic card, ensuring only authorized people get in.
- Majority of the wall at Stockwell Street facility is constructed with glass panels, as depicted in **Figure 4**. Surrounding the premises is wired fencing, and rear section is enclosed by brick walls.

- Cameras are only installed in the rear areas of the premises; otherwise, we did not observe any cameras in other exterior locations around the premises.
- The premise's wall is not up to standard because it's made of glass. The usual recommendation is to use concrete or cement, which is much harder to break.

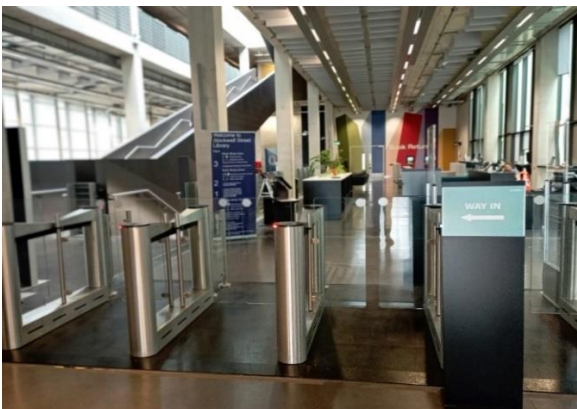
Figure 5: Entry barrier with electronic card reader

- Access to the premises is securely controlled by barrier that only opens with an authorized electronic card, complying with standard security protocols as seen in **Figure 5**.
- Security personnel are stationed at the security desk, situated close to the entry barriers, to ensure thorough monitoring of the premises and individuals who enter in this premises.
- When individuals arrive to visit the premises without an ID card or authorized entry, security guard records their name, contact information, purpose of visit, and the time of arrival etc., in the visitor log book kept at the security desk.

- During our visit, we observed instances during our visit where students were exchanging ID cards with others to gain entry into the premises. This behavior poses a serious threat to the security of the facility. We suggest training security personnel to detect and address this behavior.
- There is no visitor badge policy in place, making it difficult to distinguish between authorized personnel and visitors, which poses a security risk within the premises.

- Enforce a policy requiring all students to wear ID cards during lab time and implement verified badges for visitors, students, and staff.
- We observed that some students can enter in to premises with some other student id card so train security personal to suspect this behavior and take strict action against such individuals.

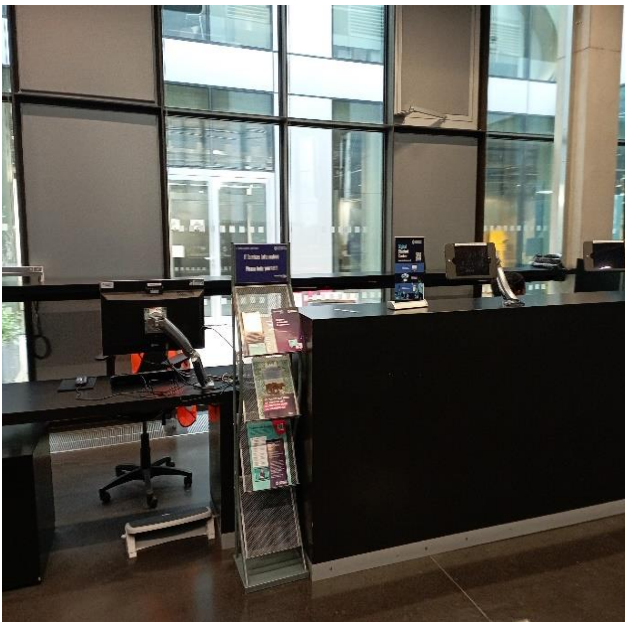
Figure 7: Reception desk

- A reception area is situated on the ground floor as seen in **Figure 7**, to assist students, staff, and other individuals with their queries and concerns. The administration at this desk is responsible for approving requests for group study rooms.

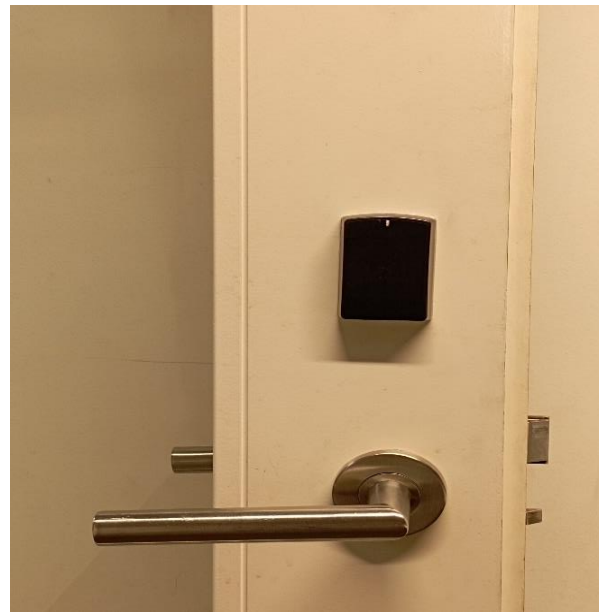
Figure 8: Card reader in Group Study room

- The facility has group study rooms for meetings and collaborative work, situated in various zones within the premises. Access to these rooms is restricted to authorized individuals who must book the group study room in advance before accessing it. As seen in **Figure 8** card reader is available for accessing it.

- During our initial meeting, we noticed that noise from neighboring rooms was audible, indicating that the group rooms are not soundproof.
- The premises lack security cameras, creating blind spots and making it difficult to monitor individuals effectively. According to ISO 27002:2022, installing cameras covering all areas is recommended.

- Construct soundproof group study rooms, as we've observed that noise from neighboring rooms can significantly disrupt initial audit meetings held within these spaces.

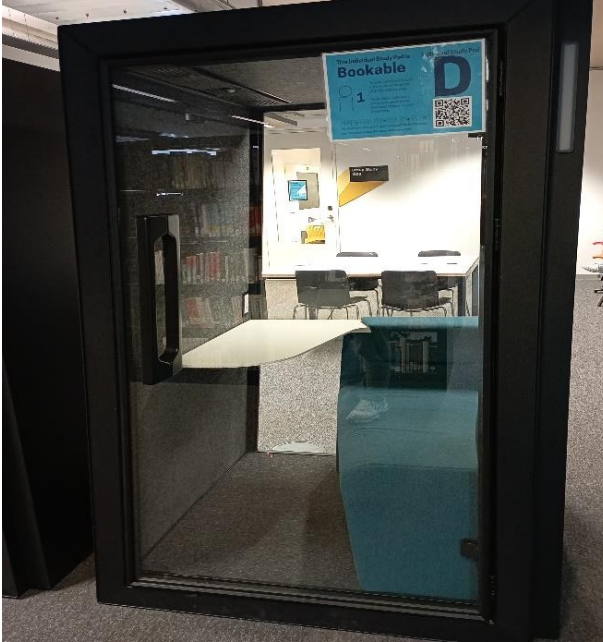
Figure 9: Individual Glass Pod

- Individual glass pods are provided for individuals as seen in **Figure 9**, seeking a quiet space for interviews or personal work. These pods feature soundproof glass to ensure privacy and minimal disruption.
- To ensure the security of staff offices within the premises, we see a signboard, as depicted in **Figure 10**, is prominently displayed. This sign clearly states that only staff members are permitted access and provides contact details in case of emergencies.

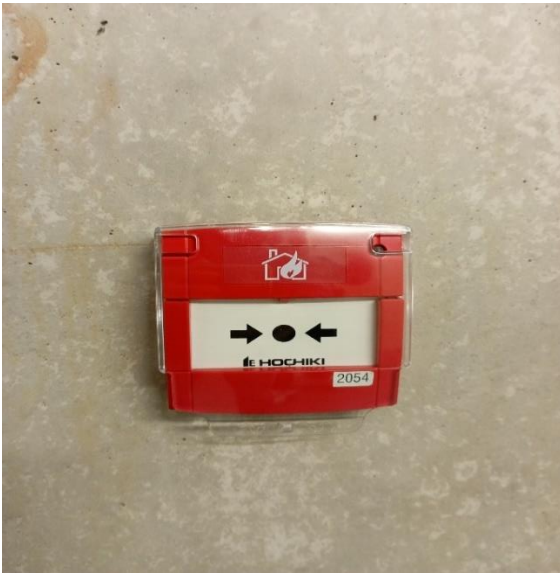
Figure 11: Fire alarm switch

- We noticed that the fire alarm system is installed throughout the premises, as shown in **Figure 11**. This is a crucial safety measure for the people working in the facility and for the overall security of the organization.
- We observed that on every exit door, there is an emergency signboard with the instruction "Keep Clear" as seen in **Figure 12**. This serves as a reminder for everyone to ensure that no objects or hazards obstruct these areas in case of an emergency.

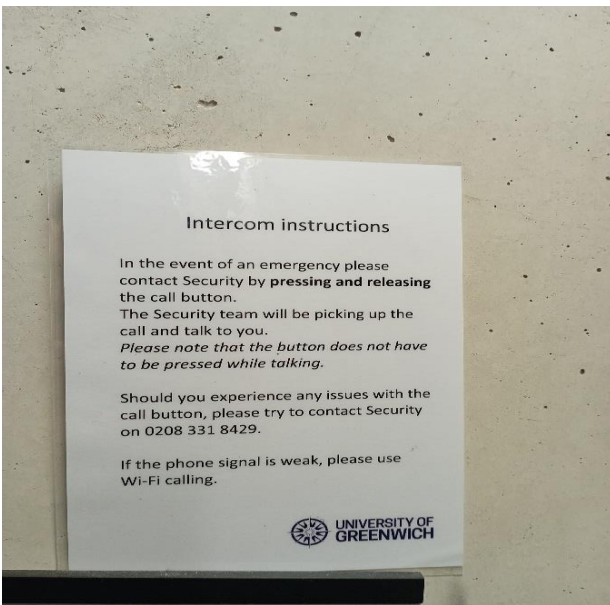
Figure 13: Intercom Communication in Emergency

- We noticed that intercom communication systems are in place for emergency situations as seen in **Figure 13**, and there are clear instructions provided on how to use them, especially in the absence of network connectivity or call button is not working.
- Additionally, warnings about the consequences of misusing the fire alarm system are prominently displayed in red color as seen in **Figure 14**. This ensures that individuals are aware of the seriousness of false alarms and discourages any unauthorized activation, preventing unnecessary panic or evacuation.

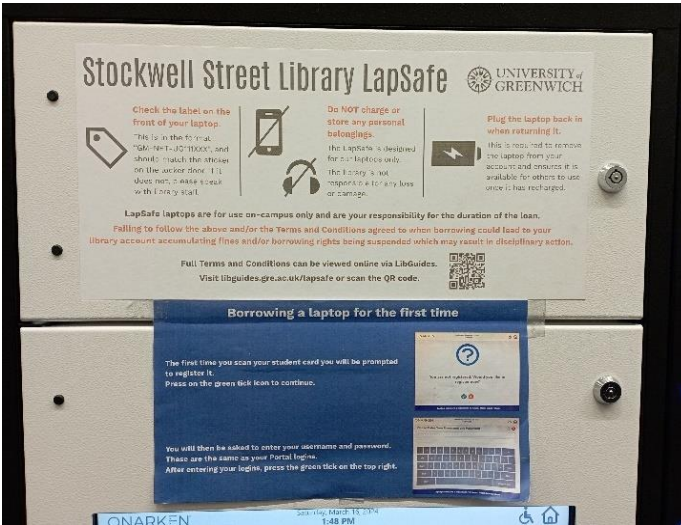
Figure 15: Instruction for borrowing Laptop

- We observed that when borrowing a laptop, students or staff must scan their ID card, and it is mandatory to return it by 10:00 PM daily. All of these instructions and guidelines are provided, as seen in **Figure 15**, which is very helpful for borrowers.
- We observed that to secure the mouse and keyboards, small cable ties are used to bundle the excess, with cable ties as seen in **Figure 16** to securing them.

- We observed that some students take laptops outside of the premises without notifying staff or security personnel. This poses a risk of laptops being stolen from the premises.
- We have also observed instances where students remove the mouse and keyboard wires to use them with their own laptops. Additionally, some students bring their own devices and occupy Facility PCs, preventing others in need from using the machines.

- Introduce temporary and restricted access permissions for the secure area.
- We've noted instances where students are able to remove laptops from the facility without being noticed by security personnel, resulting in thefts. It's recommended to install an alarm system or incorporate a tracking chip into laptops. This way, if someone attempts to take a laptop outside, an alarm will sound, alerting security.

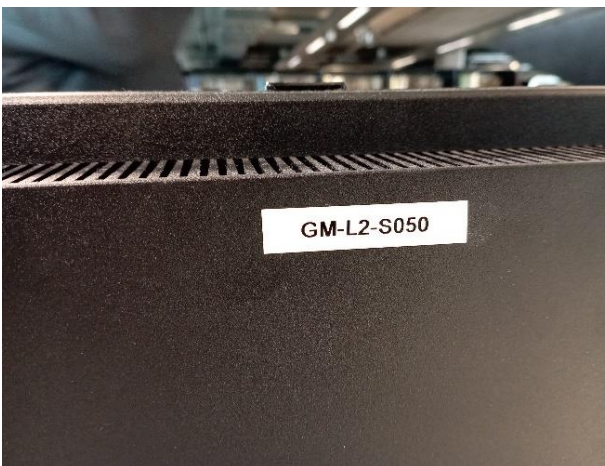
Figure 17: Asset Identity Number

- We noticed that the organization has assigned asset identification numbers, as shown in **Figure 17**, according to standards. This practice facilitates easy identification of assets in case of issues, which is a commendable security measure.

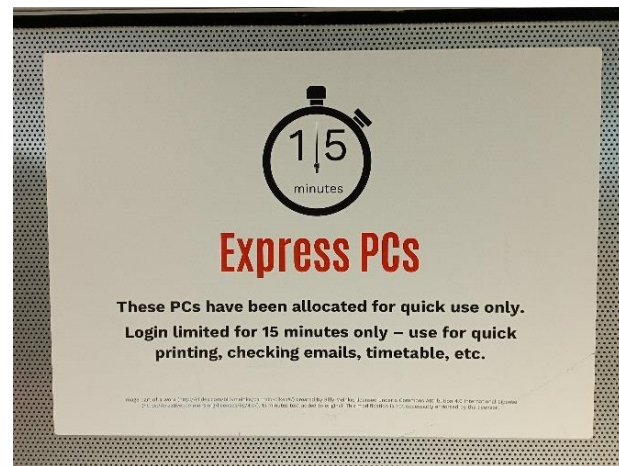
Figure 18: Instruction for Printer Machines

- For utilizing printing service and PC, notice is displayed as seen in **Figure 18**. It mentions PCs are only logged in for a max of 15 minutes for quick printing to prevent long queues.

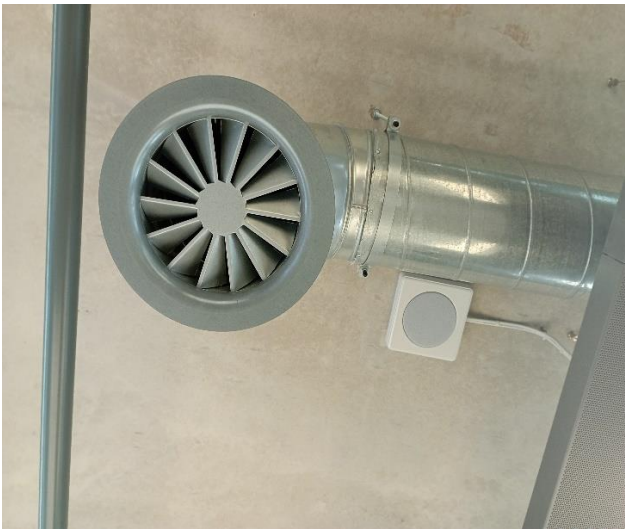
Figure 19: Ventilation

- **Figure 19** illustrates the presence of ventilation throughout the facility, which helps reduce heat generated by desktops and laptops and keeps the premises cool and comfortable. Also, lowers humidity levels and removes airborne pollutants, ensuring a cleaner and more comfortable atmosphere.
- **Figure 20** shows smoke detection systems installed throughout the facility. They quickly detect fires, sound alarms for emergencies, and help evacuate the premises while alerting the administration for necessary actions.

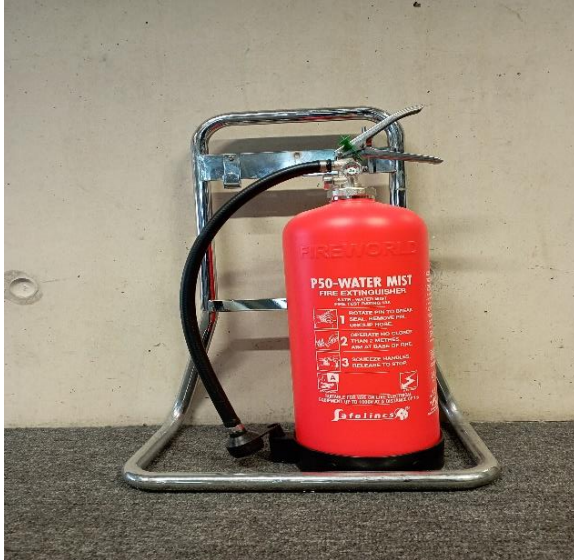
Figure 21: Fire Extinguisher

- Fire extinguishers, depicted in **Figure 21**, and fire sprinklers, shown in **Figure 22**, are installed throughout the facility to assist in case of a fire emergency.
- Periodically, the administration team conducts fire drills to ensure all equipment is functioning properly and individuals are familiar with the procedure.

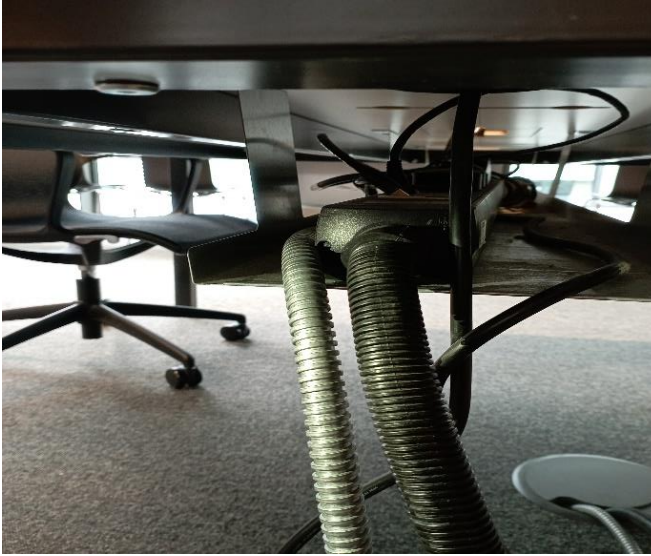
Figure 23: Separated & Secure Power and Internet Wire

- In **Figure 23**, We observed that power cables and internet cables are segregated using two distinct cable protectors. Armored conduit is utilized to safeguard fiber and ethernet cables from potential cuts or damage.
- As depicted in **Figure 24**, all internet and power cables are installed underground to mitigate risks associated with higher voltage lines. Underground wiring not only provides increased reliability but also enhances security compared to overhead lines.

- Our observation and analysis indicate that the organization has effectively implemented cable security measures by securely placing them underground in accordance with ISO 27002:2002 standards. No further action is deemed necessary for cable security.
