# **MBS KINGMAN**

## **Condition Monitoring Report**

### **SEP - OCT 2023**

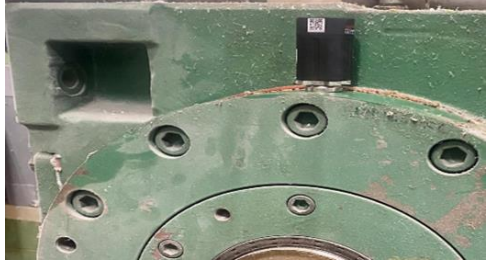
#### 3.1 EXTRUDER DRIVE GEARBOX 1301:

Equipment Condition	GOOD

Duration	SEP - OCT 2023	
Highest Surface Temperature	38 °C

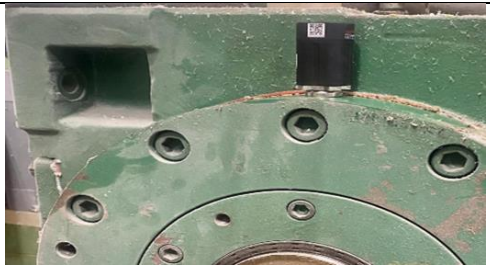
### 3.2 EXTRUDER DRIVE GEARBOX 1201:

Equipment Condition	GOOD

Duration	SEP - OCT 2023	
Highest Surface Temperature	51 °C

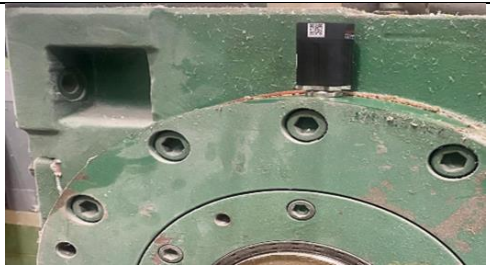
### 3.3 GODET 1 GEARBOX 1401:

Extruder Drive Gear Box 1301, Extruder Drive Gear Box 1201, and Gear pump Drive Gear Box 1202 machine vibration levels are observed within a good range, even though momentary spikes are found due to the process. Godet 1 Gear Box 1401 machine noted with high vibration range & equipment's parameters are required for further fault analysis.

Equipment Condition	GOOD

Duration	SEP - OCT 2023	
Highest Surface Temperature	49 °C

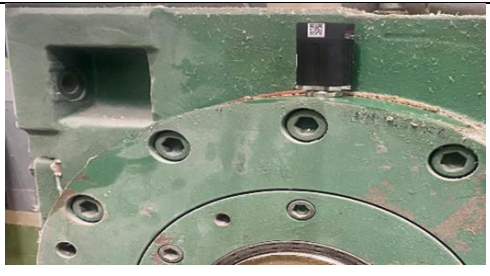
### 3.4 GEAR PUMP DRIVE GEARBOX 1202:

Equipment Condition	GOOD

Duration	SEP - OCT 2023	
Highest Surface Temperature	54 °C
