Stress and Safety Analysis of Steel Ladder: Taking Second Men's Dorm Ladder as an Example

郭偉森 B08502110、連樂 B08502132

National Taiwan University Mechanical Engineering

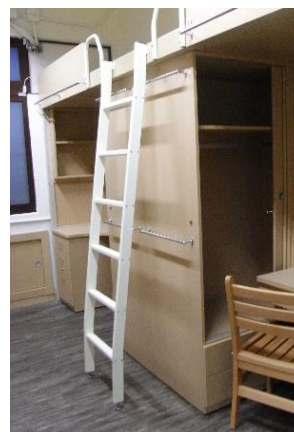
Figure 1 Ladder Design in Men 2nd Dorm. [1]

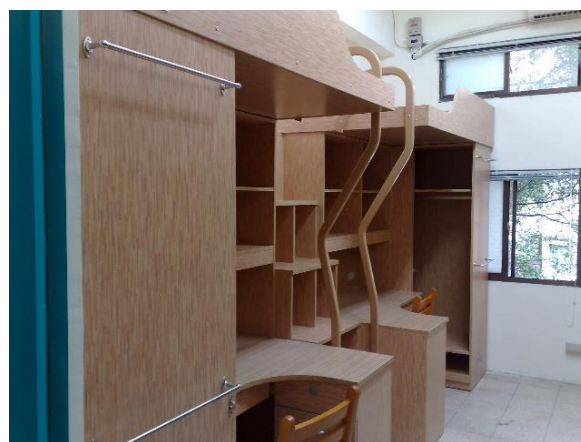
Figure 2 Ladder Design in Men 3rd Dorm. [1]

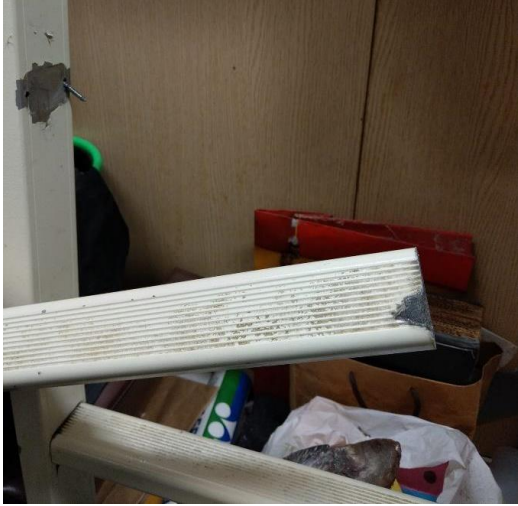
Moreover, there is breakage of ladder happened in Men 2nd Dorm, thus we are using this incident as an example, we will be analysing the design of the ladder in order to make sure that it can sustain different situations like different weight of dormmates, to prevent the breakage of ladder happening in the future again.

Figure 3 The Breakage of ladder in Men 2nd Dorm.

From Figure 3, the breakage happened at Ladder_C, therefore we are only interested in analyzing the highest Von Mises Stress in Ladder_C. After running through the four conditions stated above, stepping on the first or stepping on the third gives the same result. Thus, the result will compare the stress analysis on original design and redesign conditions.

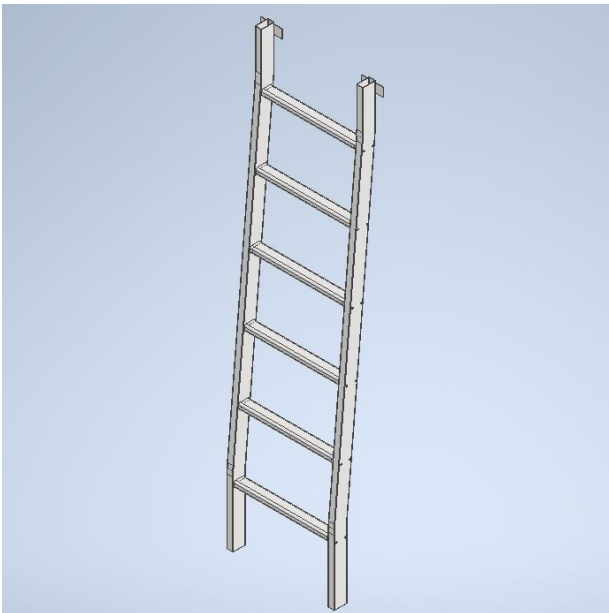
We try to obtain the engineering drawings of the ladder from the Student Housing Service Division in Office of Student Affairs, they are not able to provide us because of some privacy issues, therefore the real dimensions of the ladder are measured on our own in the Men 2nd Dorm using the Vernier Calipers and Tape Measure. The modelling of the ladder is then created in Inventor Software with the dimensions obtained.

Figure 4 The modelling of ladder using Inventor.

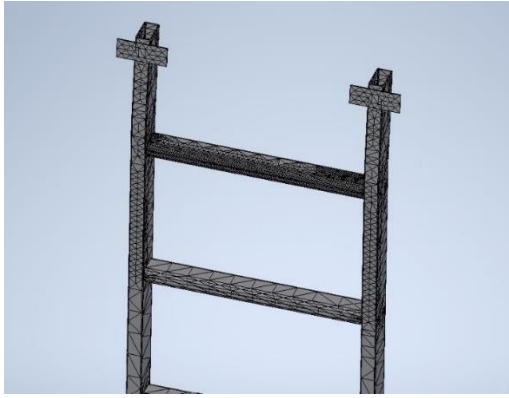
Next step is to mesh the model of ladder. In the mesh settings, average element size are set 0.100, grading factor of 1.5 and maximum turn angle of 60°. Furthermore, applying Local Mesh Control to the Ladder_C that is focused on to increase the element number in order to increase the accuracy of analyzation. Overall, there are 112150 notes and 56958 elements generated.

Figure 14 Meshing of the ladder
