**FINAL REPORT**

**NON-DESTRUCTIVE  
EVALUATION**

**OF  
SPPL DEMO PROJECT  
New Delhi  
BY**

**Sanrachna Prahari Pvt Ltd**

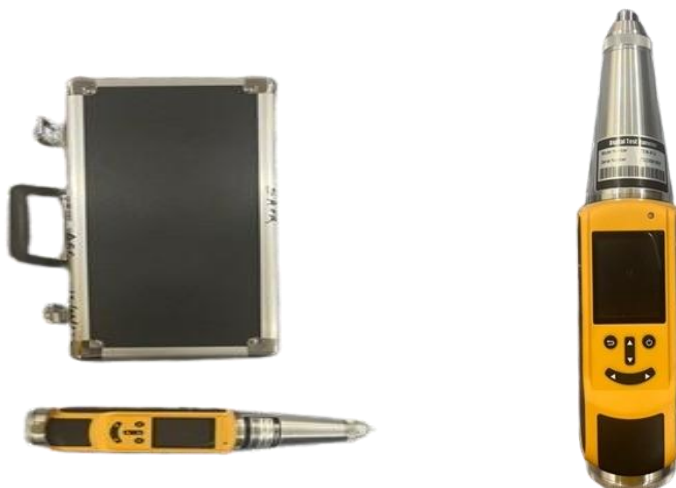
- 1. Type of Equipment: Rebound Hammer

Model: [TEM 912; ZD23091820]

Calibration Status: [Calibrated – 17<sup>th</sup> Mar 2024]

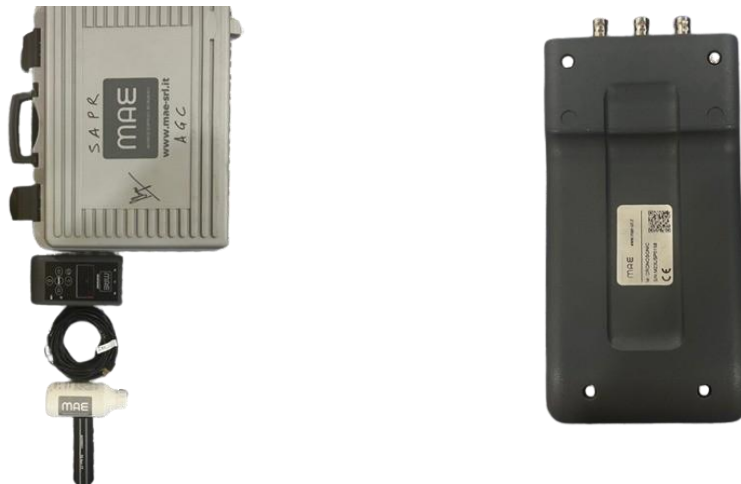
2. Type of Equipment: UPSV Tester

Model: [M23USP0158]

Calibration Status: [Calibrated – 19<sup>th</sup> Mar 2024]

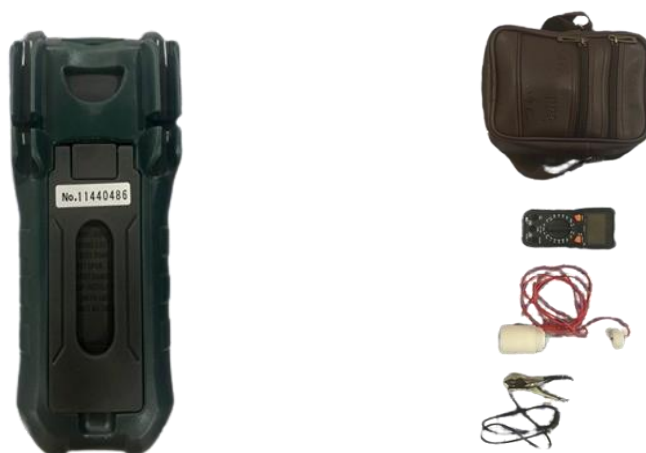
3. Type of Equipment: Half Cell Potential Tester

Model: [MCE Micro; 11440486]

Calibration Status: [Calibrated – 18<sup>th</sup> Mar 2024]

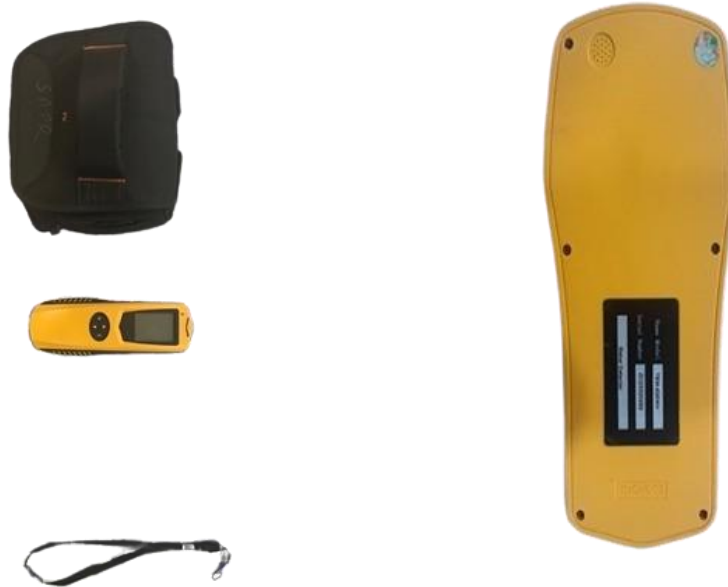
4. Type of Equipment: Rebar Detector

Model: [TEM 620XH; ZD23320282]

Calibration Status: [Calibrated – 18<sup>th</sup> Mar 2024]
