HINDUSTAN PETROLEUM CORPORATION LIMITED

COMPREHENSIVE JOURNEY RISK MANAGEMENT ANALYSIS REPORT

ROUTE ANALYSIS DETAILS

Total Distance: 131 km

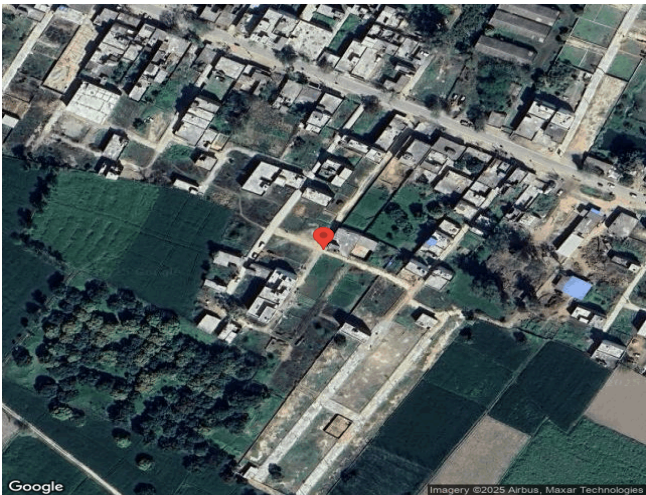
SATELLITE VIEW DATA:
File: satellite_91945c9f-c917-4ffd-999e-21ddc23cc92b_turn_1.png
Size: 317.6 KB
GPS: 29.7997, 77.4621

- AERIAL ANALYSIS:
- * Turn geometry: 180.0 deg curve
 - * Road curvature: Sharp bend visible
 - * Terrain context: Aerial perspective
 - * Traffic flow impact: Potential bottleneck

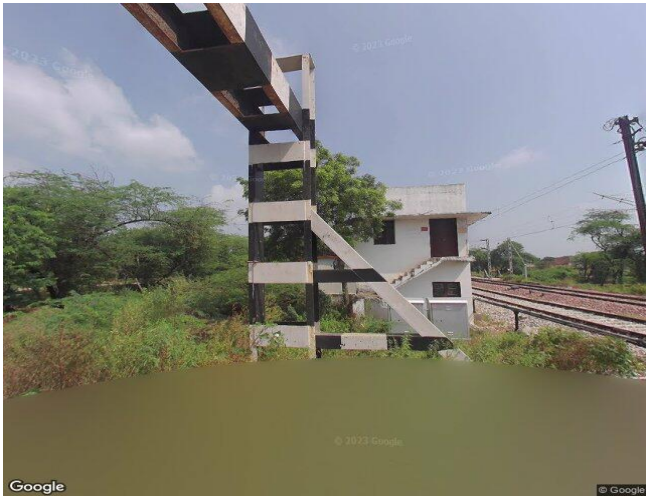
STREET VIEW DATA:
File: streetview_91945c9f-c917-4ffd-999e-21ddc23cc92b_turn_2_h0.jpg
Size: 59.0 KB
GPS: 29.8000, 77.4586

CRITICAL TURN #2: 159.6 deg - EXTREME BLIND SPOT - CRITICAL RISK

- ROAD ANALYSIS:
- * Turn angle: 159.6 degrees
 - * Visibility: Limited due to sharp curve
 - * Hazard level: CRITICAL
 - * Max speed: 15 km/h

GPS Coordinates	29.800050, 77.458640
Turn Angle	159.6 deg (Deviation from straight path)
Risk Classification	EXTREME BLIND SPOT - CRITICAL Risk Level
Recommended Maximum Speed	15 km/h
Safety Distance Required	Minimum 50m approach visibility
Driver Action Required	Reduce speed, check mirrors, signal early
Street View Images	2 images available
Satellite Images	2 images available
Total Visual Evidence	4 images for analysis

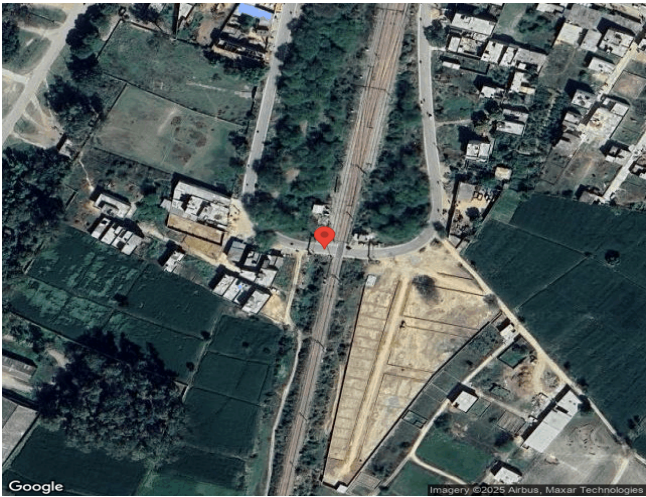
SATELLITE VIEW DATA:
File: satellite_91945c9f-c917-4ffd-999e-21ddc23cc92b_turn_2.png
Size: 308.2 KB
GPS: 29.8000, 77.4586

- AERIAL ANALYSIS:
- * Turn geometry: 159.6 deg curve
 - * Road curvature: Sharp bend visible
 - * Terrain context: Aerial perspective
 - * Traffic flow impact: Potential bottleneck

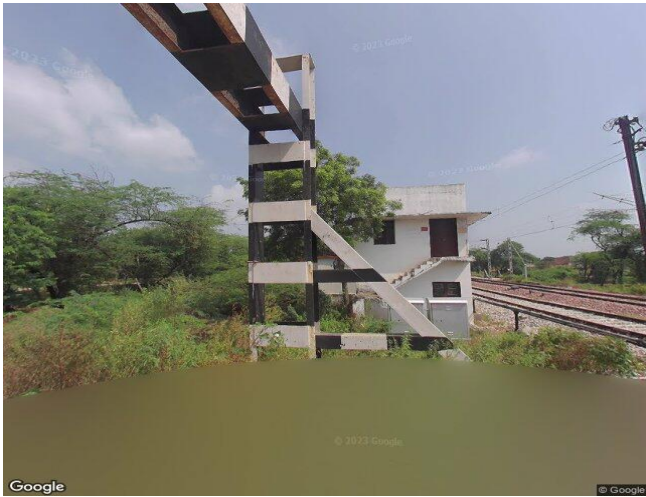
STREET VIEW DATA:
File: streetview_91945c9f-c917-4ffd-999e-21ddc23cc92b_turn_2_h0.jpg
Size: 59.0 KB
GPS: 29.8000, 77.4586

CRITICAL TURN #3: 159.6 deg - EXTREME BLIND SPOT - CRITICAL RISK

ROAD ANALYSIS:
* Turn angle: 159.6 degrees
* Visibility: Limited due to sharp curve
* Hazard level: CRITICAL
* Max speed: 15 km/h

GPS Coordinates	29.800050, 77.458640
Turn Angle	159.6 deg (Deviation from straight path)
Risk Classification	EXTREME BLIND SPOT - CRITICAL Risk Level
Recommended Maximum Speed	15 km/h
Safety Distance Required	Minimum 50m approach visibility
Driver Action Required	Reduce speed, check mirrors, signal early
Street View Images	2 images available
Satellite Images	2 images available
Total Visual Evidence	4 images for analysis

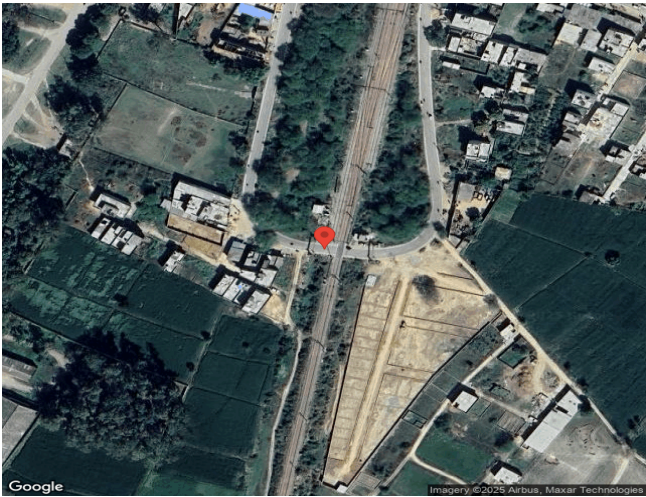
SATELLITE VIEW DATA:
File: satellite_91945c9f-c917-4ffd-999e-21ddc23cc92b_turn_2.png
Size: 308.2 KB
GPS: 29.8000, 77.4586

AERIAL ANALYSIS:
* Turn geometry: 159.6 deg curve
* Road curvature: Sharp bend visible
* Terrain context: Aerial perspective
* Traffic flow impact: Potential bottleneck

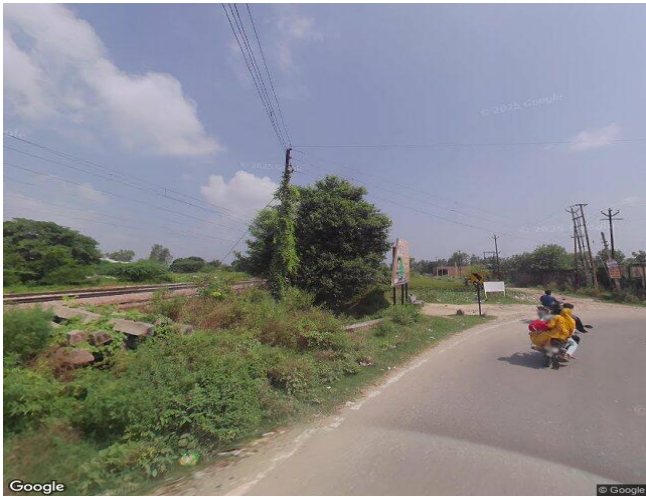
STREET VIEW DATA:
File: streetview_91945c9f-c917-4ffd-999e-21ddc23cc92b_turn_4_h0.jpg
Size: 59.5 KB
GPS: 29.8018, 77.4592

CRITICAL TURN #4: 113.0 deg - EXTREME BLIND SPOT - CRITICAL RISK

- ROAD ANALYSIS:
- * Turn angle: 113.0 degrees
 - * Visibility: Limited due to sharp curve
 - * Hazard level: CRITICAL
 - * Max speed: 15 km/h

GPS Coordinates	29.801760, 77.459240
Turn Angle	113.0 deg (Deviation from straight path)
Risk Classification	EXTREME BLIND SPOT - CRITICAL Risk Level
Recommended Maximum Speed	15 km/h
Safety Distance Required	Minimum 50m approach visibility
Driver Action Required	Reduce speed, check mirrors, signal early
Street View Images	2 images available
Satellite Images	2 images available
Total Visual Evidence	4 images for analysis

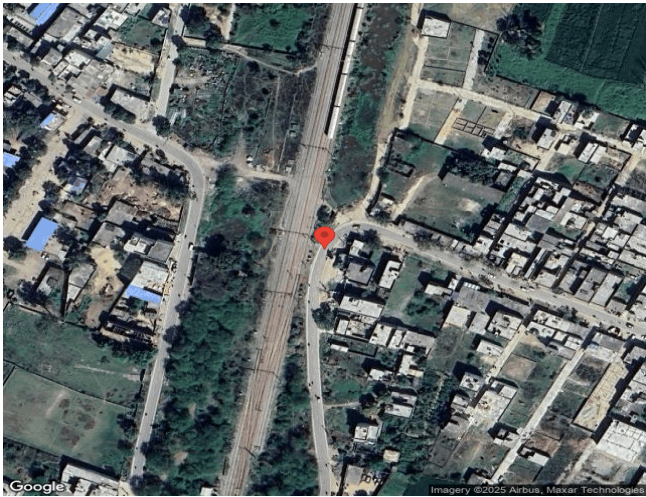
SATELLITE VIEW DATA:
File: satellite_91945c9f-c917-4ffd-999e-21ddc23cc92b_turn_4.png
Size: 342.8 KB
GPS: 29.8018, 77.4592

- AERIAL ANALYSIS:
- * Turn geometry: 113.0 deg curve
 - * Road curvature: Sharp bend visible
 - * Terrain context: Aerial perspective
 - * Traffic flow impact: Potential bottleneck

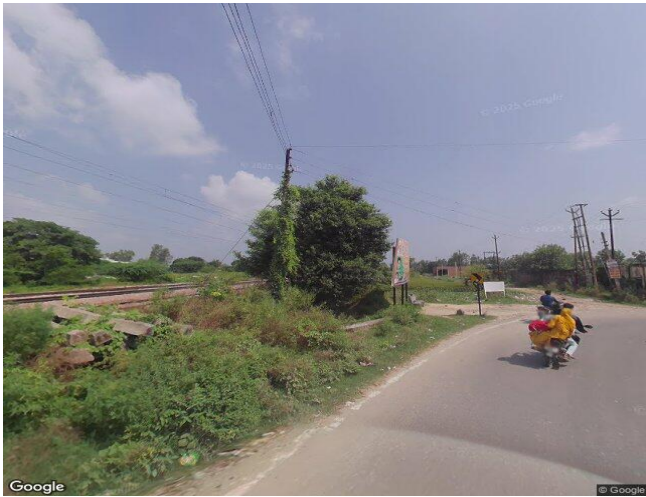
STREET VIEW DATA:
File: streetview_91945c9f-c917-4ffd-999e-21ddc23cc92b_turn_4_h0.jpg
Size: 59.5 KB
GPS: 29.8018, 77.4592

CRITICAL TURN #5: 113.0 deg - EXTREME BLIND SPOT - CRITICAL RISK

- ROAD ANALYSIS:
- * Turn angle: 113.0 degrees
 - * Visibility: Limited due to sharp curve
 - * Hazard level: CRITICAL
 - * Max speed: 15 km/h

GPS Coordinates	29.801760, 77.459240
Turn Angle	113.0 deg (Deviation from straight path)
Risk Classification	EXTREME BLIND SPOT - CRITICAL Risk Level
Recommended Maximum Speed	15 km/h
Safety Distance Required	Minimum 50m approach visibility
Driver Action Required	Reduce speed, check mirrors, signal early
Street View Images	2 images available
Satellite Images	2 images available
Total Visual Evidence	4 images for analysis

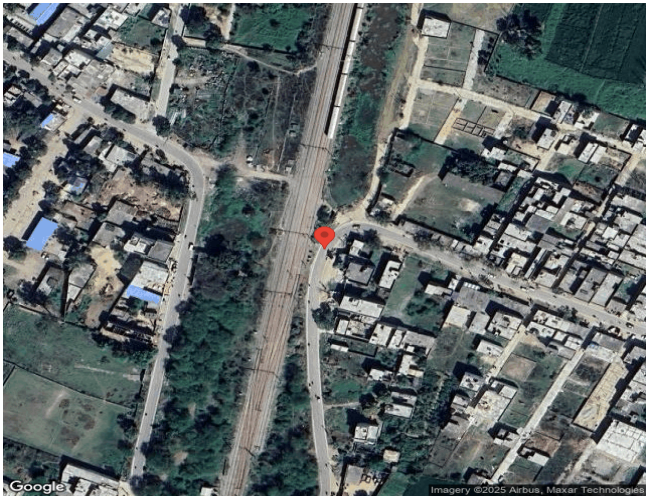
SATELLITE VIEW DATA:
File: satellite_91945c9f-c917-4ffd-999e-21ddc23cc92b_turn_4.png
Size: 342.8 KB
GPS: 29.8018, 77.4592

- AERIAL ANALYSIS:
- * Turn geometry: 113.0 deg curve
 - * Road curvature: Sharp bend visible
 - * Terrain context: Aerial perspective
 - * Traffic flow impact: Potential bottleneck

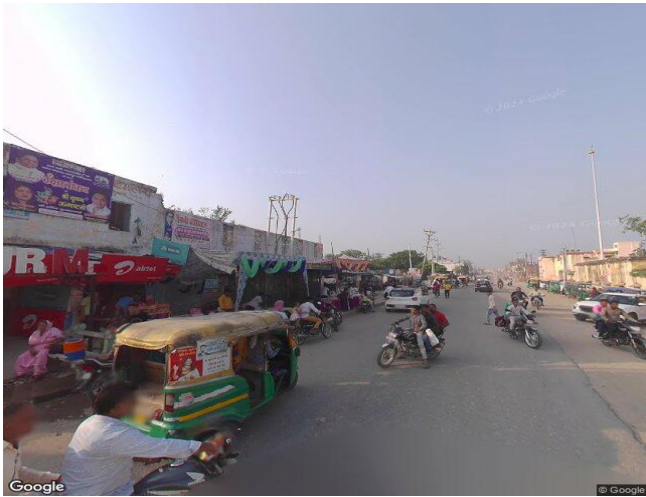
STREET VIEW DATA:
File: streetview_91945c9f-c917-4ffd-999e-21ddc23cc92b_turn_6_h0.jpg
Size: 48.4 KB
GPS: 29.8046, 77.4547

CRITICAL TURN #6: 97.4 deg - EXTREME BLIND SPOT - CRITICAL RISK	
GPS Coordinates	29.804640, 77.454670
Turn Angle	97.4 deg (Deviation from straight path)
Risk Classification	EXTREME BLIND SPOT - CRITICAL Risk Level
Recommended Maximum Speed	15 km/h
Safety Distance Required	Minimum 50m approach visibility
Driver Action Required	Reduce speed, check mirrors, signal early
Street View Images	1 images available
Satellite Images	1 images available
Total Visual Evidence	2 images for analysis

- ROAD ANALYSIS:
- * Turn angle: 97.4 degrees
 - * Visibility: Limited due to sharp curve
 - * Hazard level: CRITICAL
 - * Max speed: 15 km/h

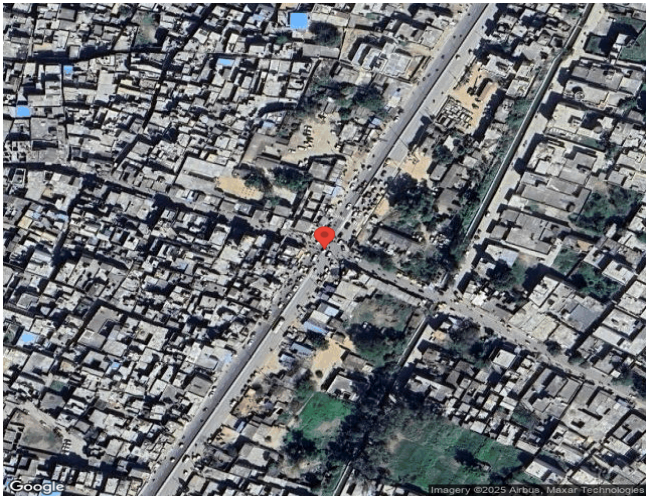
SATELLITE VIEW DATA:
File: satellite_91945c9f-c917-4ffd-999e-21ddc23cc92b_turn_6.png
Size: 353.5 KB
GPS: 29.8046, 77.4547

- AERIAL ANALYSIS:
- * Turn geometry: 97.4 deg curve
 - * Road curvature: Sharp bend visible
 - * Terrain context: Aerial perspective
 - * Traffic flow impact: Potential bottleneck

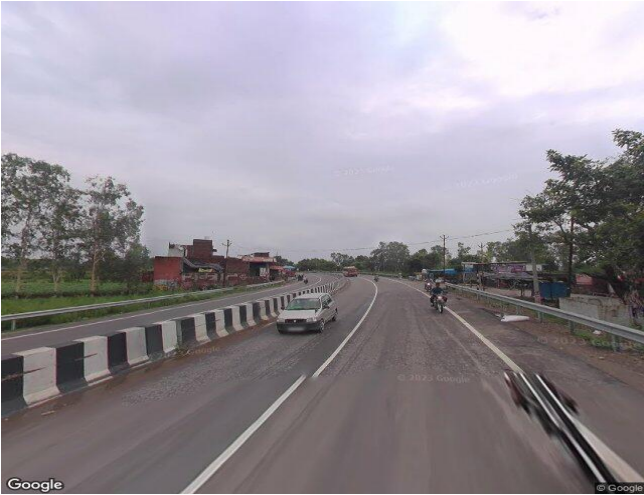
STREET VIEW DATA:
File: streetview_91945c9f-c917-4ffd-999e-21ddc23cc92b_turn_7_h0.jpg
Size: 50.9 KB
GPS: 29.6253, 77.4392

CRITICAL TURN #7: 75.7 deg - BLIND SPOT - HIGH RISK

- ROAD ANALYSIS:
- * Turn angle: 75.7 degrees
 - * Visibility: Limited due to sharp curve
 - * Hazard level: HIGH
 - * Max speed: 25 km/h

GPS Coordinates	29.625320, 77.439180
Turn Angle	75.7 deg (Deviation from straight path)
Risk Classification	BLIND SPOT - HIGH Risk Level
Recommended Maximum Speed	25 km/h
Safety Distance Required	Minimum 50m approach visibility
Driver Action Required	Reduce speed, check mirrors, signal early
Street View Images	1 images available
Satellite Images	1 images available
Total Visual Evidence	2 images for analysis

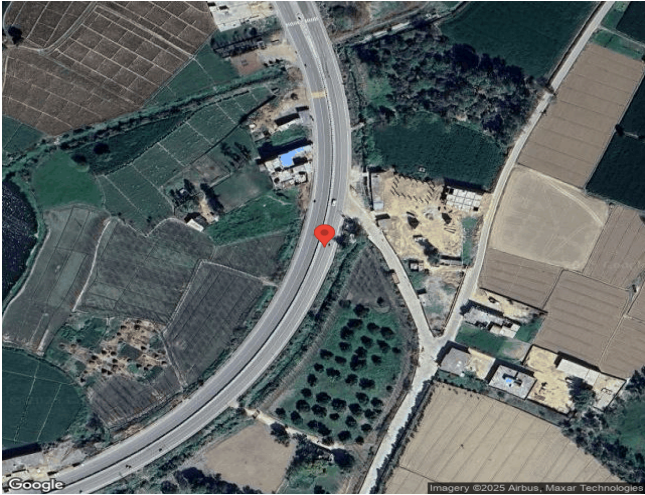
SATELLITE VIEW DATA:
File: satellite_91945c9f-c917-4ffd-999e-21ddc23cc92b_turn_7.png
Size: 299.5 KB
GPS: 29.6253, 77.4392

- AERIAL ANALYSIS:
- * Turn geometry: 75.7 deg curve
 - * Road curvature: Sharp bend visible
 - * Terrain context: Aerial perspective
 - * Traffic flow impact: Potential bottleneck
