# HINDUSTAN PETROLEUM CORPORATION LIMITED

## COMPREHENSIVE JOURNEY RISK MANAGEMENT ANALYSIS REPORT

### ROUTE ANALYSIS DETAILS

Route ID: 91945c9f-c91...

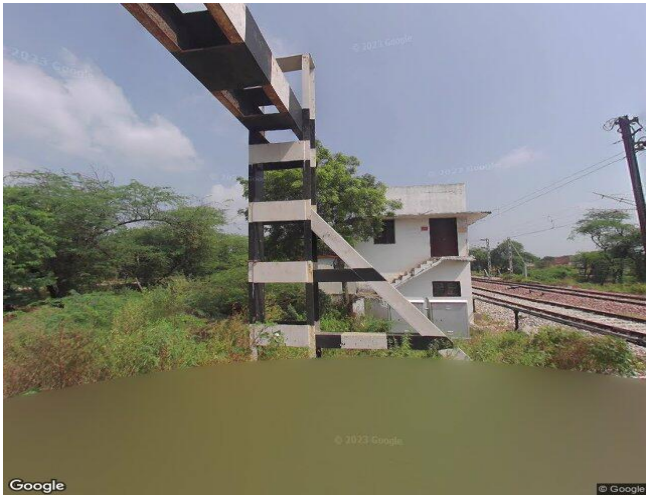
VISUAL EVIDENCE FOR TURN #2:  
STREET VIEW ANALYSIS:

GPS Coordinates	29.800050, 77.458640
Turn Angle	159.6 deg (Deviation from straight path)
Risk Classification	EXTREME BLIND SPOT - CRITICAL Risk Level
Recommended Maximum Speed	15 km/h
Safety Distance Required	Minimum 50m approach visibility
Driver Action Required	Reduce speed, check mirrors, signal early

- ANALYSIS:
- \* Turn angle: 159.6 deg
  - \* Visibility: Limited due to sharp curve
  - \* Road condition: Visual inspection required
  - \* Hazard level: CRITICAL
  - \* Recommended action: Reduce speed to 15 km/h

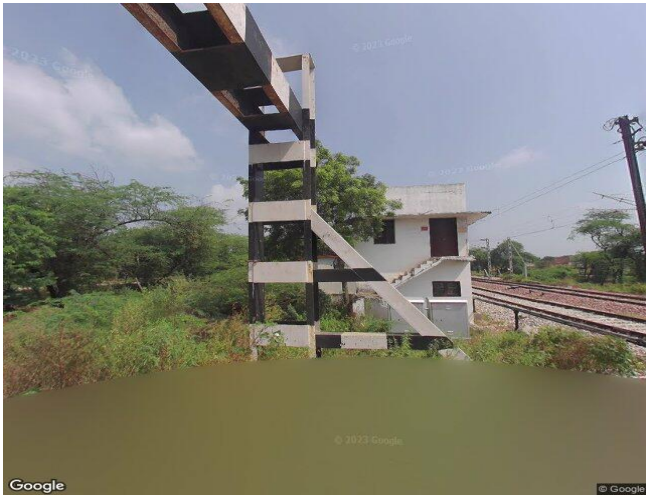
VISUAL EVIDENCE FOR TURN #3:  
STREET VIEW ANALYSIS:

GPS Coordinates	29.800050, 77.458640
Turn Angle	159.6 deg (Deviation from straight path)
Risk Classification	EXTREME BLIND SPOT - CRITICAL Risk Level
Recommended Maximum Speed	15 km/h
Safety Distance Required	Minimum 50m approach visibility
Driver Action Required	Reduce speed, check mirrors, signal early

- ANALYSIS:
- \* Turn angle: 159.6 deg
  - \* Visibility: Limited due to sharp curve
  - \* Road condition: Visual inspection required
  - \* Hazard level: CRITICAL
  - \* Recommended action: Reduce speed to 15 km/h

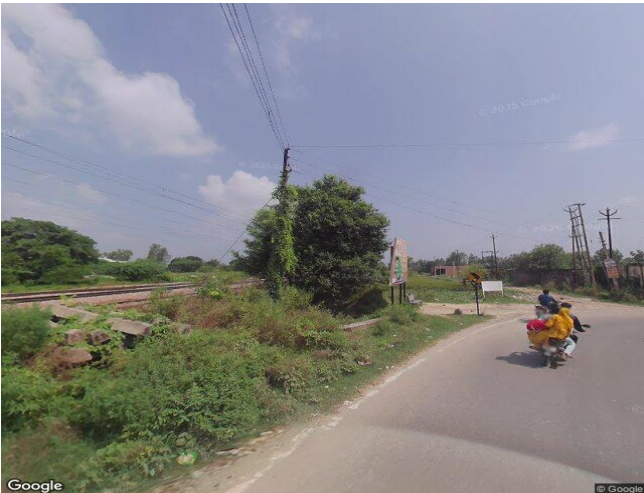
VISUAL EVIDENCE FOR TURN #4:  
STREET VIEW ANALYSIS:

GPS Coordinates	29.801760, 77.459240
Turn Angle	113.0 deg (Deviation from straight path)
Risk Classification	EXTREME BLIND SPOT - CRITICAL Risk Level
Recommended Maximum Speed	15 km/h
Safety Distance Required	Minimum 50m approach visibility
Driver Action Required	Reduce speed, check mirrors, signal early

- ANALYSIS:
- \* Turn angle: 113.0 deg
  - \* Visibility: Limited due to sharp curve
  - \* Road condition: Visual inspection required
  - \* Hazard level: CRITICAL
  - \* Recommended action: Reduce speed to 15 km/h

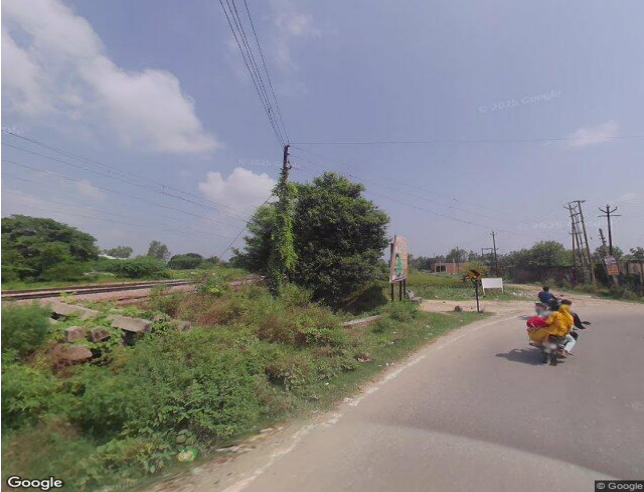
VISUAL EVIDENCE FOR TURN #5:  
STREET VIEW ANALYSIS:

GPS Coordinates	29.801760, 77.459240
Turn Angle	113.0 deg (Deviation from straight path)
Risk Classification	EXTREME BLIND SPOT - CRITICAL Risk Level
Recommended Maximum Speed	15 km/h
Safety Distance Required	Minimum 50m approach visibility
Driver Action Required	Reduce speed, check mirrors, signal early

- ANALYSIS:
- \* Turn angle: 113.0 deg
  - \* Visibility: Limited due to sharp curve
  - \* Road condition: Visual inspection required
  - \* Hazard level: CRITICAL
  - \* Recommended action: Reduce speed to 15 km/h

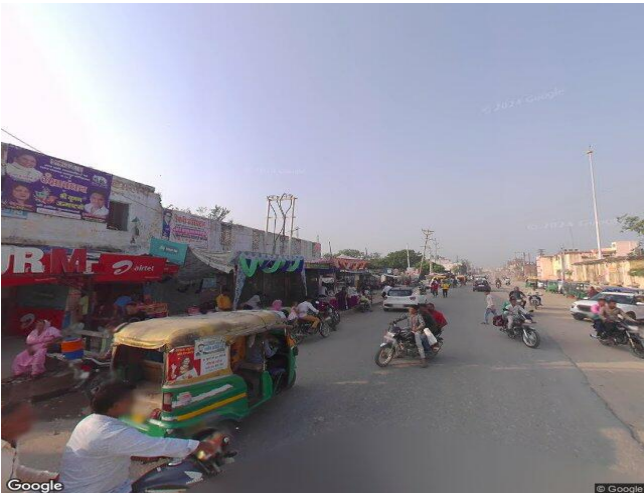
VISUAL EVIDENCE FOR TURN #6:  
STREET VIEW ANALYSIS:

GPS Coordinates	29.804640, 77.454670
Turn Angle	97.4 deg (Deviation from straight path)
Risk Classification	EXTREME BLIND SPOT - CRITICAL Risk Level
Recommended Maximum Speed	15 km/h
Safety Distance Required	Minimum 50m approach visibility
Driver Action Required	Reduce speed, check mirrors, signal early

- ANALYSIS:
- \* Turn angle: 97.4 deg
  - \* Visibility: Limited due to sharp curve
  - \* Road condition: Visual inspection required
  - \* Hazard level: CRITICAL
  - \* Recommended action: Reduce speed to 15 km/h

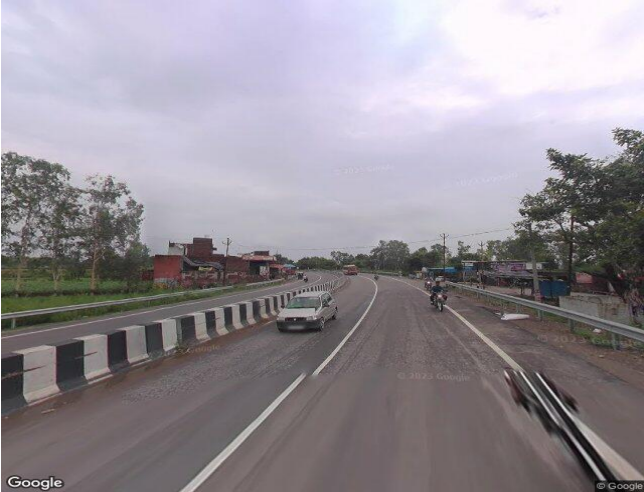
VISUAL EVIDENCE FOR TURN #7:  
STREET VIEW ANALYSIS:

GPS Coordinates	29.625320, 77.439180
Turn Angle	75.7 deg (Deviation from straight path)
Risk Classification	BLIND SPOT - HIGH Risk Level
Recommended Maximum Speed	25 km/h
Safety Distance Required	Minimum 50m approach visibility
Driver Action Required	Reduce speed, check mirrors, signal early

- ANALYSIS:
- \* Turn angle: 75.7 deg
  - \* Visibility: Limited due to sharp curve
  - \* Road condition: Visual inspection required
  - \* Hazard level: HIGH
  - \* Recommended action: Reduce speed to 25 km/h
