Progress Report - 22 June 2016

### PROGRESS WITH REHABILITATION OF THE VILJOENSKROON WATER SUPPLY SYSTEM

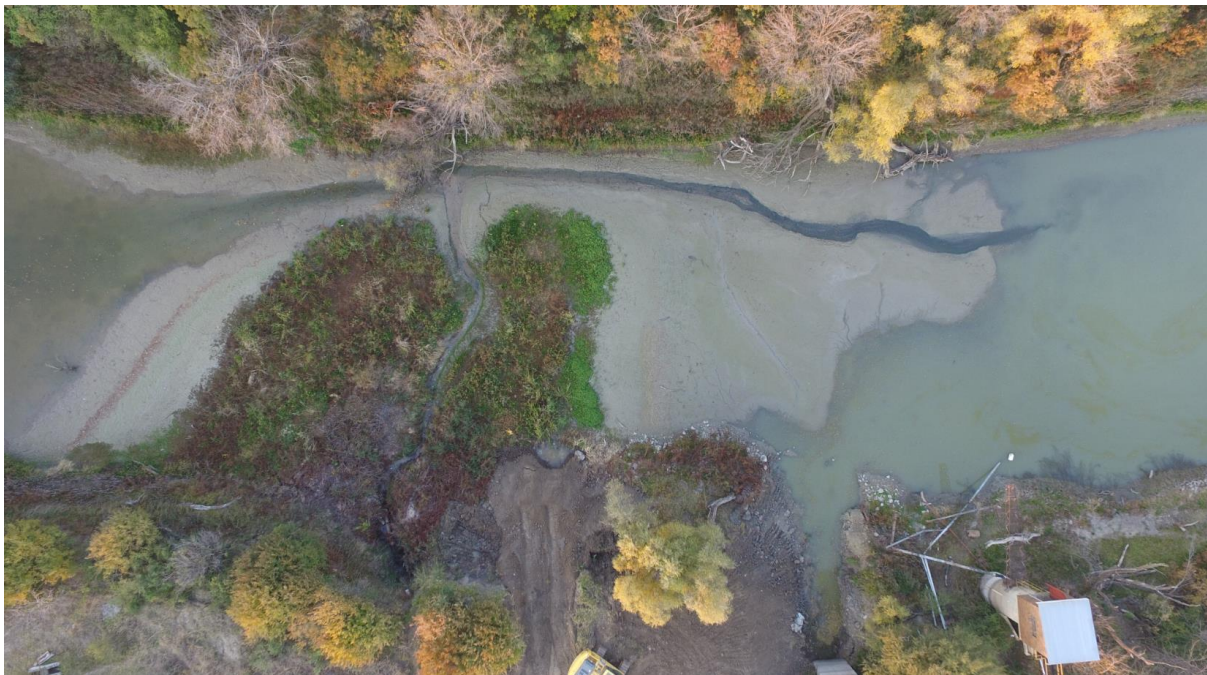
1. Backwash blockage and the new coffer dams. As mentioned previously we have damaged the Renoster river in such a way that we nearly blocked the free flow of water with the backwash from the purification plant. (see picture 1). Further to this, the backwash into the river at the extraction point not only blocked the water but it keeps on building up the turbidity. This imply that the purification process worsens and become more difficult and expensive.

Picture 1. Silt build-up in the Renoster river next to our extraction point.

To limit further damage to the Renoster river and stop the release of the backwash into the river, DWS started to build coffer dams so that we can release the backwash into the coffer dams instead of directly into the Renoster river. By end of today the first two coffer dams were in full operation (see picture 2).

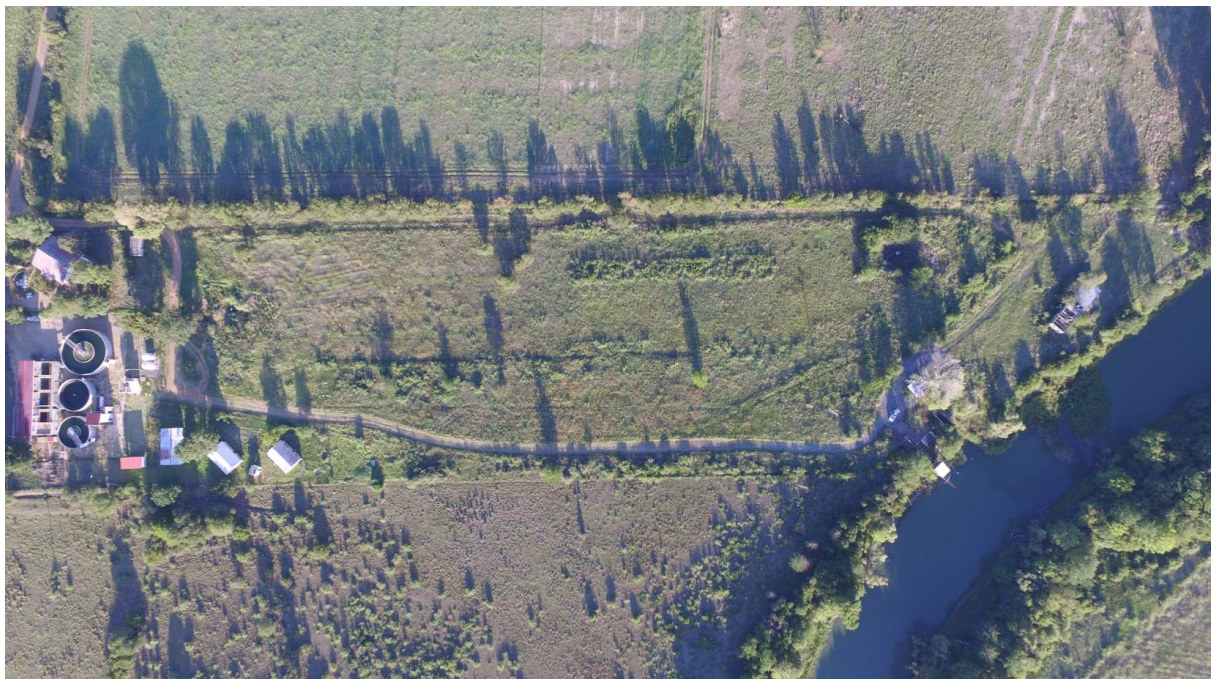
To visualise the total impact it is worth to compare the before and after pictures of our water works facility to get a full picture of the impact of the work been done in just more than 2 weeks' time (see pictures 3 and 4)

Picture 3 taken on 12 February 2016

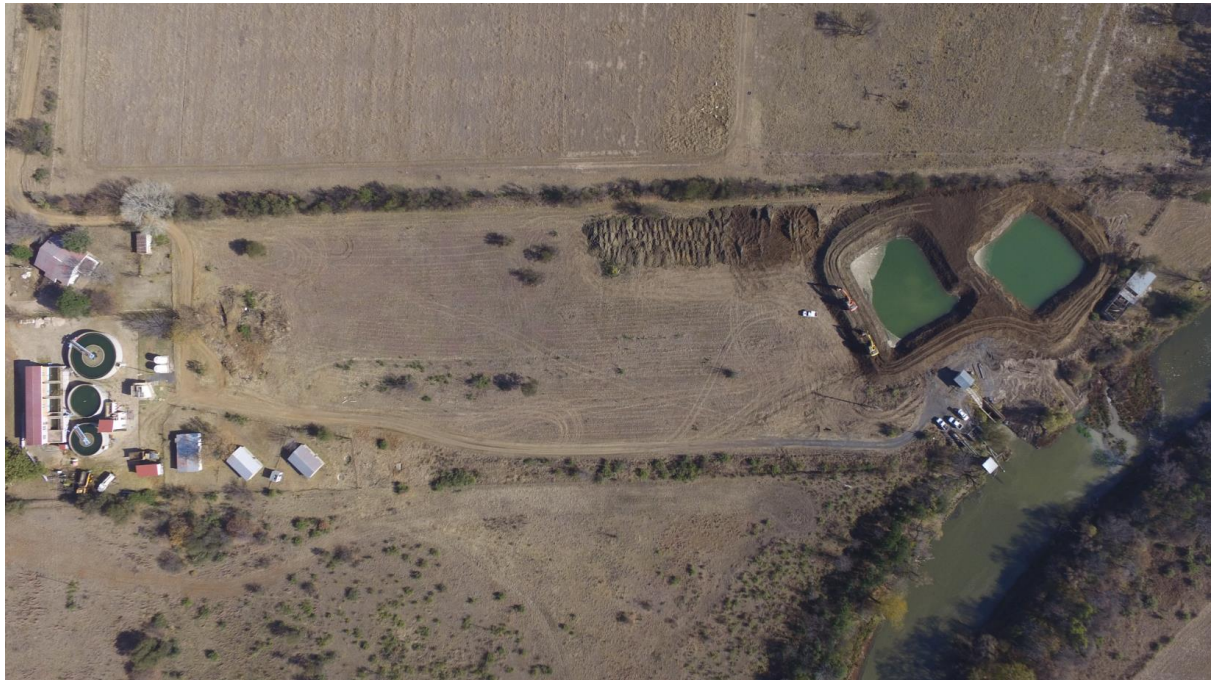
Picture 4 taken on 22 June 2016.

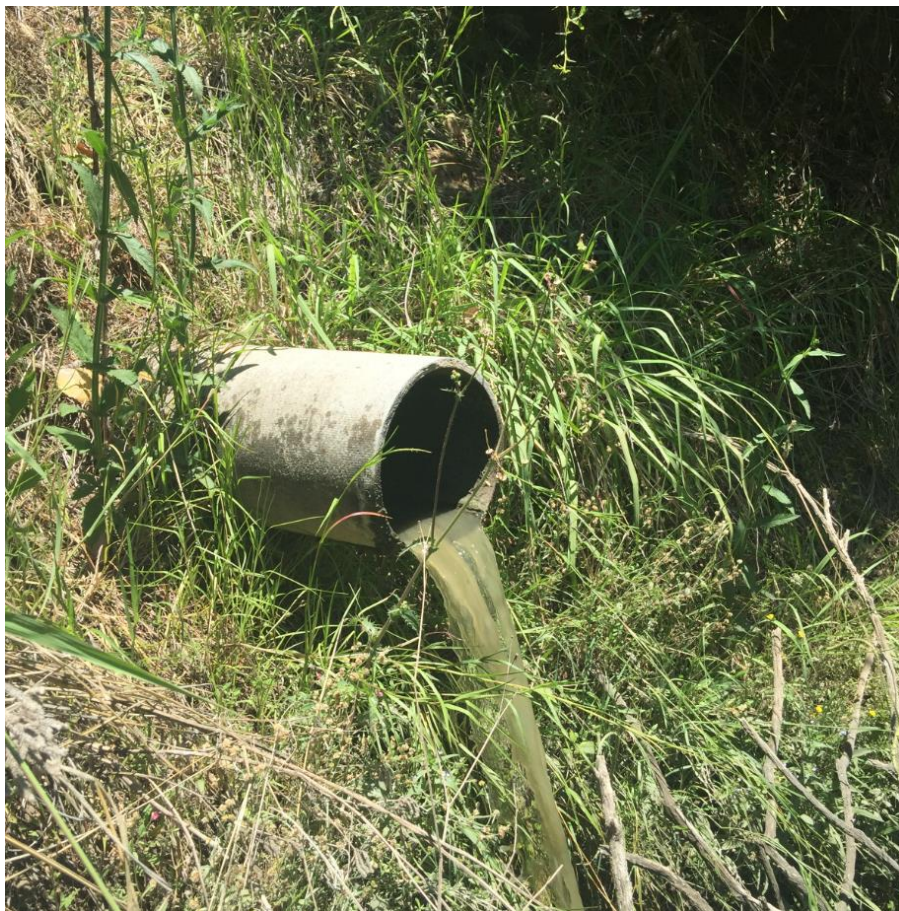
The impact and success with the implementation and commissioning of the cofferdams can only be realised when we measure the results. On visual inspection this morning the clarity of the overflow water into the Renoster river from the cofferdam was clearly visible (see picture 5 and 6).

Picture 5 taken on 31 May 2016 of the backwash released

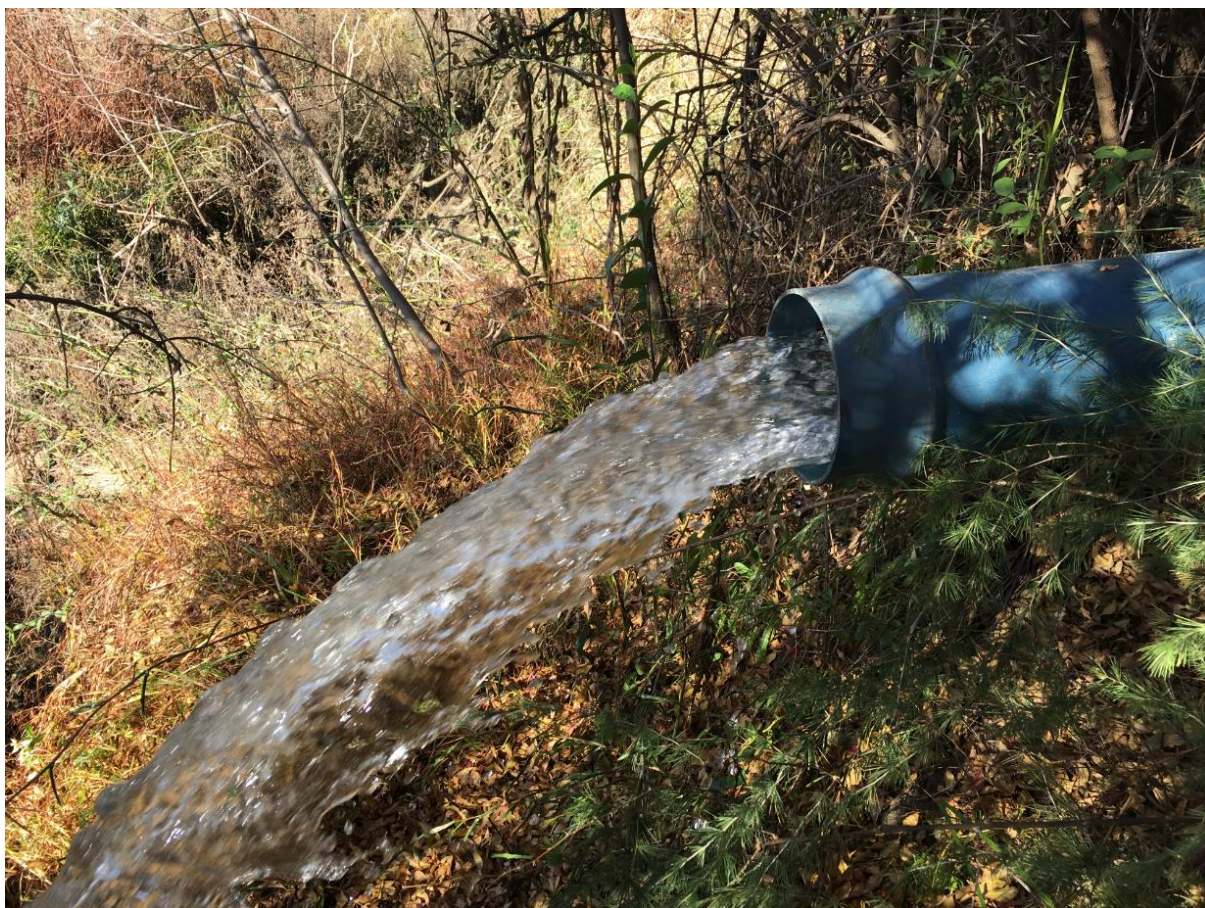
Picture 6 taken on 22 June 2016. The backwash water released after settling in the cofferdam is nearly clean and clear.

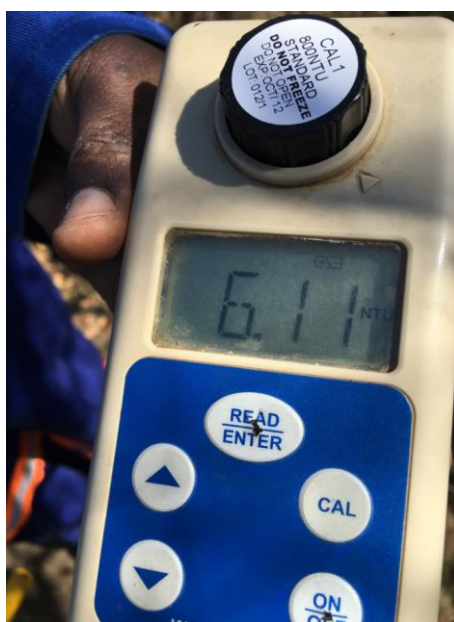
Picture 7

To fully understand the impact, we measured the turbidity of the water released from the cofferdam and it is cleaner than the water we extract from the Renoster river. On 22 June 2016 we measured a turbidity of only 6.11 NTU for the backwash water released from the cofferdam (see picture 7).

With all this said we envisage to recycle the water from the cofferdams in future instead of releasing it into the river as it is just >5 NTU higher than purified water. We will also investigate the possibility and cost effectiveness of building a “settling-dam” in the open space just in front of the water purification plant to pump the raw water first into the settling dam. If feasible and we can manage the natural cleaning of raw water in a similar way as with the backwash and describe above, we hope to minimise the purification cost of water at our purification plant.

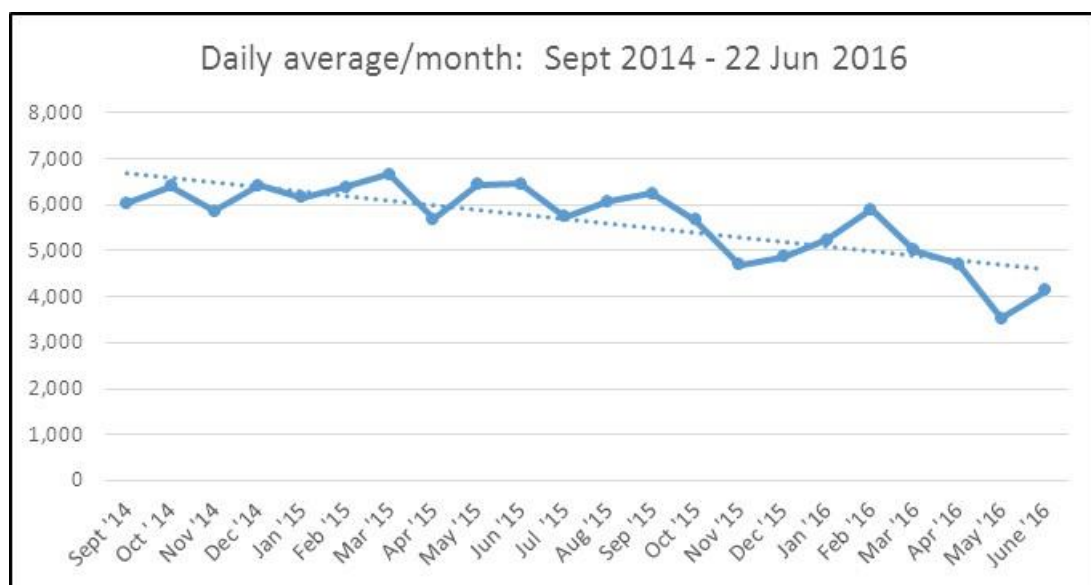
Picture 8

Over the last 7 days our water delivery for June 2016 increase from an average of 3,633 Mega litres/day to 4,134 Mega litres/day (see picture 8.)

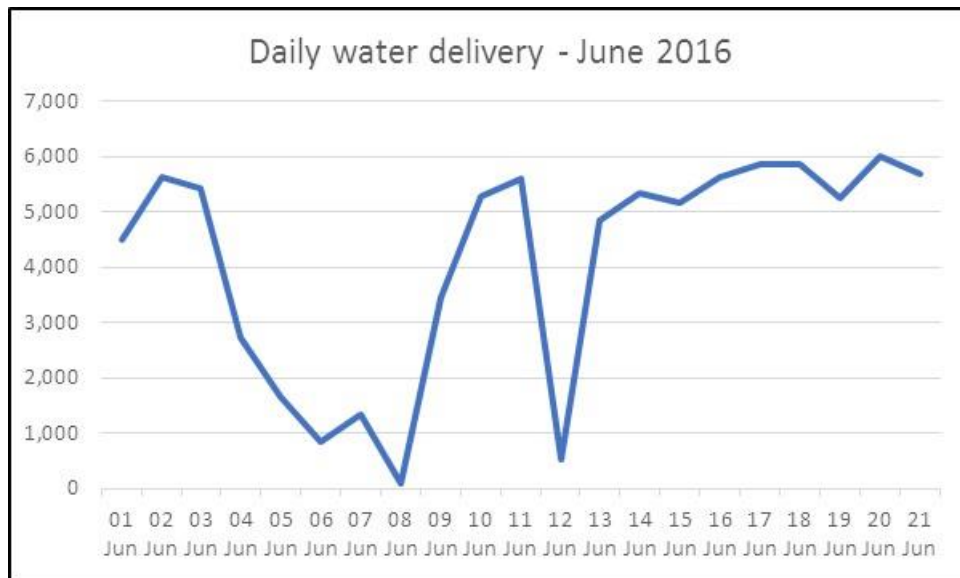
Picture 9

Please take note that the average is negatively influenced by the water shortage and poor delivery in the beginning of June 2016. However, as indicated in picture 9 we have recovered fairly well and already managed to reach 6 Mega litres on 20 June 2016 (see picture 9). We trust to improve delivery and reach an average of 6,22 Mega litres/day.
