SITUATION REPORT NO.3

Further to our previous reports we would like to inform all concern of the latest status of various activities in Rammulotsi and Viljoenskroon.

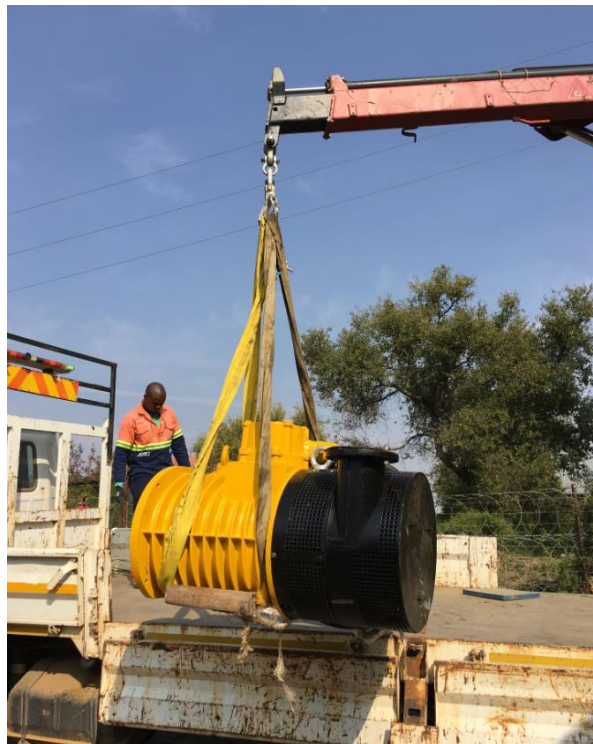
1. **Viljoenskroon water treatment works.** To summarise the progress, allow me to start from our raw water source and work through the full cycle.
 - a. Vaal river pump station. We still operate with the pump De Beers Group has provided to us on loan. The submersible pump was installed and commissioned on 8 June 2016.

The submersible pump delivers ± 80 litres/second and have made a huge impact on our natural reservoir at the Renoster river side. Based on the experience over the last view weeks we have various proposals to upgrade and install new pumps at the Vaal river pump station. It will not alone ensure adequate supplementary supply in future but also offer redundancy at all times. Final presentation to be made later this week.

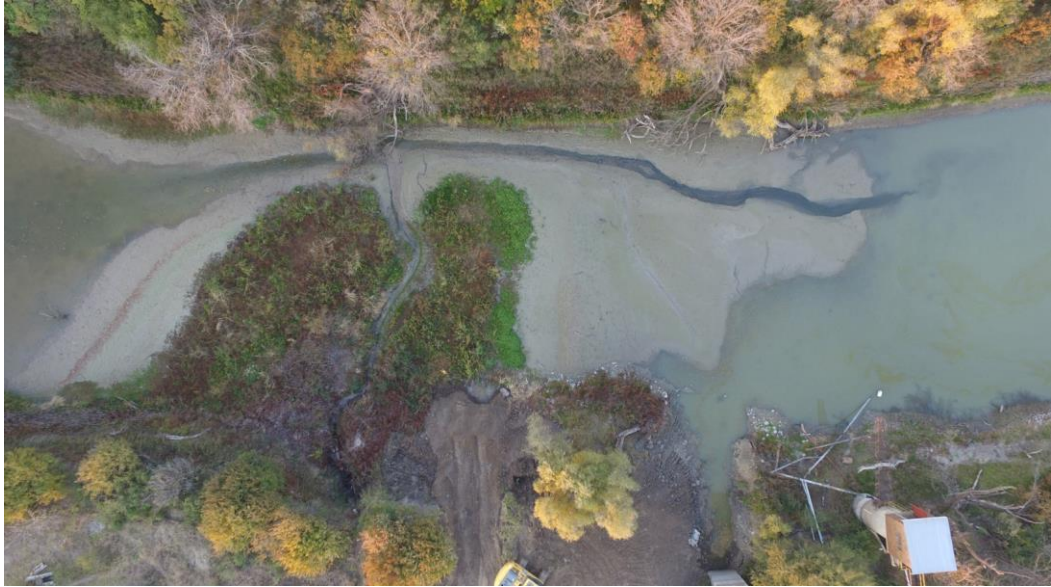
- b. Renoster river. We have showed the situation we were in on 7 June 2016 before the new pump was commissioned. As mentioned before, the backwash blocked the free flow of water and we were literally without water on 7 June 2016 and all water purification got to a standstill. Further to this, the backwash into the river at the extraction point not only blocked the water but it keeps on building up the turbidity. This imply that the purification process worsens and become more difficult and expensive.

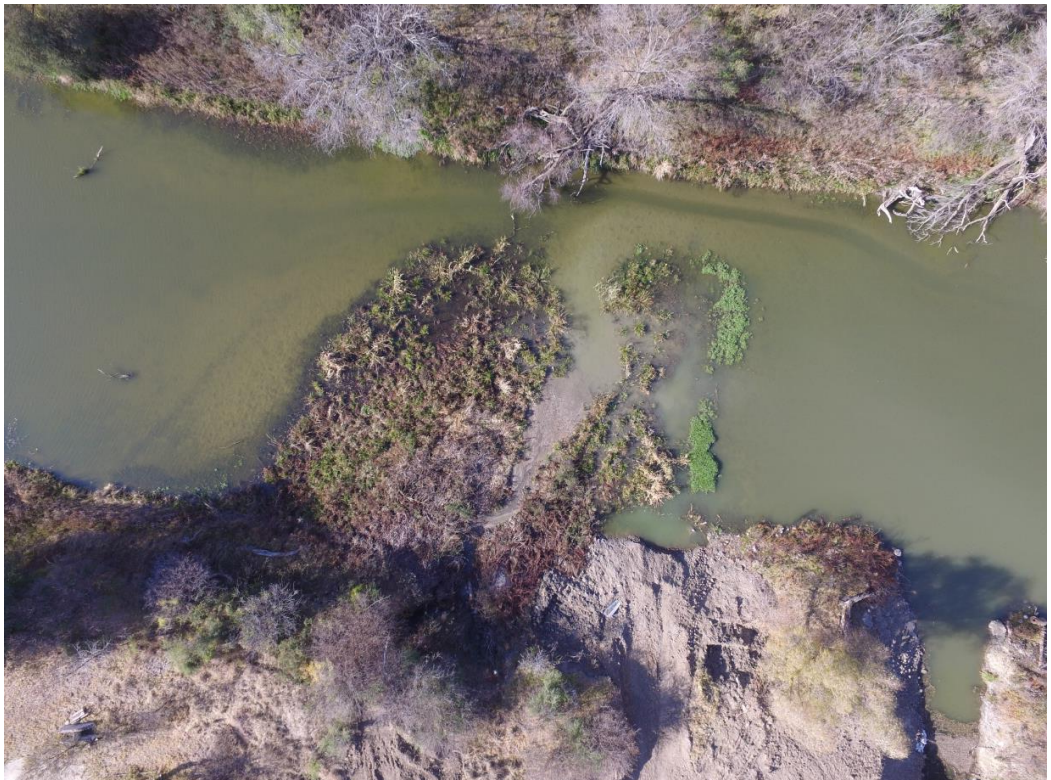
On 3 July 2016 the situation is very different and we are pleased with the progress and water levels in the Renoster river. In the first 14 days we have an increase of more than 400 mm in the water level.

As the water surface increase over the full distance from the weir to the first big rapid ± 2.94 km in length and with an average width of ± 32 metres, the increase in water level slows down. However, we are pleased to inform you that the water level still increase considering the fact that we now reached our maximum extraction of just over 6 million litres per day for purification purposes.

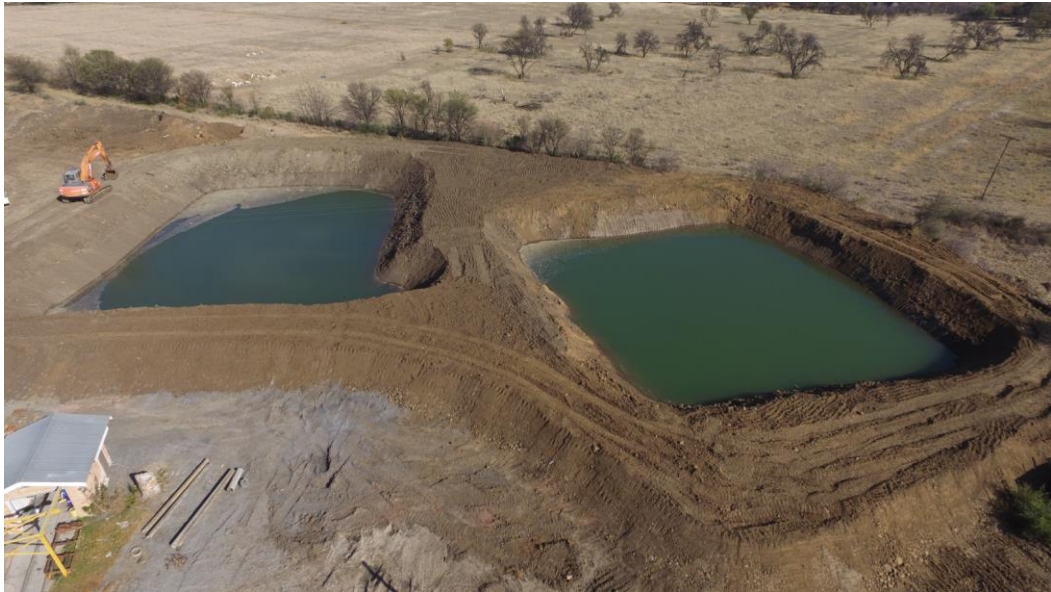
- c. Silt/Coffer dams. To limit further damage to the Renoster river and stop the release of the backwash into the river, DWS build two coffer dams so that we can release the backwash into the coffer dams instead of directly into the Renoster river. On 22 June 2016 we reported that the first two coffer dams were in full operation.

On 22 June 2016 we indicate the success and total impact on our WTP at the Renoster river. We also refer to the impact and improvement with the water quality of the Renoster river. We monitored the turbidity over time now and it is worth to report the improvement and success until now. This all by basic natural settling. The following turbidity minimum and maximum measurements at strategic points to take note off: -

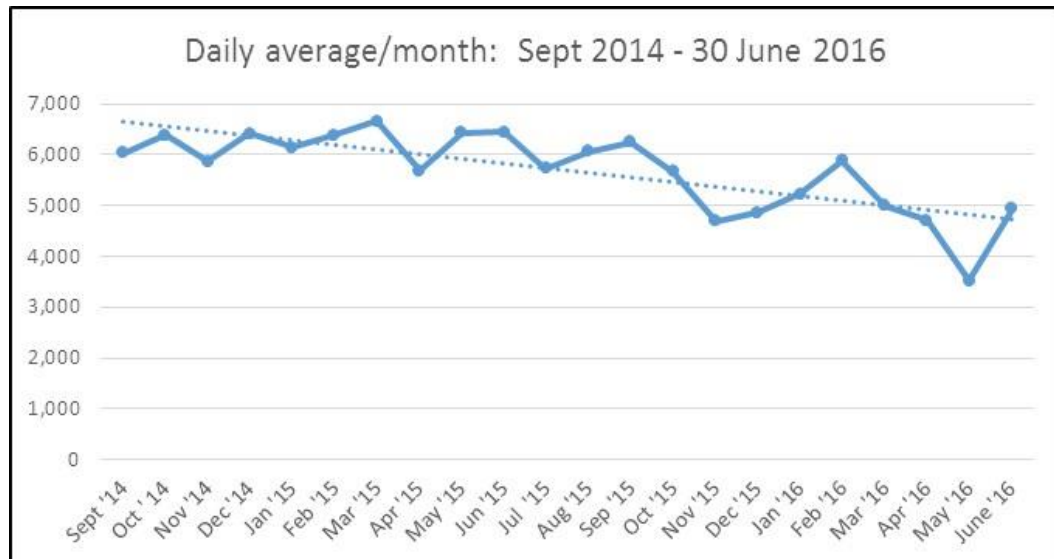
- d. Water purification and delivery. We are pleased to inform you that we are at the same maximum level reached since September 2014. Our maximum purification capacity is about 6,65 million litres per day. We also break the trend barrier been indicated in the graph hereunder. Please take note that the poor performance in June was due to nearly a week of no water supply and the Renoster river that was nearly without water at the time. However, with that included we still break the first trend barrier

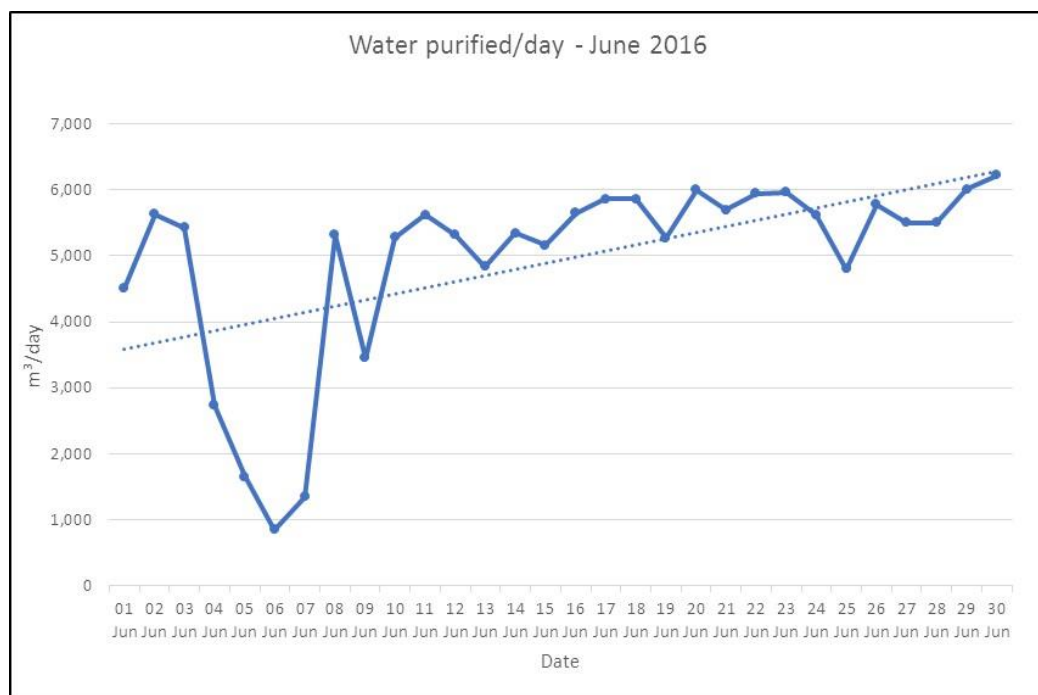
It is also noteworthy to have a look at the daily reports for purification during June 2016. The same improvement is also clearly visible.

From the graph above you will notice the difficult situation in the beginning of June 2016. You will also notice two incidents after the first week where we experience a lower delivery due to shift worker(s) that did not report to work and/or a lower pump figure to reasons yet to be determine with the operators on duty.

A personnel meeting is scheduled for tomorrow 12 July 2016 to discuss the importance of essential jobs or as sometime refer to work of strategic importance. To have a clearer picture without the skew results in the first week of June 2016 it is necessary to look at the last 22 days when water delivery normalised and stabilised. We trust that we can keep at this level and get as close as possible to the maximum our WTP can offer to deliver.

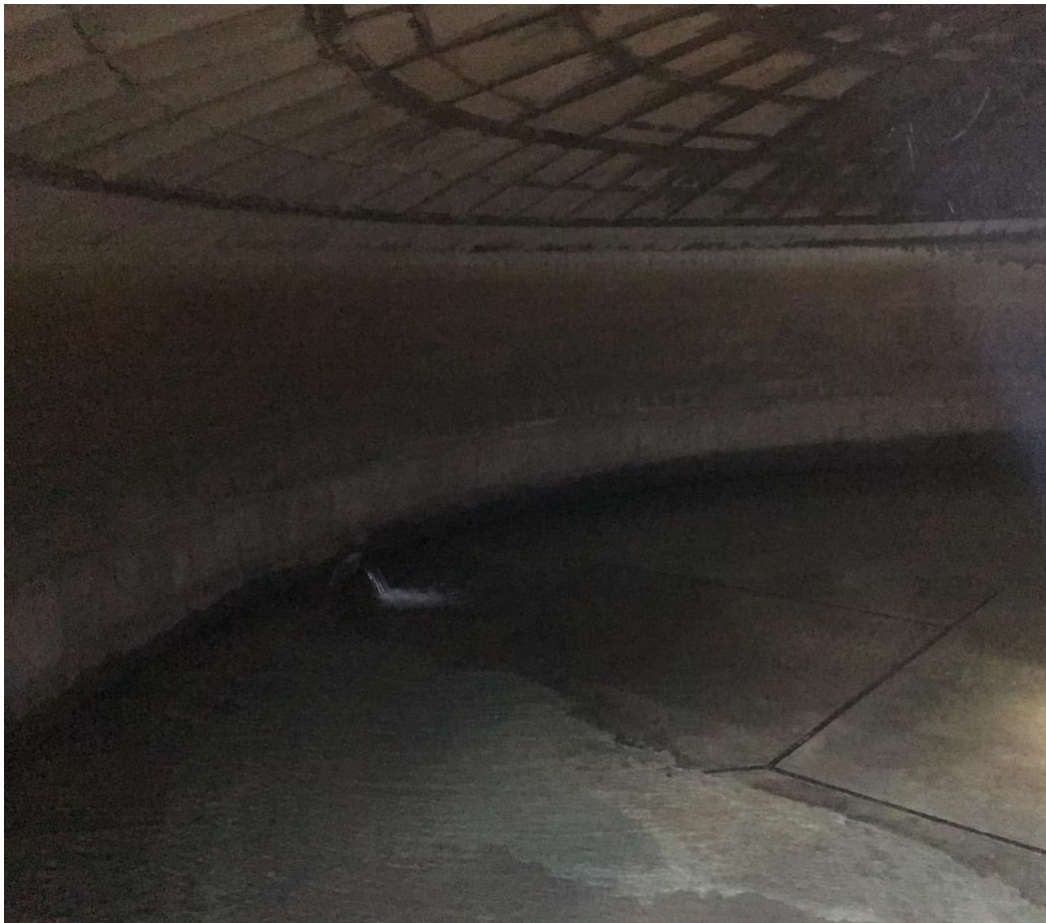
The following picture taken on 3 July 2016 of the inside of reservoir C (the big reservoir to the West of the R501 to Potchefstroom). Except for the fact that the water level is still nearly at the bottom we can also see that the water reservoir is fairly clean and not seriously influenced with sedimentation. The water inflow also visible just left from the centre of the picture.

We urge all residents to use water sparingly even if there is water in the tap. The last 2-3 weeks there was no shutdowns. If we cannot manage to fill the reservoirs we have to implement water restriction by closing the supply for the published times (See report 22 June 2016) in order to build a backup of at least 2 days if the reservoirs are full.

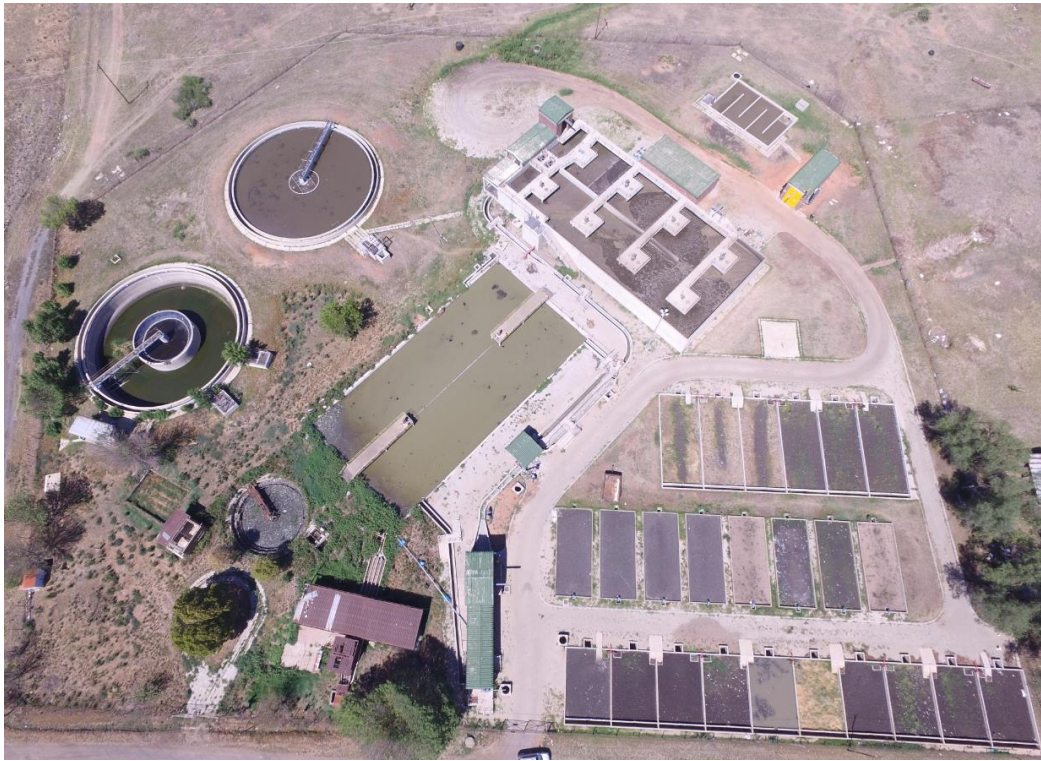
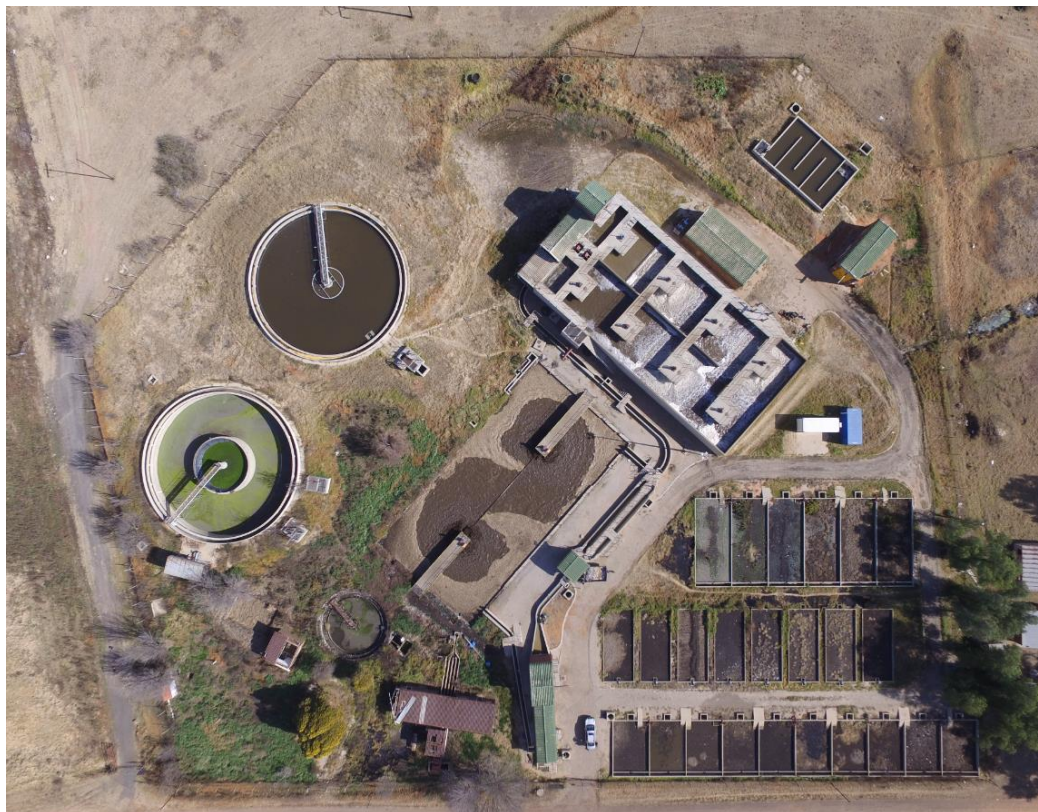
2. **Waste Water Management.** The rehabilitation of the first phase of our waste water treatment plant (WWTP) is also nearing completion. From the picture hereunder and taken on 6 December 2015 most of the units at WWTP were not operational. The intervention by DWS was welcomed by all and the improvement is visible.

Mr Arnold Richter from Envirocure was called in by Kroonstad and with the natural bacteria even the odour is greatly reduced within the last 7 days. The liquidity of the sludge improved and we trust to improve the quality of the water released into the wetland to acceptable standards.

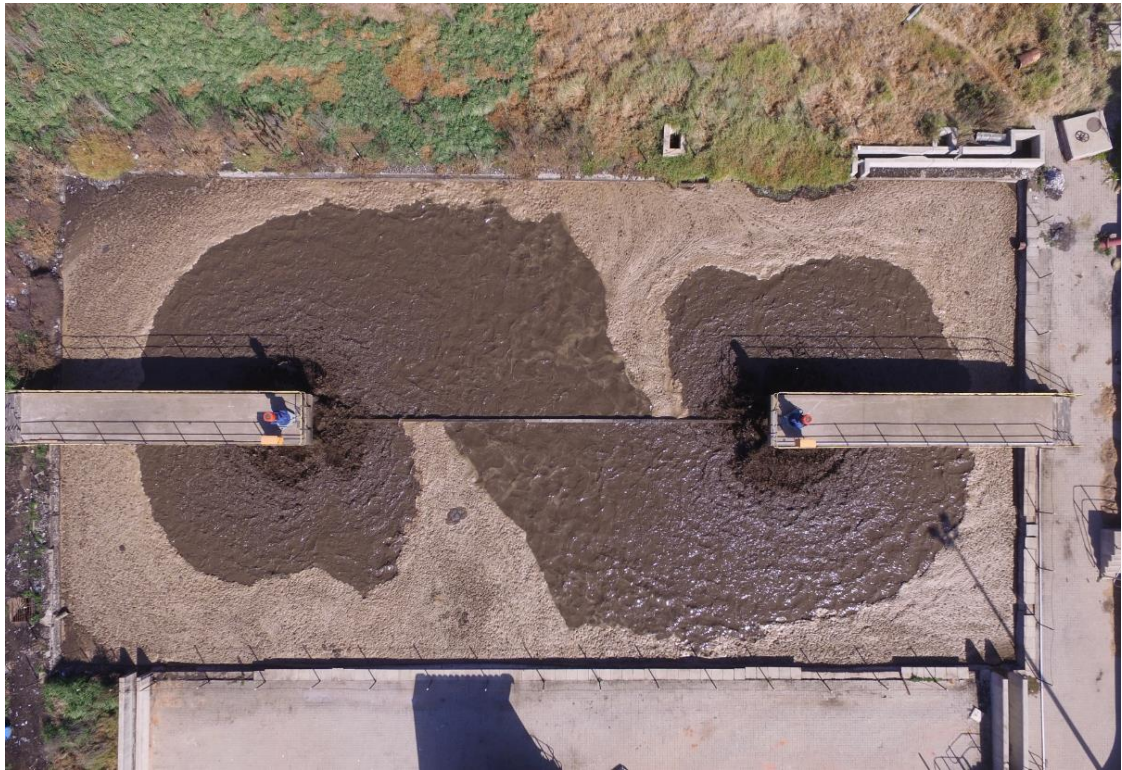
From the above picture and the closer view in the next picture clearly indicate the improvement in liquidity of the sludge which now start flowing with the aerators in full operations. This is due to the new machines and also the natural bacteria from Envirocure which live on the organic material from the sewer.

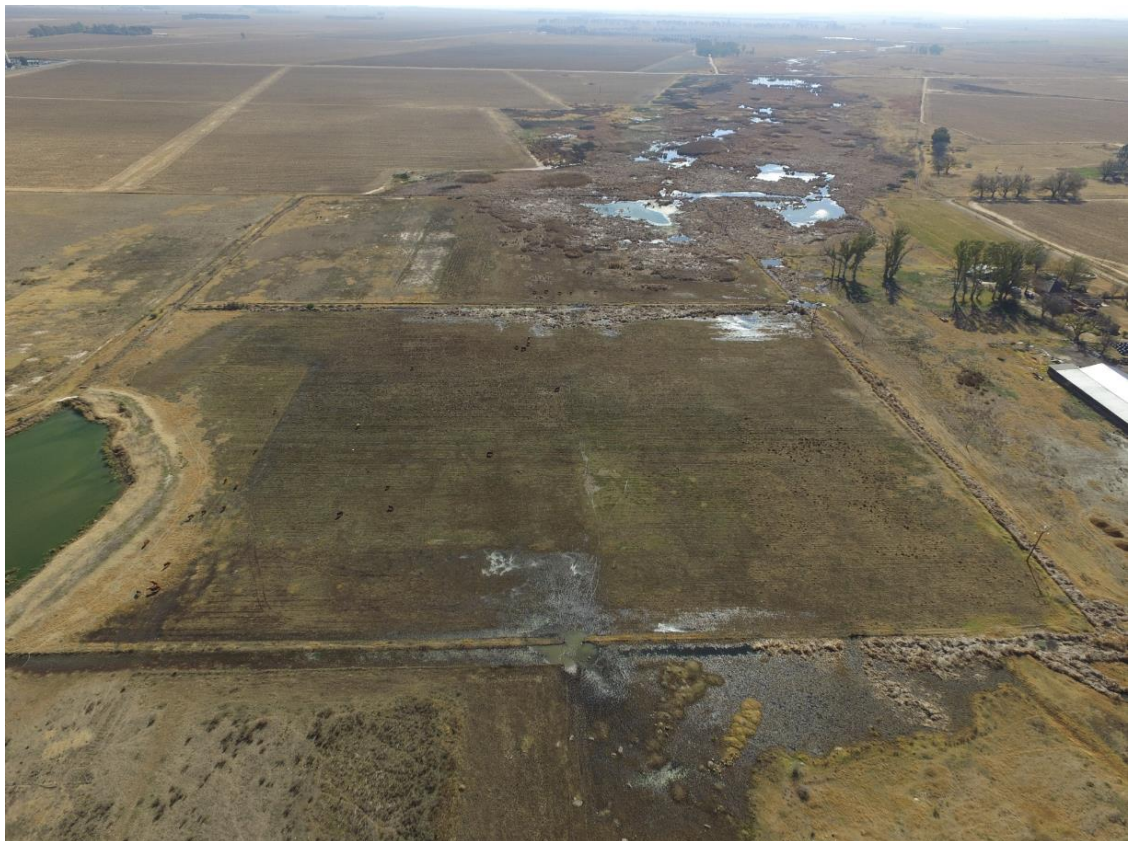
The aim in the near future is to ensure “clean” water released into the wetland and also the redevelopment of the wetland and the proclaimed nature reserve. The following picture shows the status of the wetland influenced by the water release from our WWTP.

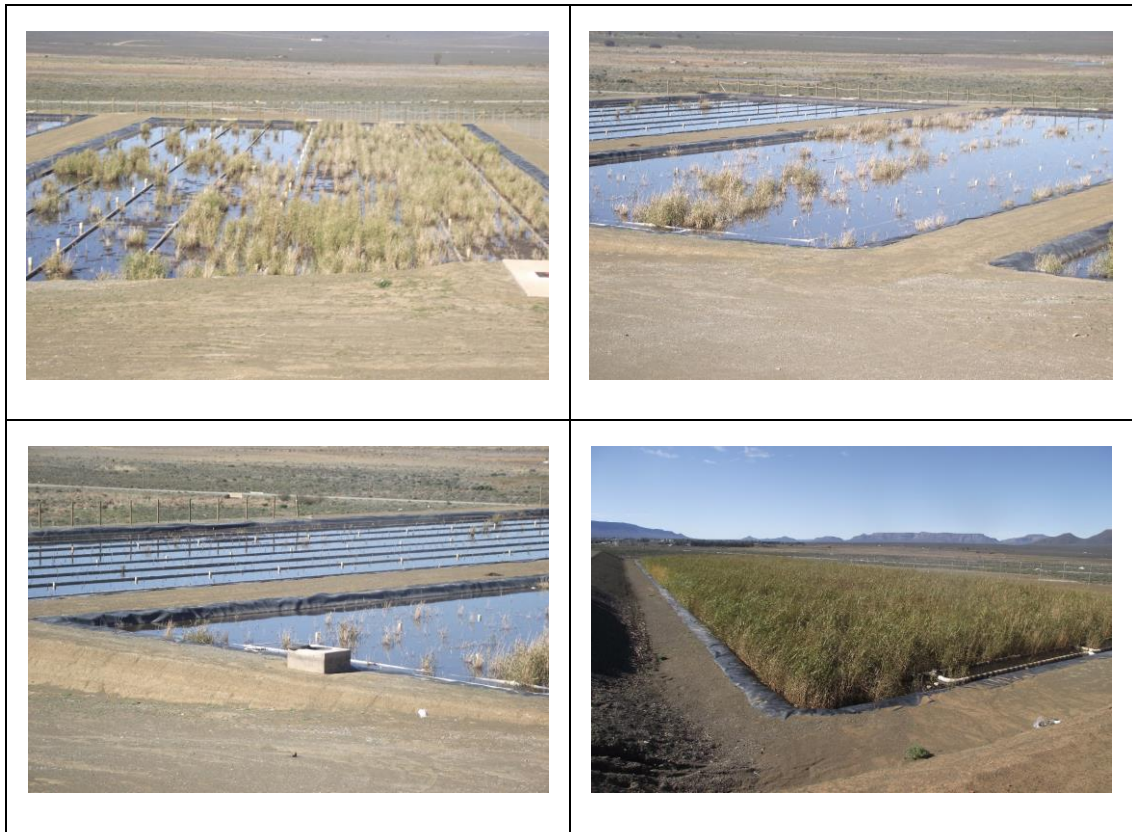
Based on the success with the coffer dams at the Renoster river WTP we are sure we can meet the standards set by Department of Environmental Affairs with regards to wetland development and the release of sewer water into our wetland. Hereunder what we envisage to ensure a clean and safe environment.
