Notes on Rebuilding an SB-220 Linear Amplifier

Brad Rehm, KV5V
Salado, Texas

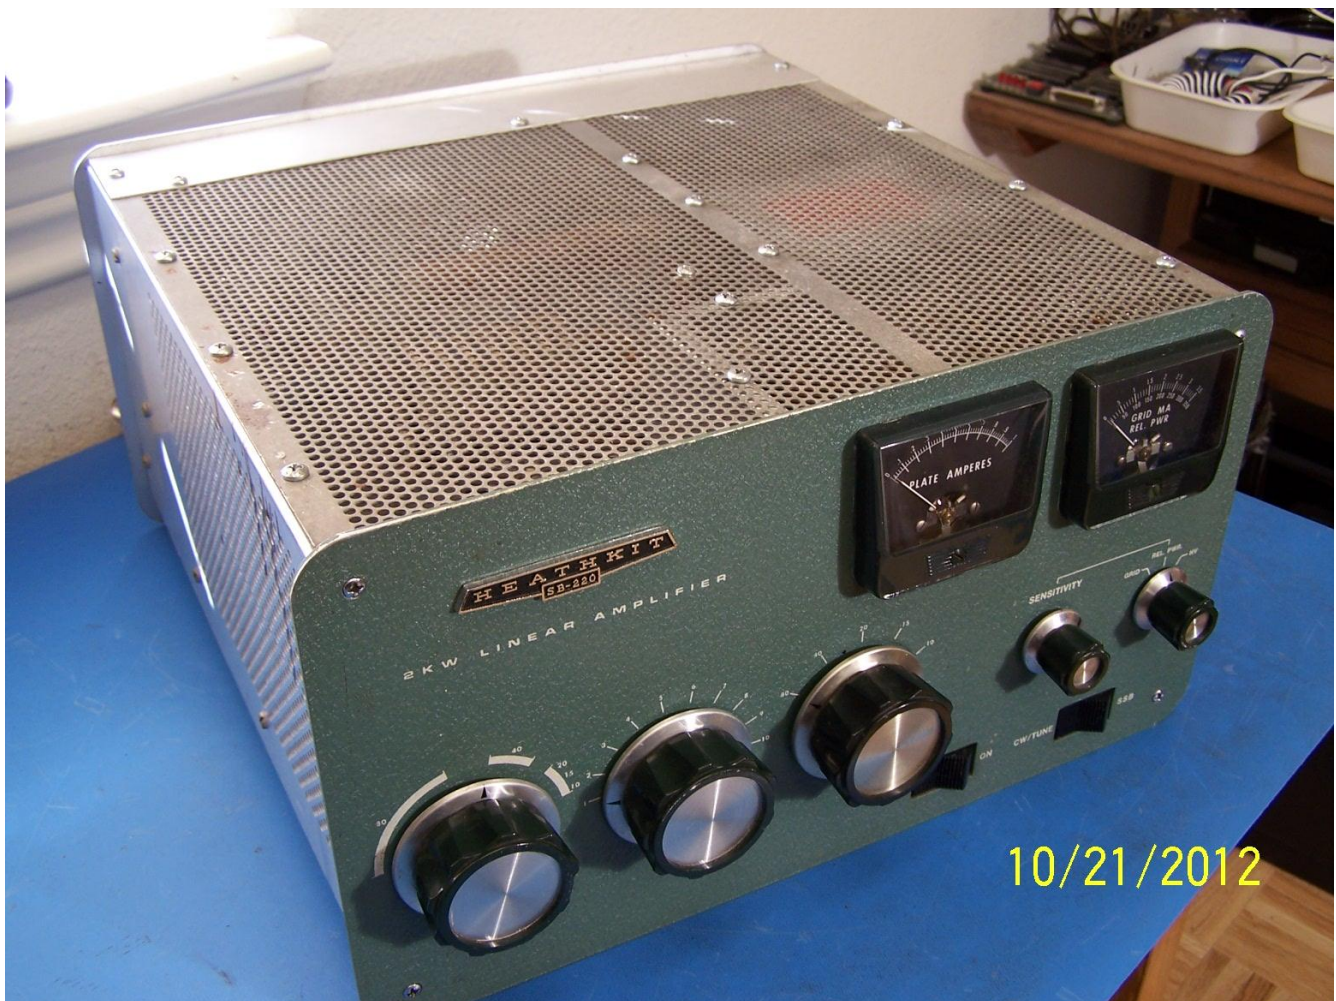
Photo 1 - The Heath SB-220 at the beginning of the project. The outer enclosure has been removed.

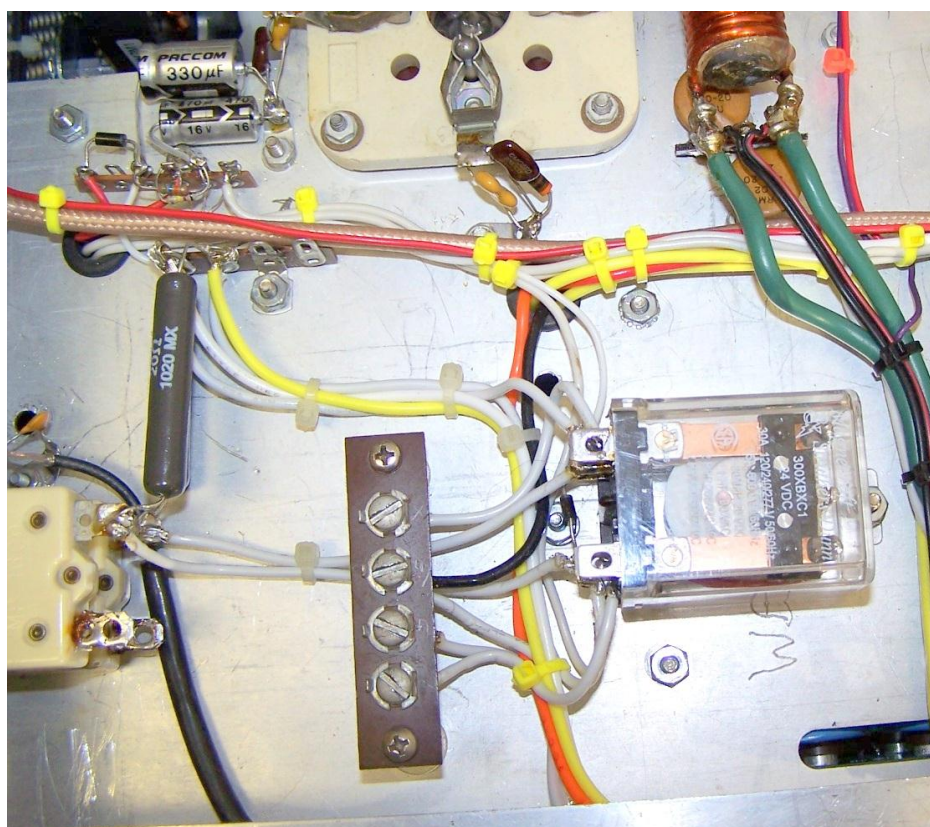
Photo 2 - The components of the step-start circuit were located next to the circuit breakers

and the power cord entry. The cord and voltage-select jumpers have not yet been installed. For the final endurance change, we added a step-start circuit which limited the turn-on or inrush current due to the initial low resistance of the tube filaments and the high energy demanded by the filter capacitors when charging begins. I've used two approaches to this task in other amplifier projects. The simplest inserts a negative temperature coefficient (NTC) thermistor in series with one of the incoming AC mains. These devices present a relatively high resistance when cold and reduce their resistance to a small fraction of an Ohm when they become warm. Several commercial soft-start products use this approach.

I chose the relay approach, shown in Photo 2 above, using a simple R-C and transistor timer. The start-up current requirement of an amplifier of this size can exceed the current ratings of the largest NTC thermistors, especially when the amp is operated at 120 Volts. The relay approach can be very reliable if the resistors and relay are selected carefully. After a two-second delay, two 15 Ohm, 5 Watt resistors in parallel in each leg of the incoming AC are removed, using a double-pole, 20 Amp relay. The component values allow the simple, 28-Volt delay circuit to operate properly at 120 and 240 Volts.

Photo 2 shows the Magnecraft relay used to bypass each of the series resistors, which are located to the right and above the circuit breakers. The terminal strip to the left of the 3-500Z socket contains the 28 Volt rectifier and delay circuit. The transformer which powers this circuit was bolted to the side panel on the top of the chassis. It is shown in Photos 3 and 12. The final schematic includes the relay control circuit and 28 Volt power supply.

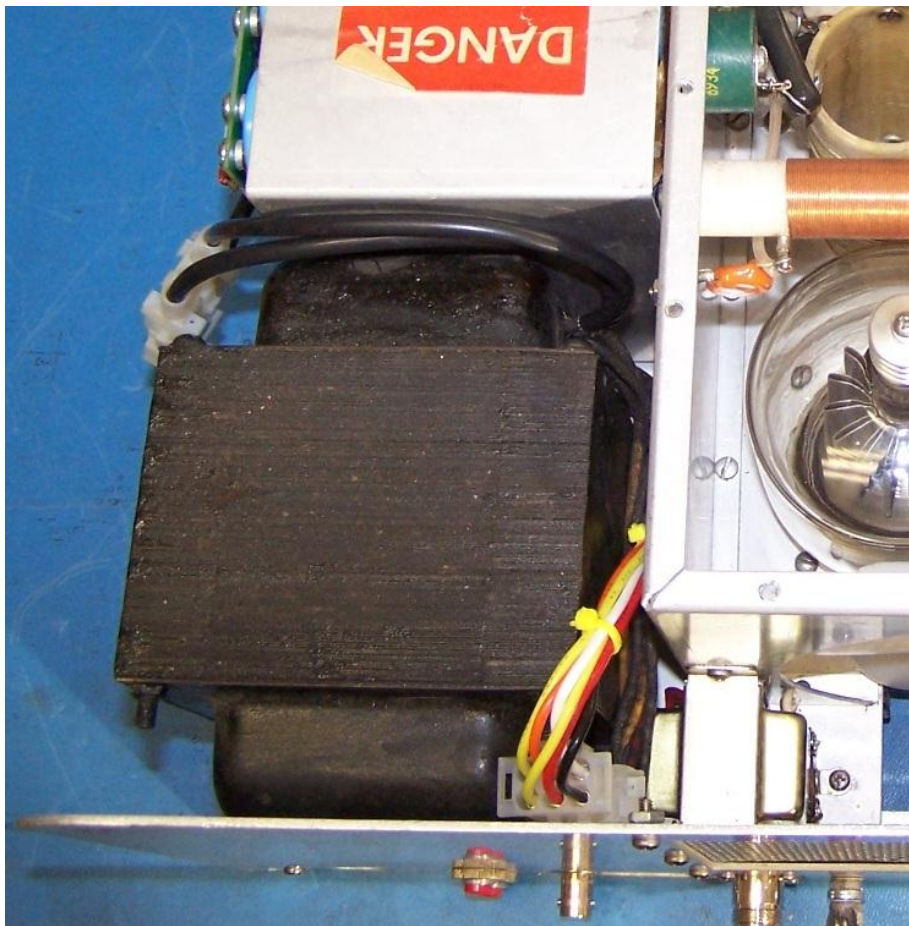
Photo 3 Molex connectors as installed at the high voltage power transformer. The connectors make it easier to remove the transformer for shipping. The original transformer was replaced with a Harbach/Peter W. Dahl unit, which increased the available high voltage from about 3200 to nearly 3500 Volts. This photo also shows the Alpha Wire sleeving which was installed on the transformer secondary leads. The breakdown rating of the sleeving is 8000 Volts.

1. Molex connectors were installed in the high voltage transformer leads and in the wiring to the front panel. These are shown in Photos 3 and 4. The primary connectors were Molex 50-84-1060 and 50-84-2060. The secondary connectors were Molex 50-84-1040 and 50-84-2040.

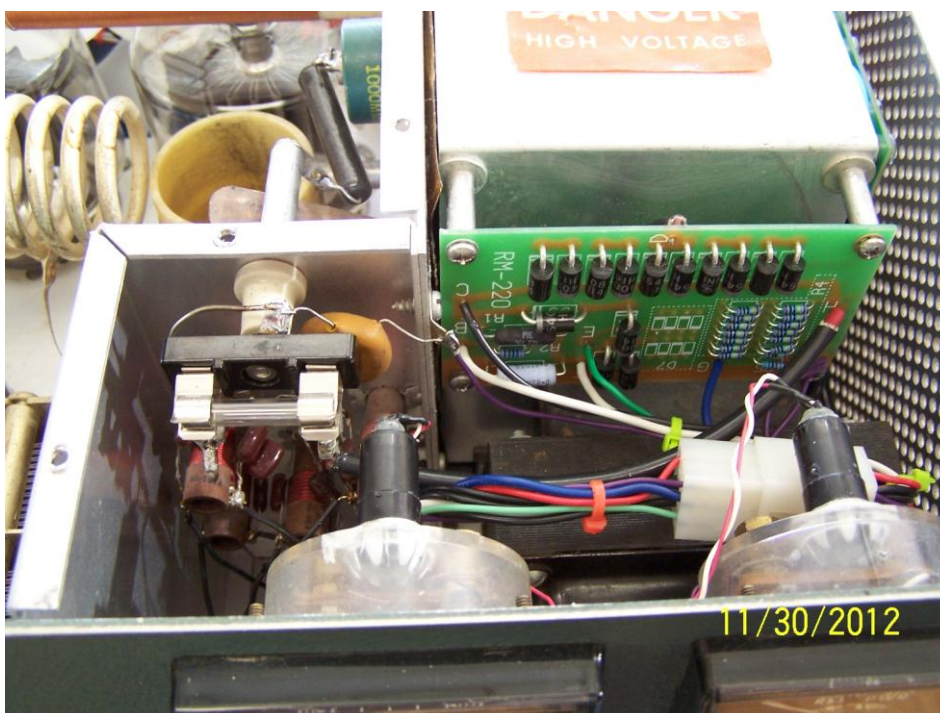
Photo 4 The Harbach diode board, which replaces the original voltage doubler board. The area of this board which contained the zener diode replacement is not populated because this function is performed by the W7RY QSK Board. Also visible in this photo is the Molex connector which allows detaching and removing the front panel. The fuse, visible on the left side of the photo, protects the power

4. The Harbach SB-220 diode board uses newer 1N5408 diodes, which increase the peak current rating from 1 to 3 Amperes. An additional diode was installed on the back of the board to reduce the chance of damage from tube flashovers. (See the discussion of this change below.)

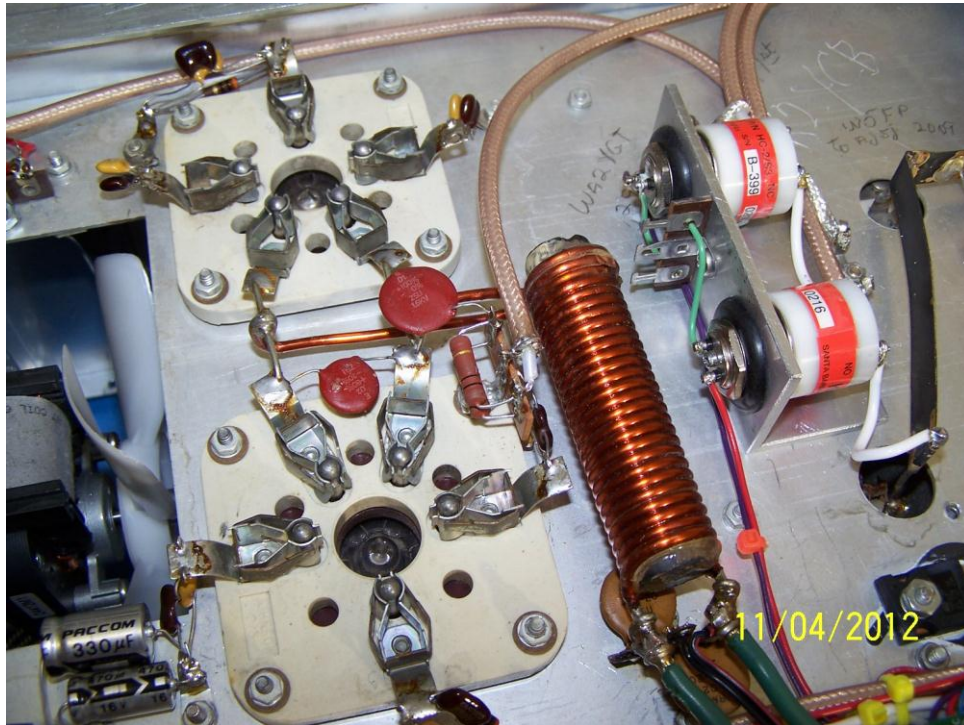
Photo 7 - Kilovac HC-2 vacuum relays are shown in this photo. The resistor which sets current through the relays at 60 mA will be installed on the terminal strip between the relays.

The relays are mounted in rubber grommets (Mouser 534-750) to reduce mechanical switching noise. Also visible in this photo are the parallel 10 Ohm resistors in series with the coax and RF drive to the filaments. These reduce the Q of the bandswitch-to-tube wiring.

5. The ALC circuitry was removed because reliable ALC loops are already incorporated in modern transceivers.
6. The three-pole antenna- and bias-switching relay was discarded, and several components were added to replace it. The vacuum relays are shown in Photo 7. The upgrades accomplished with the W7RY QSK Board are discussed below. All coax in the SB-220 was replaced with Teflon dielectric, RG-303.

The first step in preventing this kind of damage is to abandon the practice of isolating the grids of the tubes from ground with chokes, resistors, or fuses. Photo 7 shows resistors installed between one of the grid terminals on each tube and each grid pin taken to RF ground with pairs of capacitors. These were replaced with buss wire connections to ground. The ground connection ensures that the grids can never be driven very positive in a flashover

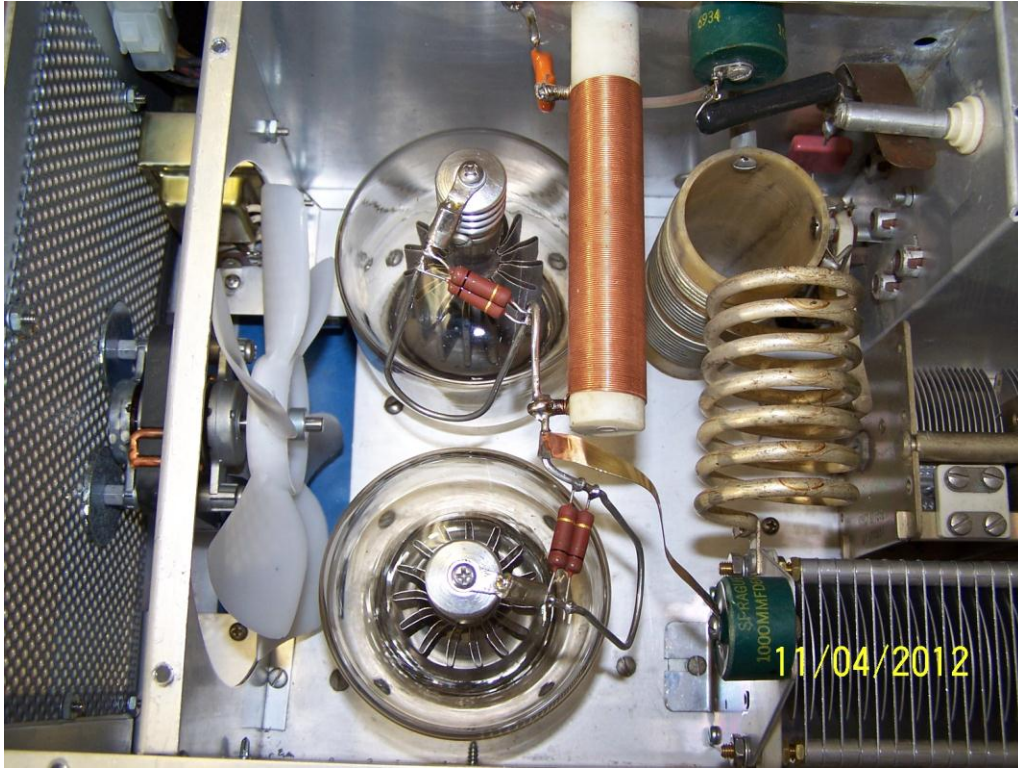
Photo 8 - The hairpin parasitic chokes are supported by the plate choke. The Q-killer resistors are placed at the “bottom” of each choke. Notice the ceramic disc capacitor which was added at the base of the plate choke. The new fan and motor are visible to the left of the tubes. The mounting bolts were replaced with longer ones, which permitted using fender washers on the inside and outside surfaces of the intake grill. These reduced motor vibration. The small transformer above the fan motor was later moved to the opposite side of the fan because the space was needed for the larger Peter W. Dahl transformer.

Hairpin loops shunted by low-inductance resistors have self-resonant frequencies well above the VHF range and appear to work well as parasitic suppressors. The loops are typically just wide enough to allow the resistors to be soldered across the bases, and they are made somewhat longer than they are wide. I haven't seen the loop dimensions fully-defined yet, but Richard Measures, AG6K, gives a fairly complete description in his on-line paper on the TL-922 and the SB-220. (See the "Anode Circuit Modification" section of <http://www.somis.org/QSK922.html>.) Although Measures also recommends using nichrome wire for the loop, I have found 12-gauge, tinned buss wire to be satisfactory. Photo 8 shows the hairpin loops installed in this SB-220. Observing the output of the amp with a spectrum analyzer, I have found no tendency to oscillate, even under a variety of load conditions.

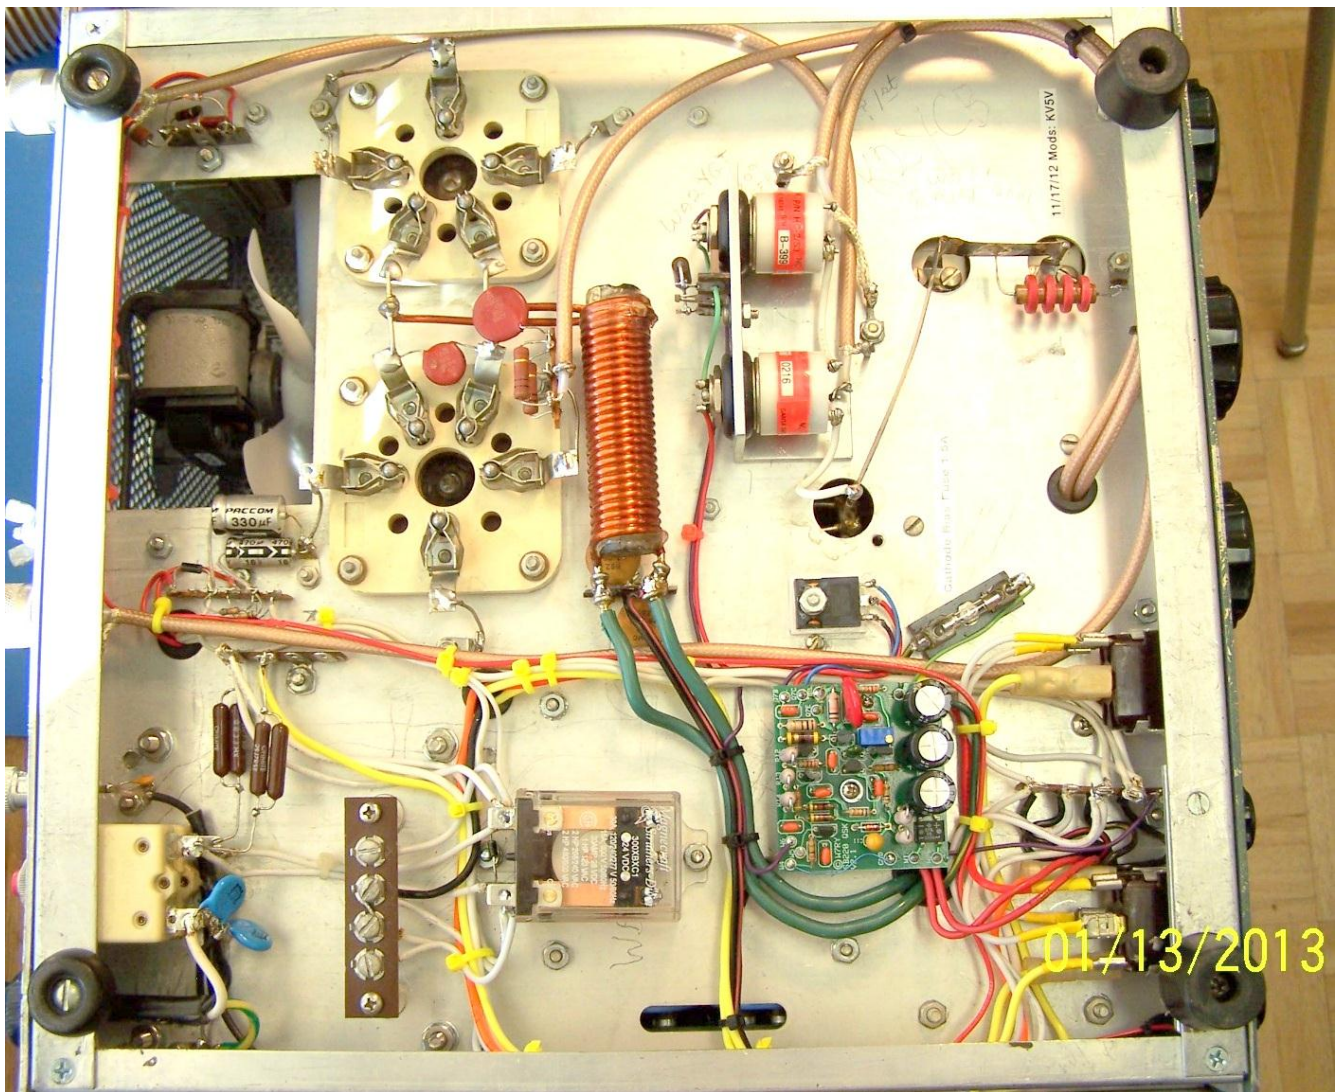
Photo 9 - The finished underside of the amp. The QSK Board is on the lower-right in this photo. The Darlington bias-control transistor and filament center-tap fuse are mounted just above it, using available chassis holes.

The QSK Board has a role in preventing catastrophic failures in the SB-220, because a failure mode of the Zener diode which controls cathode bias in the original circuit is a short circuit. When the Zener fails in this manner, the tubes are turned fully on, and damage can result when excessive current flows. The QSK Board uses a TIP147 power transistor which is protected by an MOV (a Metal-Oxide Varistor). If the transistor should fail, the voltage across the varistor would rise to its 130 Volt avalanche rating, thus biasing the tubes into cut-off. The normal failure mode for an MOV is to go open, but this only occurs after the part has been driven into conduction many times. The scheme isn't completely failure-proof, but I believe it's less failure-prone than the original circuit. The installed board is shown in Photo 9.

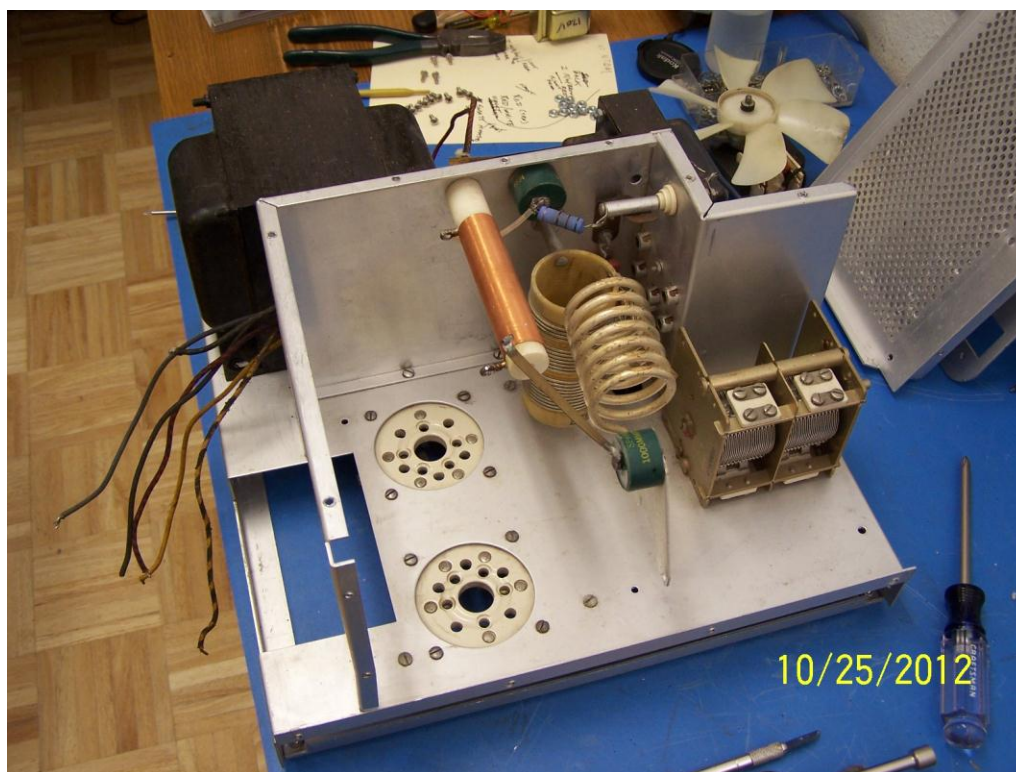
Photo 10 - Most components have been removed so that the chassis can be cleaned and old hardware can be replaced. The resistor which feeds high voltage to the bypass capacitor and plate choke was also replaced

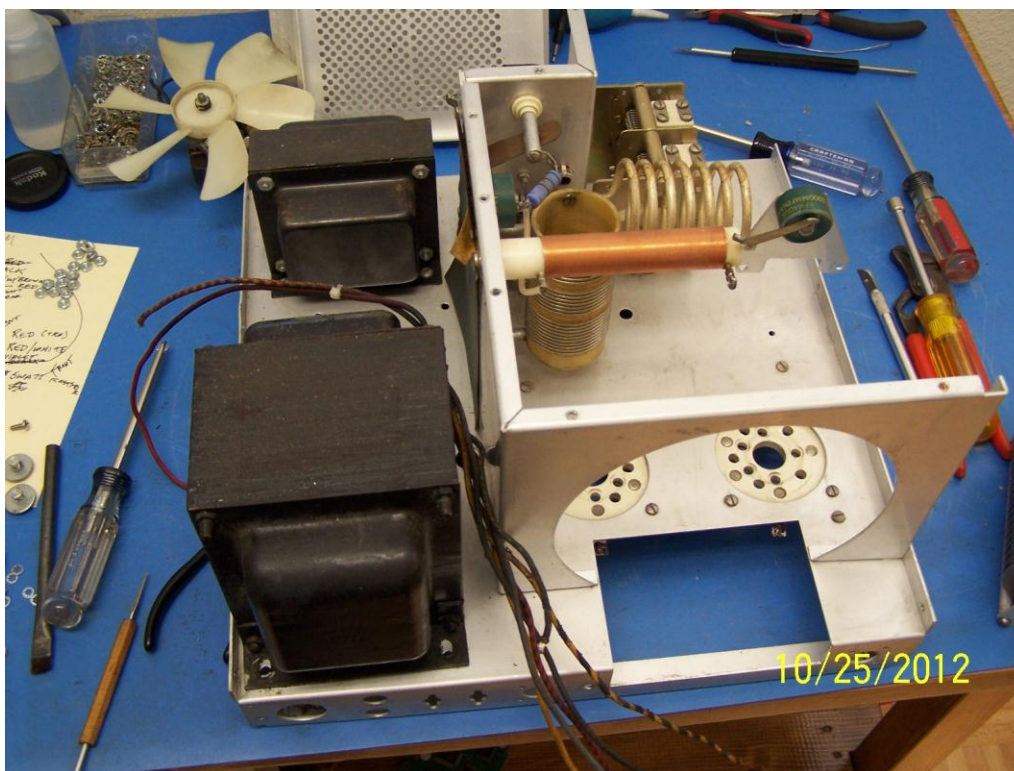
Photo 11 - Another view of the chassis, ready for rewiring. One RCA connector on the rear of the chassis was removed. The other was replaced with a BNC at the "Relay" input.

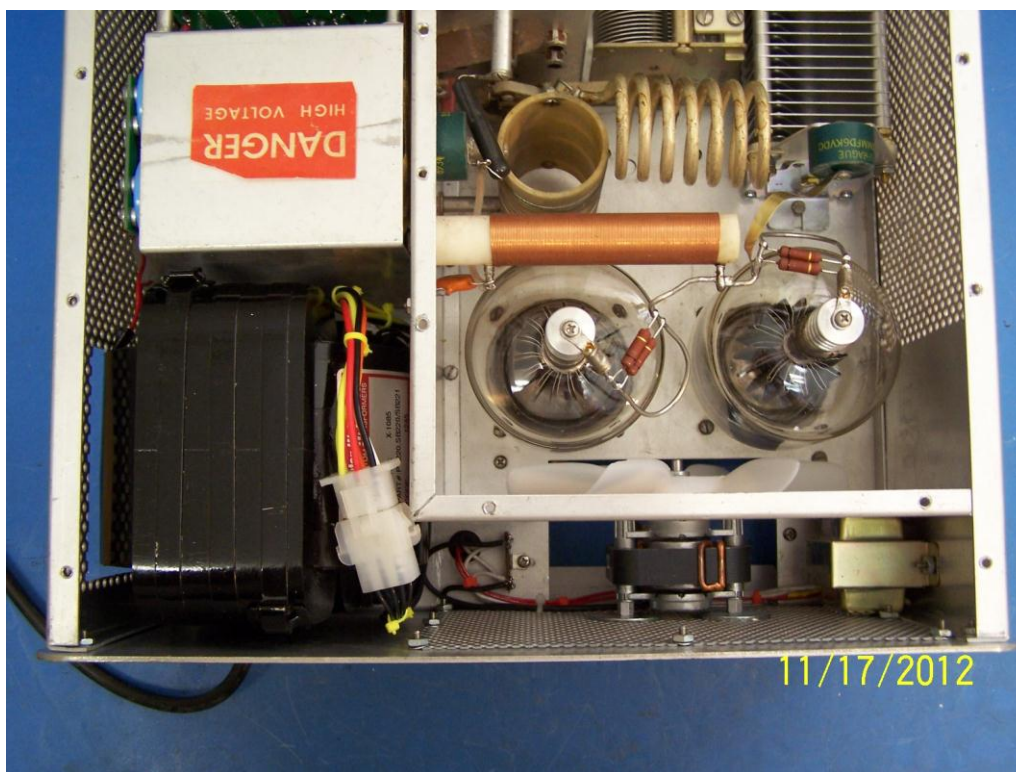
Photo 12 - This view shows the Harbach/Peter Dahl HV transformer, which is slightly larger than the original transformer. The 24 Volt transformer which supplies power for the step-start circuit has been moved to the lower-right corner to make room for the Harbach.

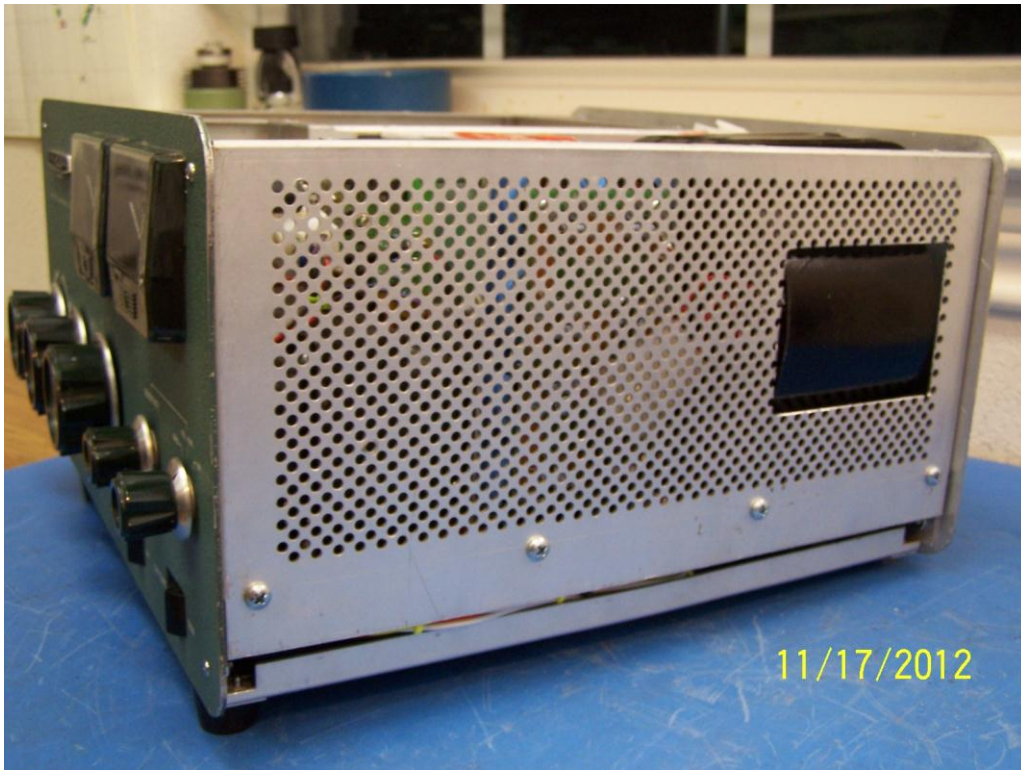
Photo 13 - It was necessary to cut a rectangular hole in the right-side panel to make room for the Harbach transformer. The transformer will not interfere with the outer enclosure for the amp.
