ENVIRONMENTAL ESSENTIALS

# Manchester Metropolitan University

Ryebank Fields  
Chorlton-cum-Hardy  
Manchester  
M21 9NS

Consultancy Report – Issued 08 June 2020

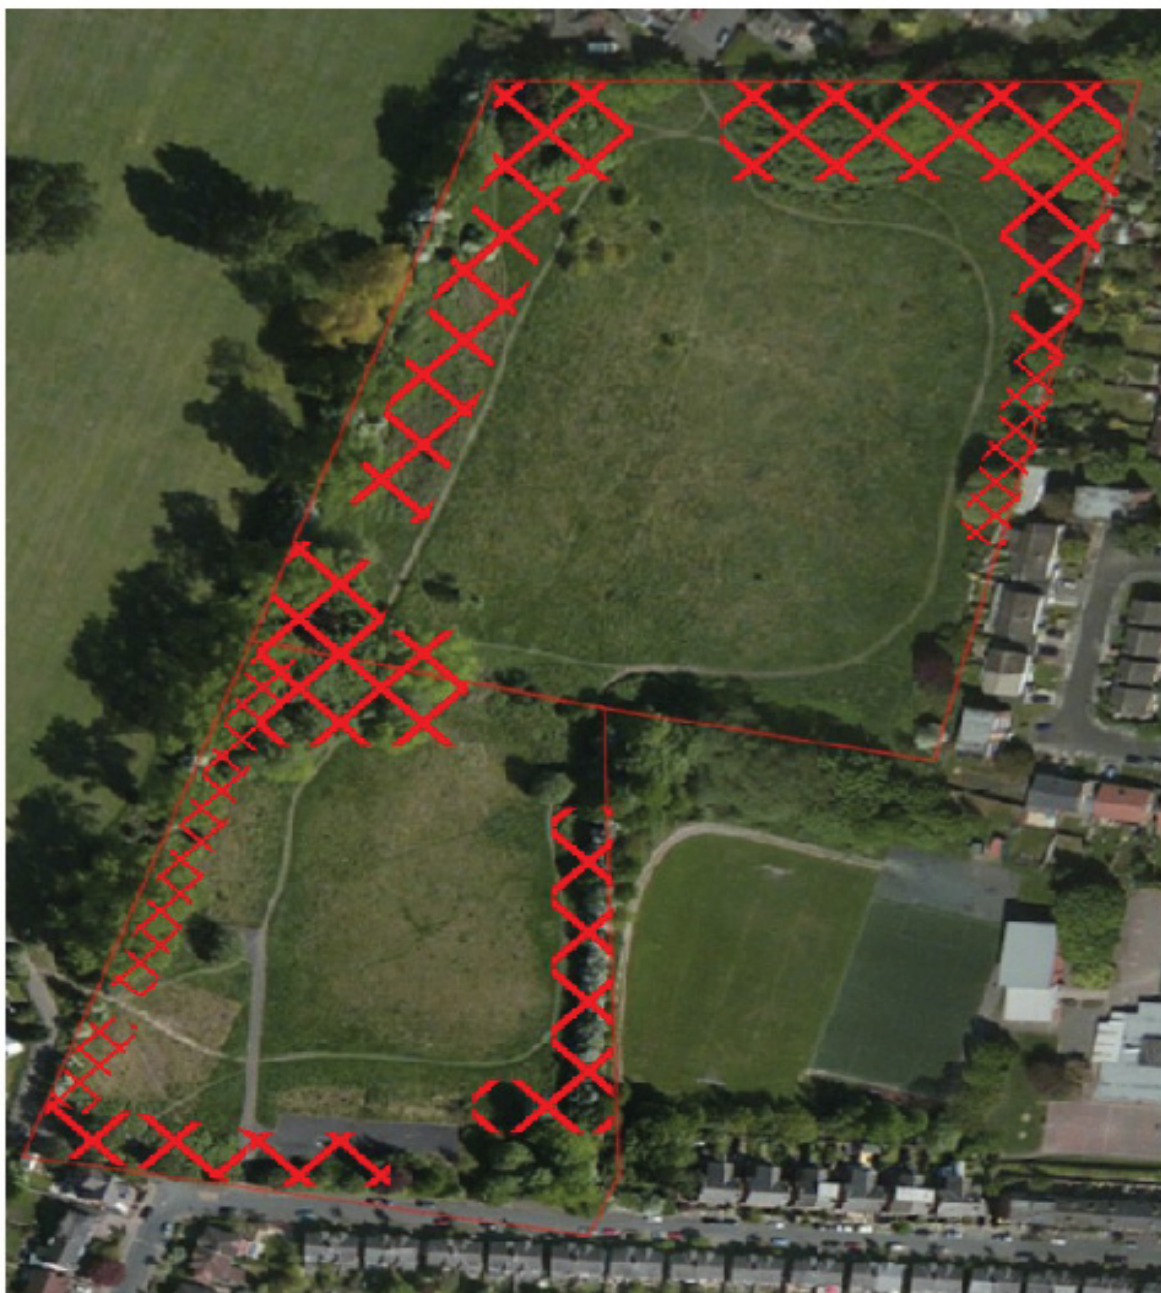
- It would be suggested that a further widespread inspection be undertaken in mid-late September, once plants etc. start to die back, but prior to trees sheading their leaves. This is important in the areas highlighted with red x symbols on the site plan below, which could not be accessed / inspected during this site visit in May 2020. Additional areas possible to inspect should be recorded on a site aerial view plan in order to update the records for the site, in terms of assessments made, and remediation planned at the earliest opportunity, should further suspect materials be identified.

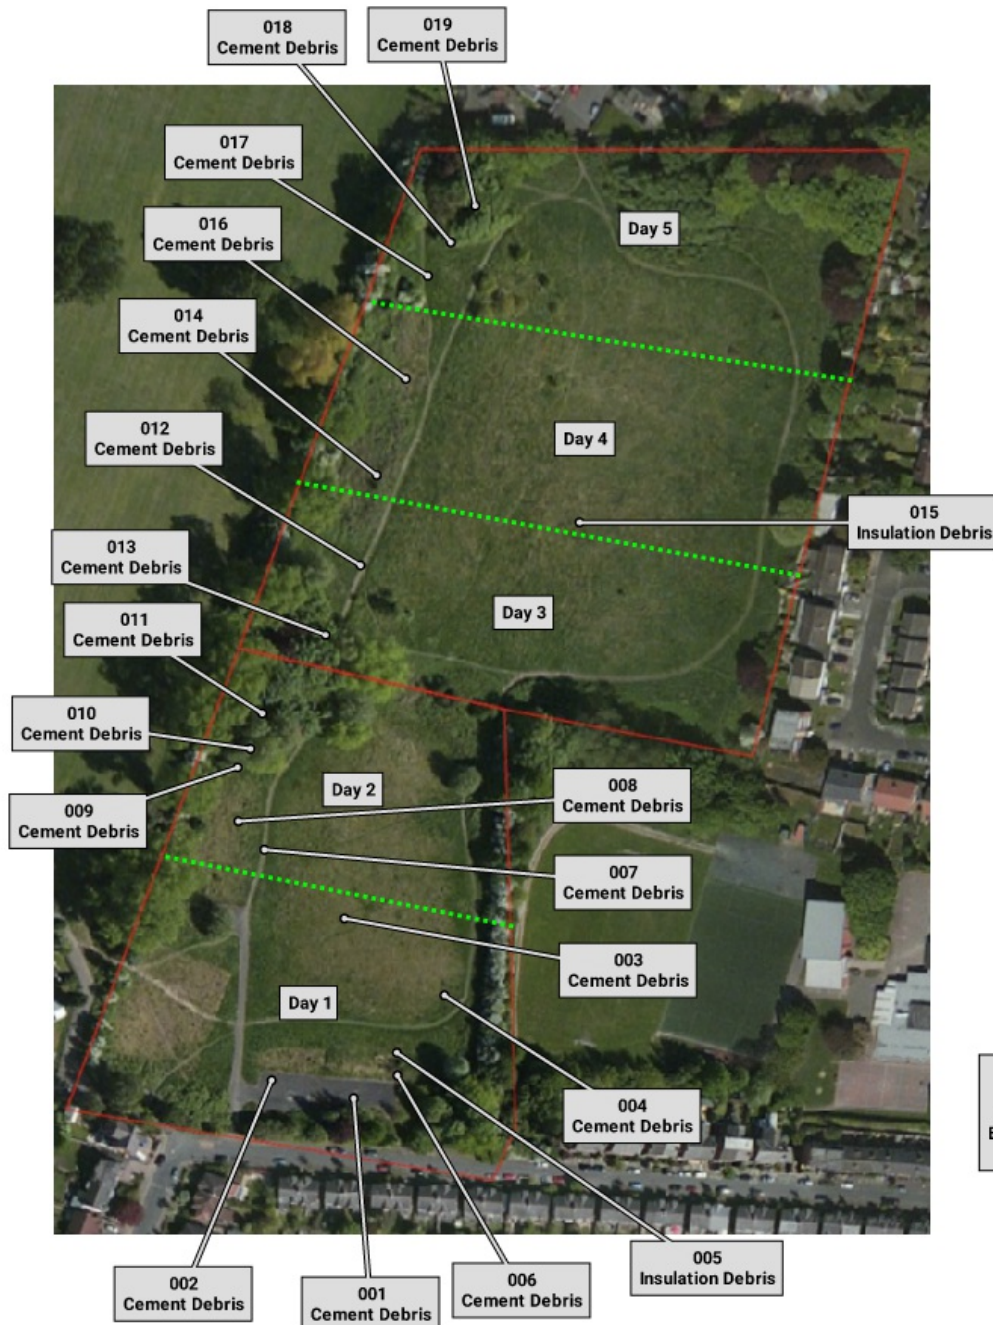
P-369565  
MMU  
Ryebank Field's  
Bulk Sampling Plan  
21-29/05/2020

In summary, asbestos cement debris proved to be widespread, although not in large quantities, throughout each grid area / day. This debris has been removed as far as practicable and where visible. Not every piece of asbestos cement was sampled, the samples were taken in representative locations to provide overall evidence of findings in each grid area, each day.

Asbestos insulation was identified, in localised areas, to the grid area on the drawing marked 'day 1' and 'day 4'. The only way to remove this material in the two locations identified, in the opinion of OPS Environmental, would be to notify the removal via ASB5 and complete under fully controlled conditions. This is to be completed at a later date and the areas were therefore made safe via temporary sealing over the insulation material with gravel and fixed sheeting.

The full bulk certificate results and associated plan which illustrates the position of each material can be found in Appendix A.

- The asbestos insulation material must be removed as far as practicable, taking the material slightly beneath the ground level and using an aggregate (such as gravel, or a layer of correx / sheeting then covered by soil) to cover the hole created and try to prevent further asbestos insulation in these immediate areas from working their way back to the surface.

- Until such point that the asbestos insulation material be removed, it is suggested that a weekly inspection be made to ensure the temporary making safe measures remain in tact. Such inspections should be recorded.

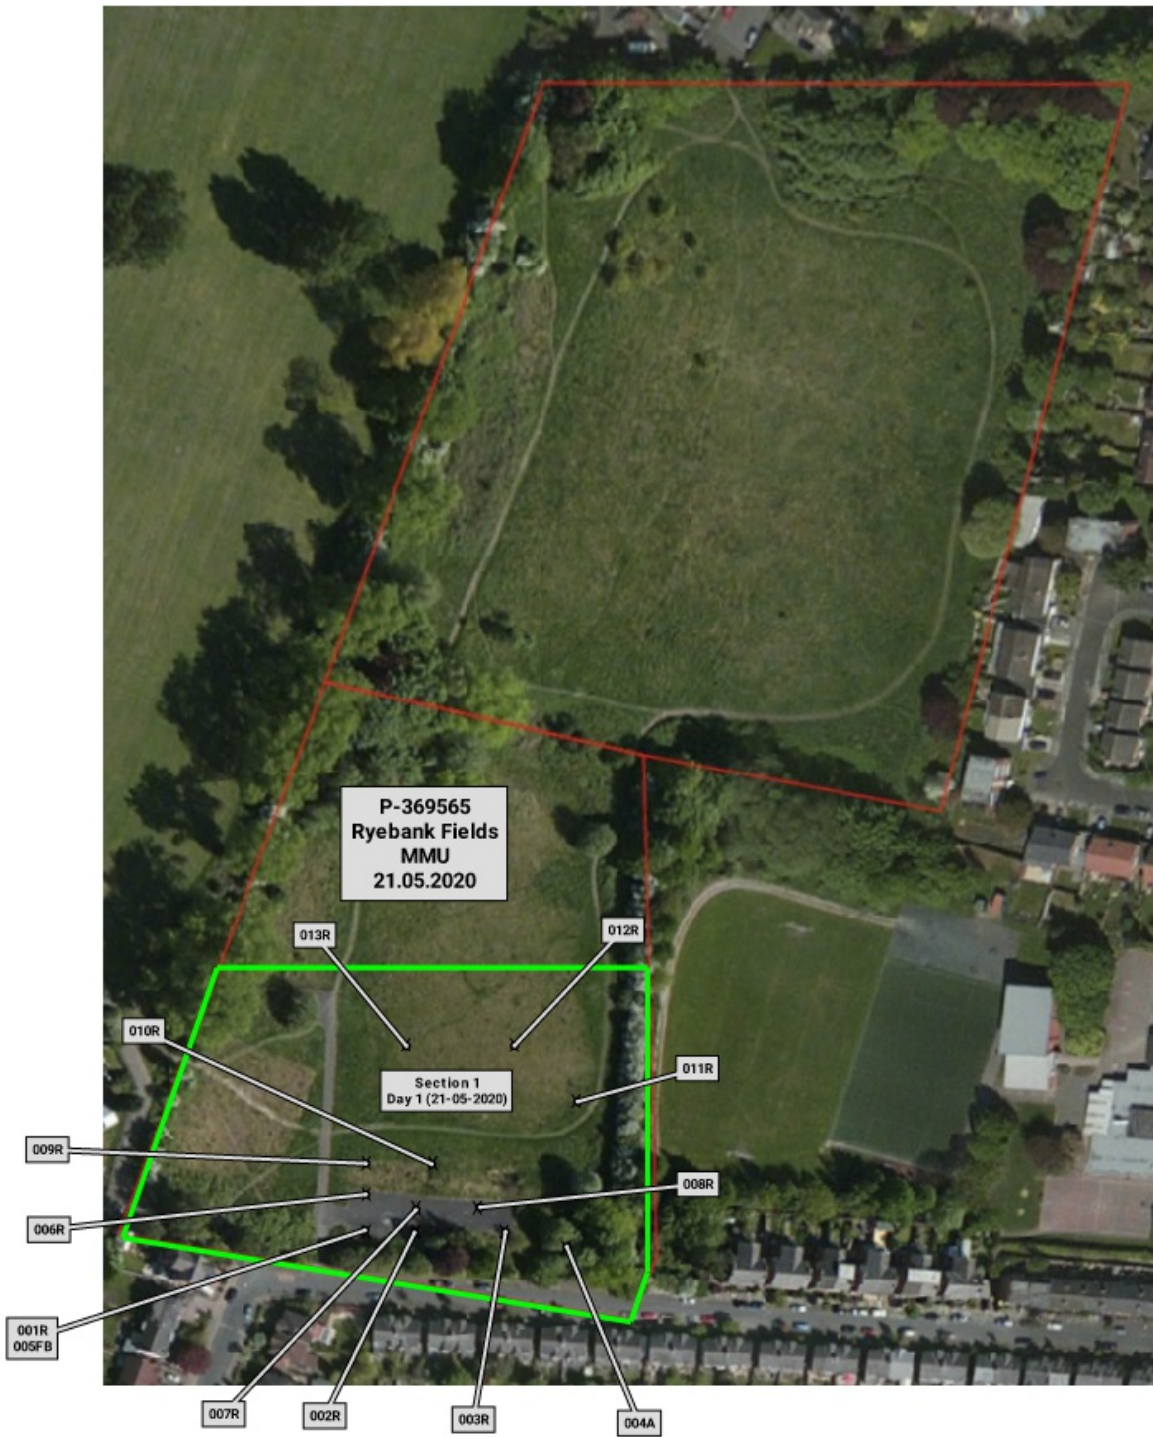
Client Name and Address:	Manchester Metropolitan University, 99 Oxford Road, Manchester, M1 7EL, ,	Project Number:	P-369565
Site Address:	Ryebank Fields, Chorlton-cum-Hardy, Manchester, M21 9NS	Certificate Number:	20200521/JLO/001

Static reassurance air samples were taken over the course of 6 days. These were positioned in various locations, taking into consideration, wind direction, perimeter of work zones, close proximity of removal work being undertaken etc. These air tests provide a range of information, including the ambient fibre levels in the air, within the boundary of the field areas.

All static reassurance air test results, including those taken in close proximity to the insulation materials identified, proved to be satisfactory, being below the limit of quantification.
