A. INTRODUCTION

SBStruc Engineering conducted destructive testing, non-destructive testing, and foundation excavation on the existing ^{number of storey} three-storey school building, ^{building name} **Kapitan Eddie T. Reyes Integrated School – Phase 2**, located in ^{building location} **Brgy. Pinagsama, Taguig City**.

Kapitan Eddie T. Reyes Integrated School – Phase 2

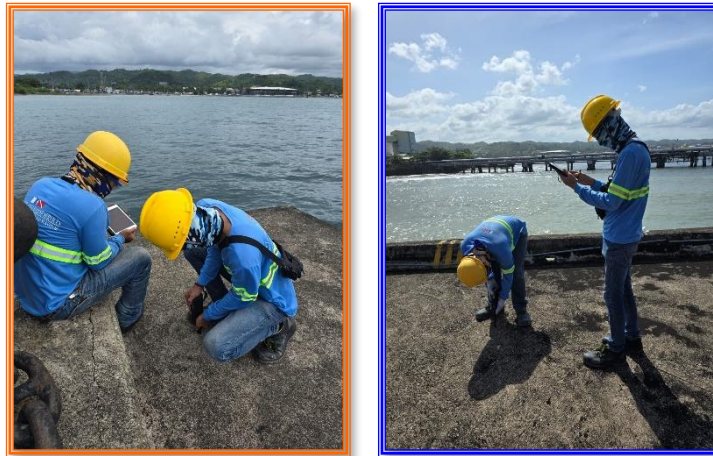
Figure B.2. Rebound Hammer Tests

strength, as indicated by the measured Q-values. A total of **eighteen (18) test locations** were evaluated and distributed across the structure. At each test location, ten (10) rebound hammer impacts were applied in accordance with standard testing procedures consistent with ASTM C805. The rebound numbers obtained were statistically analyzed, with mean values calculated for each structural member. A summary of the rebound number test results is presented in **Annex II**.

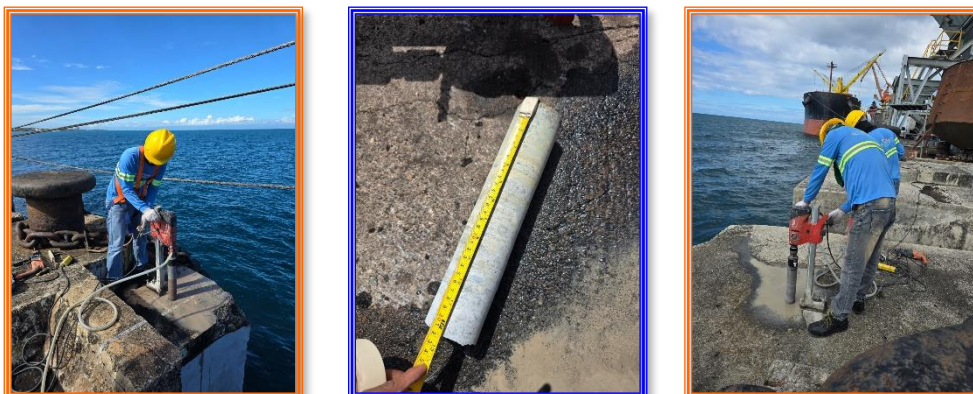
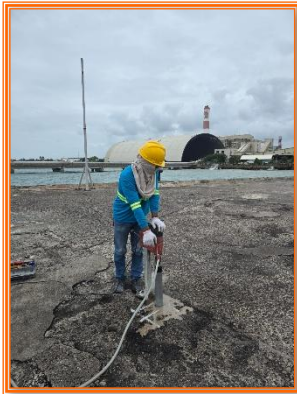
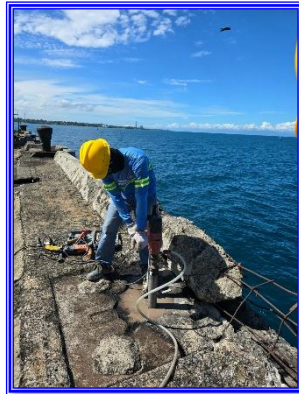
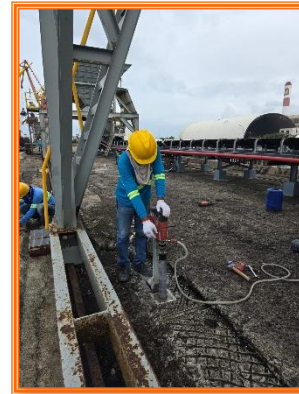
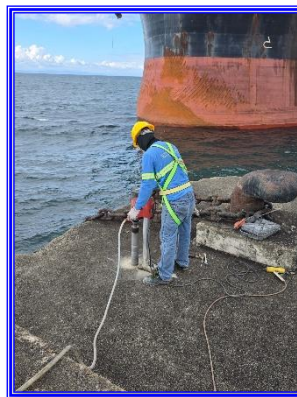
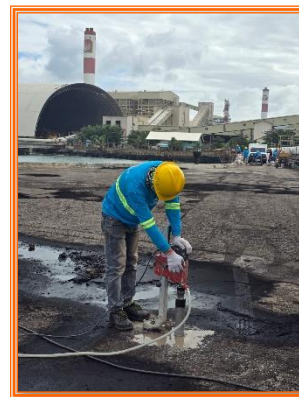
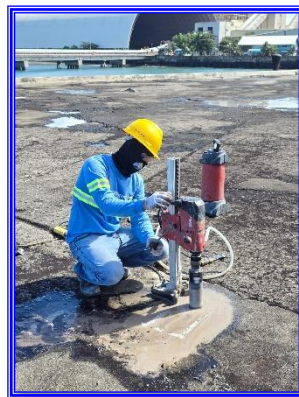
*Figure B.3.1 Concrete Core Extraction*

Concrete core extraction was conducted on selected structural members to obtain representative samples of the building's in-situ concrete. A total of **eight (8) cores** were extracted. The specimens were used to assess concrete quality, including compressive strength and overall material condition. Compressive strength testing was performed in accordance with ASTM C42/C42M, and the corresponding results are presented in **Annex III**.

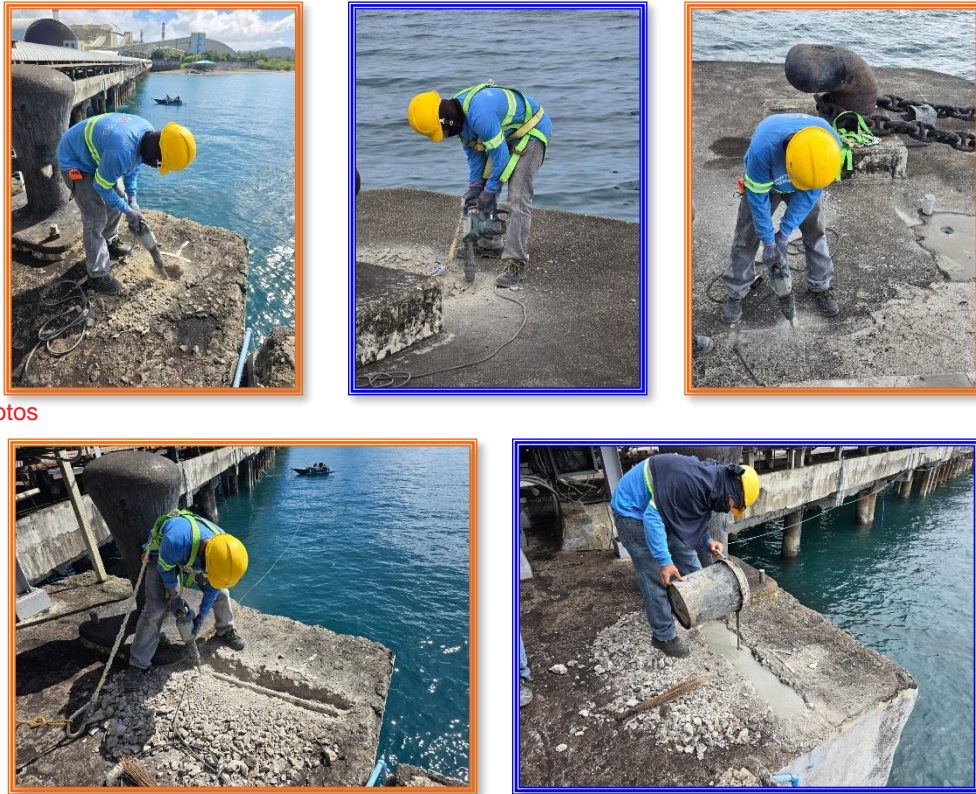
Figure B.4.1. Rebar Extraction

Rebar extraction was carried out on selected structural members to obtain representative reinforcement samples from the building's structural system. A total of **two (2) rebar samples** were extracted.

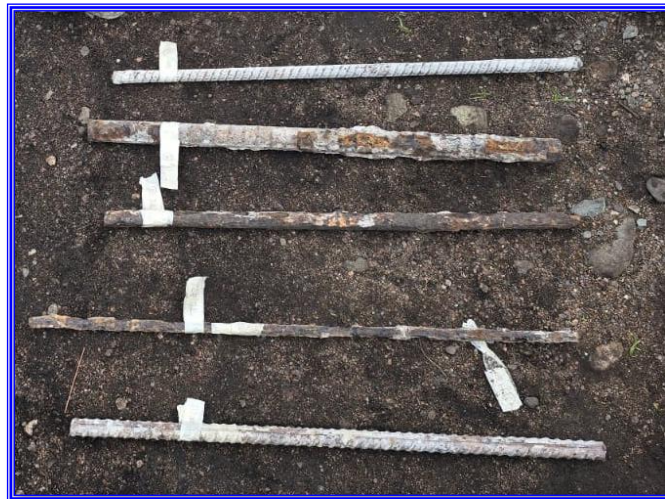
**Figure B.4.2. Extracted Rebar Samples**

The extracted rebars were evaluated to determine their material properties, including tensile strength. The tensile test results are presented in **Annex IV**.
