AT+Mock-1:50-3.rma6

Damage plot for Bacillus_anthraxis node

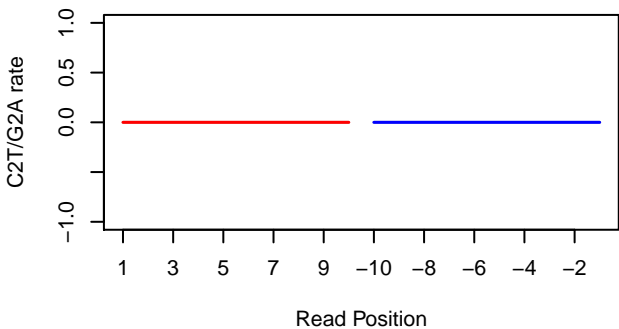
Node	Bacillus_anthraxis
Top Reference	Bacillus_anthraxis_str._CDC_684
assigned reads	4
all reads	4
nonDup	4
readDis	0.495
nonStacked	2
destacking?	On
C>T_1	0
G>A_-1	0
mean length (sd)	74 (2.121)
