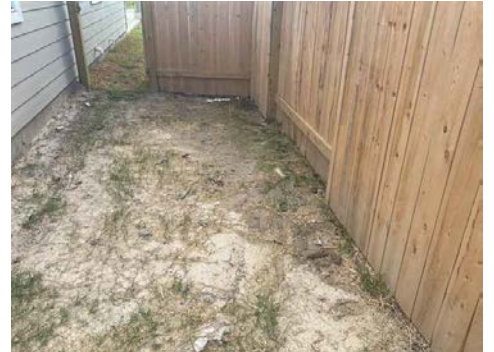
LEFT SIDE OF HOME NEAR PROPERTY LINE.

STANDING WATER

Standing water observed, which could indicate poor drainage and/or grading. Recommend monitor and/or have landscaper correct.

Contact a qualified professional.

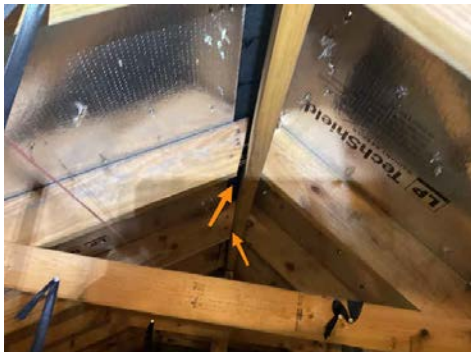
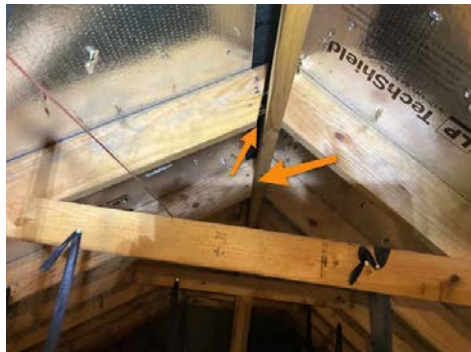
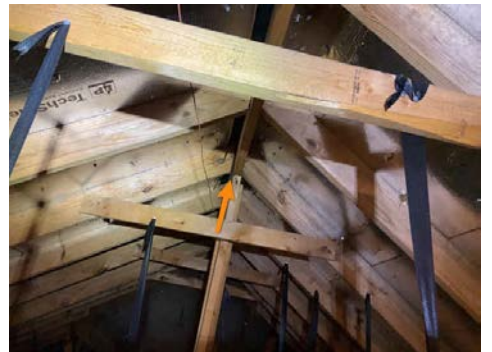
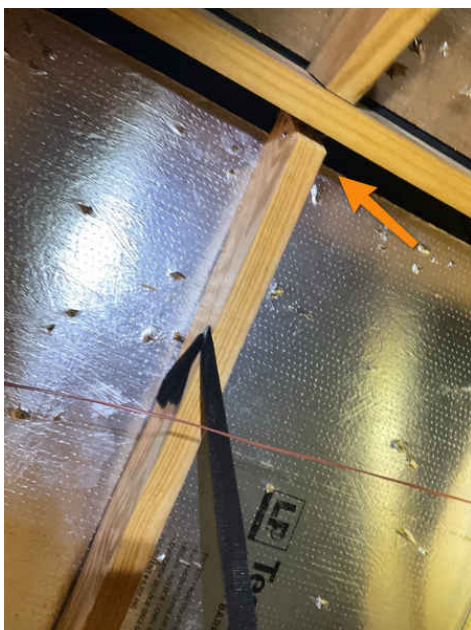
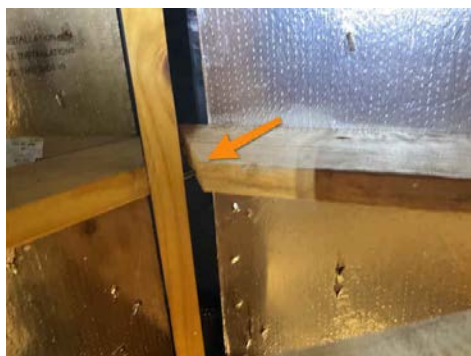
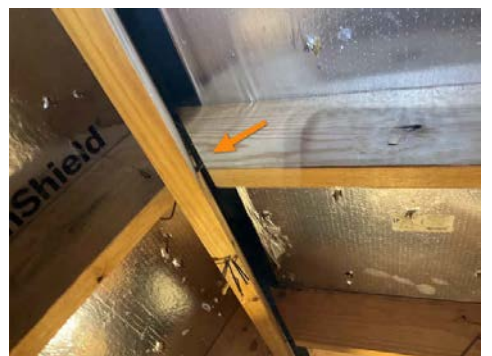
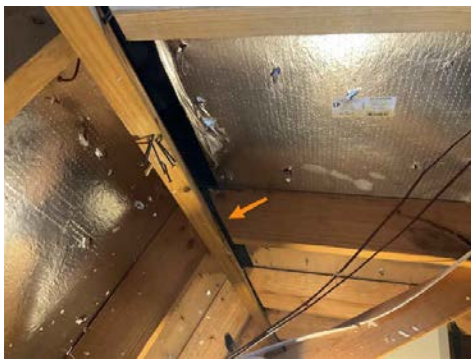
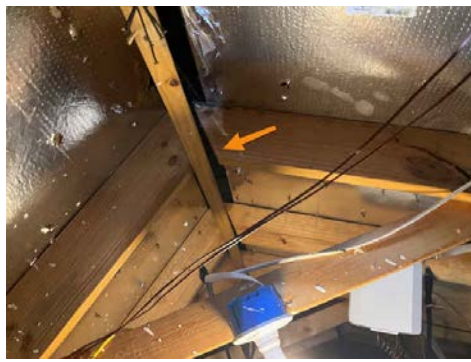
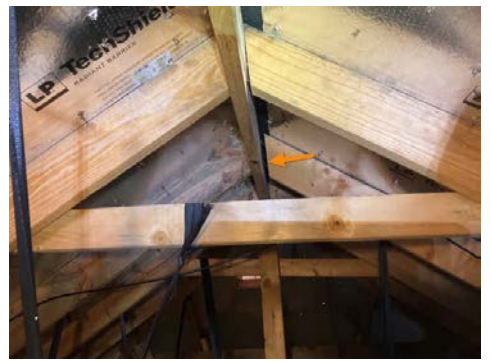
GAPS IN ROOF FRAMING AT RIDGEBOARD

At the time of today's inspection there are gaps that exceed one half inch on a number of the roof structural framing members at the ridge board. Recommend reinforcement or correction by the builder.

Contact your builder.

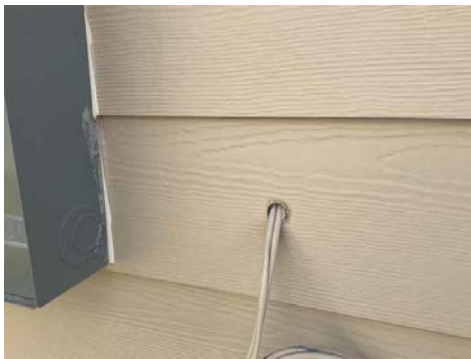
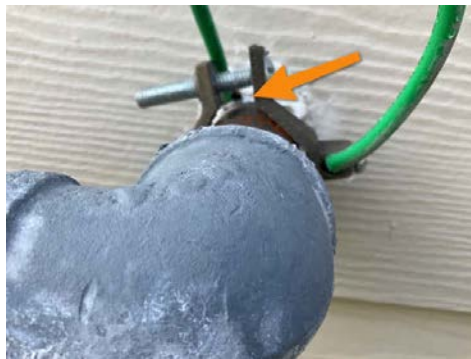
SEAL GAPS AND UTILITY PENETRATIONS

Gaps and or cracks and holes were observed in the siding and exterior finish at today's inspection. I recommend that you see all these to keep water insects and vermin out of the walls and structure. A gap 1 finger wide is large enough for mice and insects to enter. A gap 2 fingers wide is large enough for rats to enter.

Contact a qualified painting contractor.

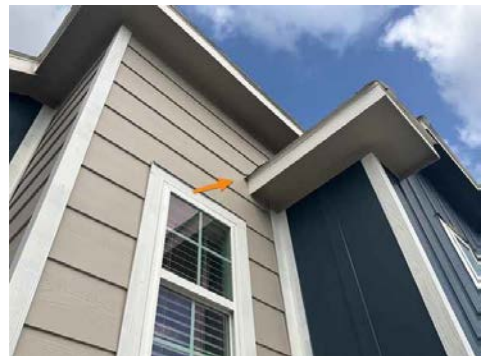
MISSING KICK OUT FLASHING

At the time of today's inspection some of the siding was missing kick out flashing where it drains adjacent to a vertical wall.

Contact a qualified roofing professional.

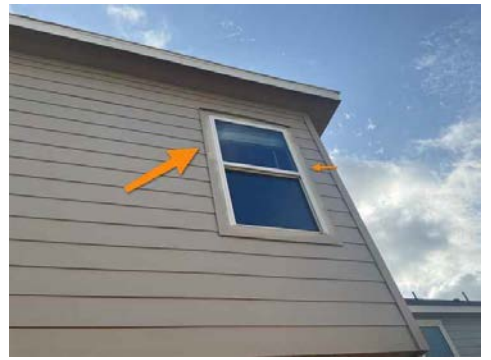
PAINT NEEDS TOUCHED UP

At the time of today's inspection some pieces of the siding did not have paint on them. In accordance with the manufactures instructions the primer is only rated for so many days of outdoor exposure before it must be painted. The siding material may deteriorate if it is not painted in accordance with the manufactures instructions.

Recommendation
Contact your builder.

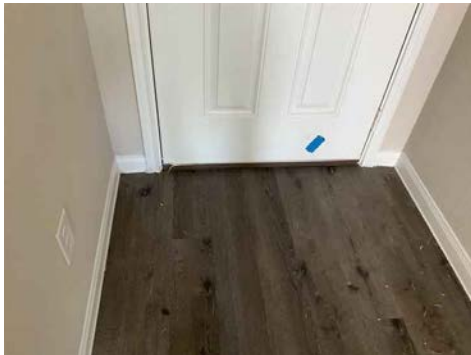
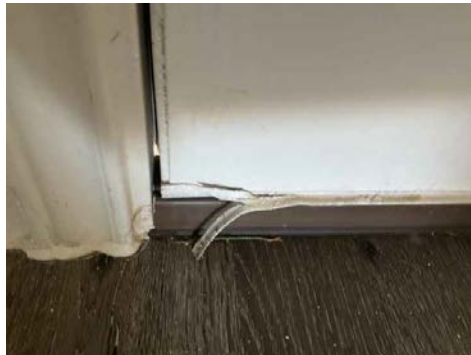
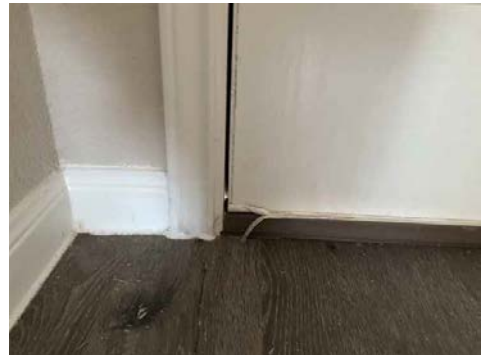
FRONT DOOR

WEATHERSTRIPPING NEEDS IMPROVEMENT

The weatherstripping at one or more of the exterior doors needs improvement.

Contact a handyman or DIY project

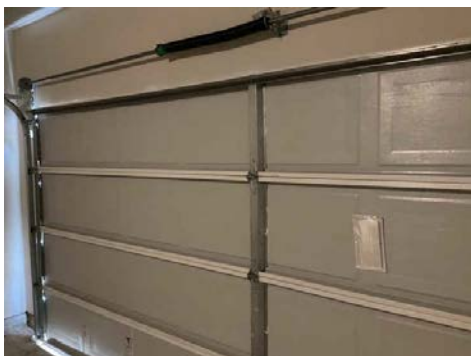
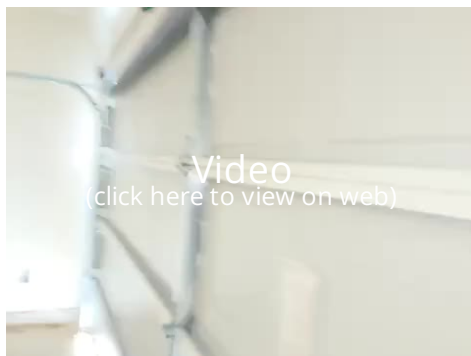
GARAGE OVERHEAD DOOR NOISY

Edit the time of the inspection the overhead garage door pops when it is opened or closed. The noise appears to be coming from the top panel.

Contact your builder.

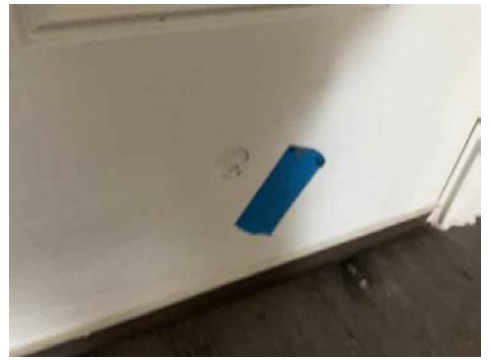
FRONT DOOR - INNER SIDE

SURFACE DAMAGE TO DOOR

At the time of today's inspection there was surface damage on one or more of the doors.

Contact a qualified door repair/installation contractor.

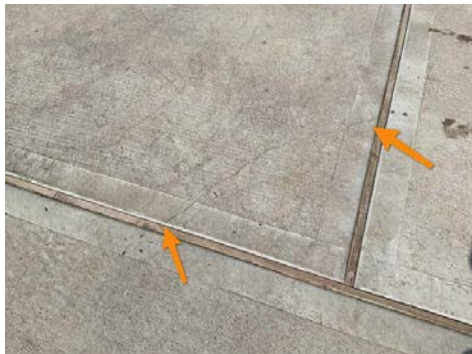
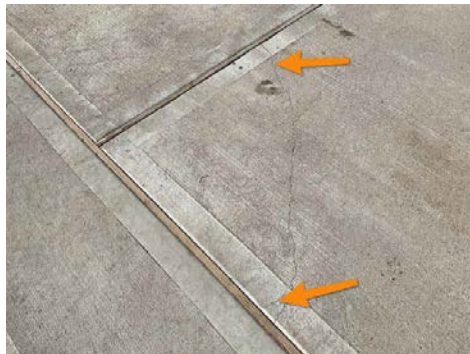
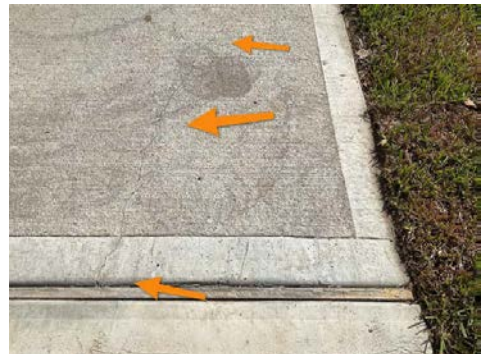
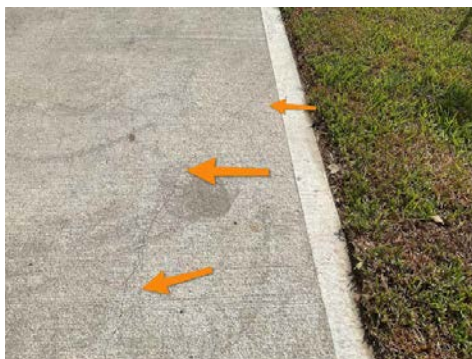
DRIVEWAY: CRACKS IN PANELS

At the time of today's inspection there were cracks observed in the panels of the driveway. These are not present in the neighboring driveways.

Contact your builder.

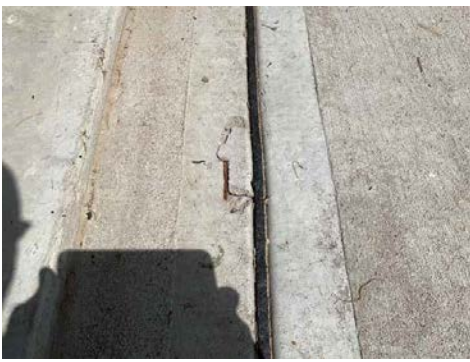
SPALLING AT GARAGE ENTRANCE

Spalling at garage entrance was observed

Contact your builder.

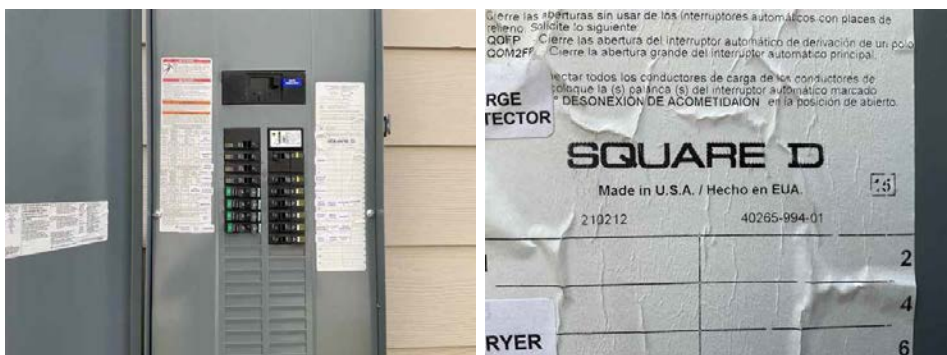
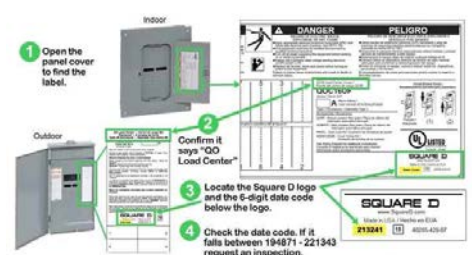
PANELS: PANEL MAY BE RECALLED

At the time of today's inspection a Square D electrical panel was installed. There is a strong possibility that this panel is part of a recall due to manufacturing errors. I recommend that you contact Square D and have them verify if this panel is recalled or has already been inspected/serviced. If this panel is part of the recall I recommend that you pursue having Square D address any deficiencies with the panel. It is outside the scope of today's inspection to determine if this panel is subject to a recall.

Your panel was made at Plant 15, and on a date that is involved in the recall. I recommend contacting Square D to schedule a recall inspection.

Contact a qualified electrical contractor.

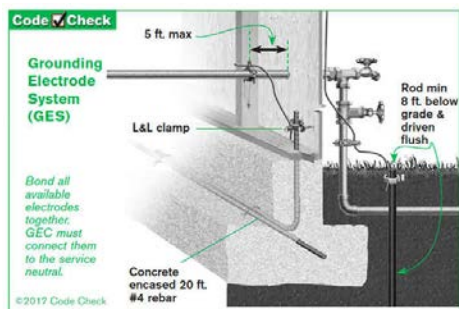
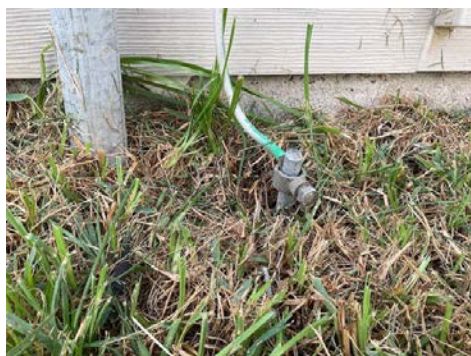
GROUNDING: GROUND ROD NOT DRIVEN FLUSH

The ground rod should be driven flush.

IRC E3608.1.4.1 - Regarding Rod electrodes: The upper end of the electrodes shall be flush with or below the ground level except where the above-ground end and the grounding electrode conductor attachment are protected from physical damage.

Code illustration showing proper Ground Rod Installation Requirement.

Contact a qualified professional.

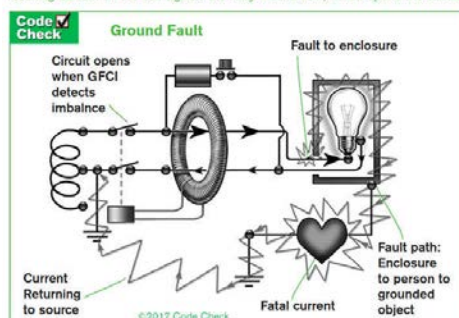
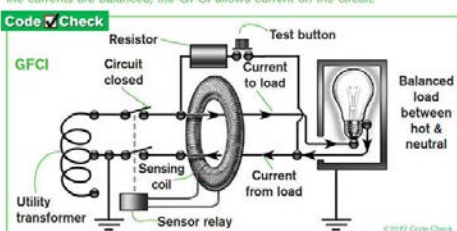
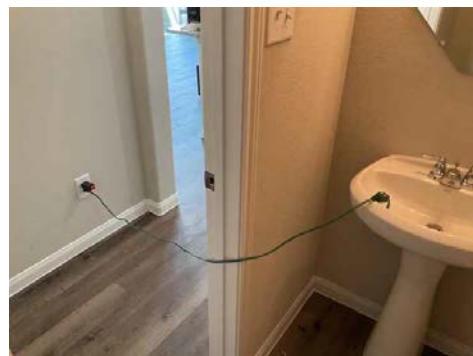
DOWNSTAIRS HALF BATHROOM

DEVICE SAFETY: GFCI OUTLETS MISSING FROM REQUIRED LOCATIONS

Outlets within 6 feet of edge of sink

Under the TREC Inspection Standards it is a deficiency if any of the following areas are not protected by GFCI devices: bathroom receptacles, garage and accessory building receptacles, outdoor receptacles, crawlspace receptacles and lighting outlets, kitchen countertop receptacles and receptacles located within 6 feet of the outside edge of a sink, shower, bathtub, laundry room receptacles, indoor damp/wet location receptacles, kitchen dishwasher receptacle, and circuits serving electrically heated floors.

During a ground fault more current flows to the load than from the load. This differential creates a magnetic field that induces voltage on the sensing coil. The resulting current on the coil signals the relay mechanism, which opens the circuit.

Below, equal currents are flowing to & from the load. The magnetic fields generated by the flow of electrons in these 2 conductors are of opposite polarity & their magnetic fields cancel each other. The circuit passes through a coil of wire inside the GFCI & the GFCI accounts for the electrons on each conductor. As long as the currents are balanced, the GFCI allows current on the circuit.

How GFCI's work Illustration

GFCI Circuits protect people from electrical shocks that can result in death or injury. I recommend that you have outlets and devices upgraded with GFCI protection by a qualified electrician.

Contact a qualified electrical contractor.

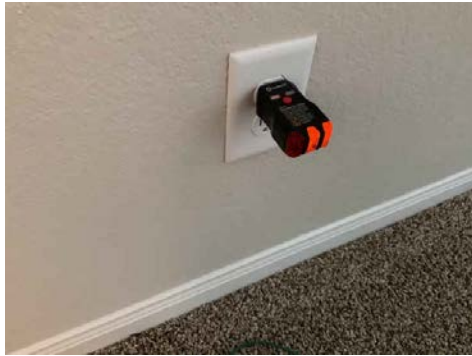
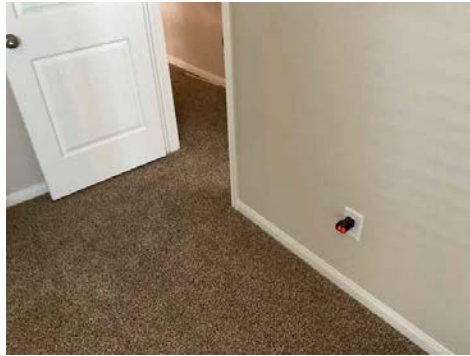
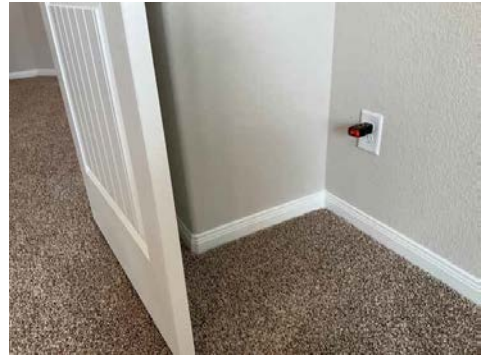
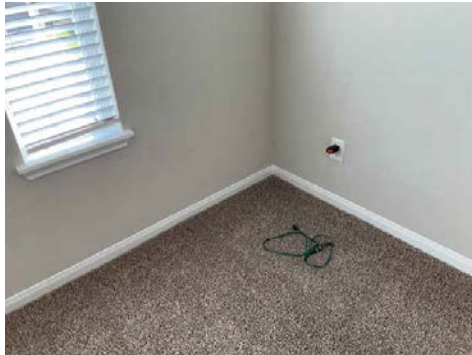
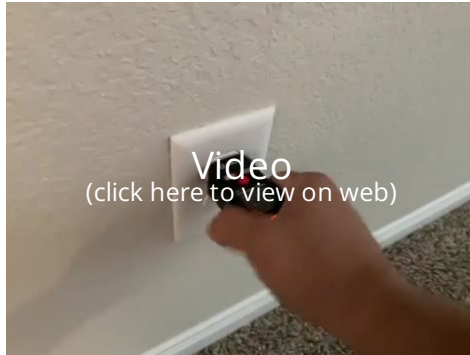
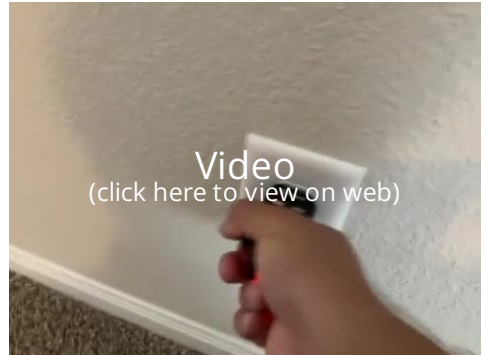
OUTLETS: LOOSE OUTLET

One or more of the outlets was loose at the time of the inspection.

Contact a qualified electrical contractor.

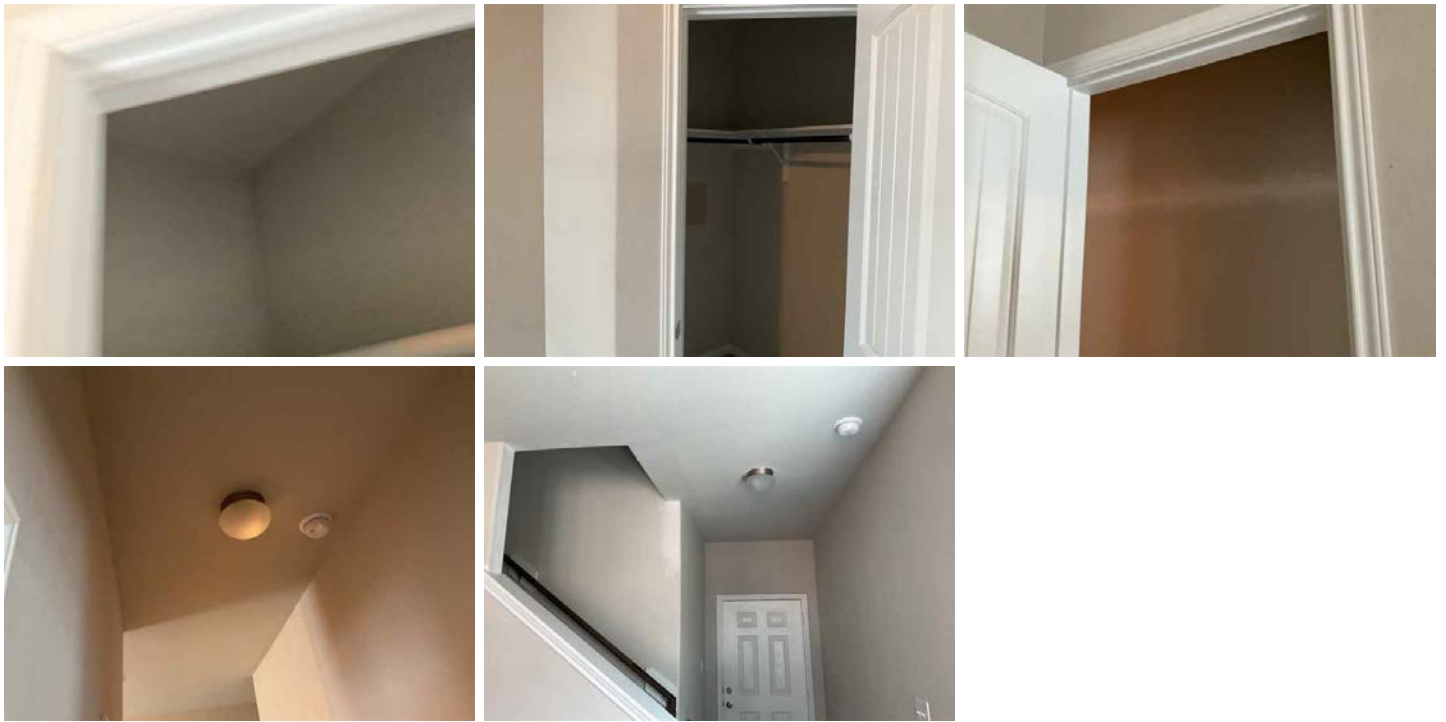
Bulb Not Lit

LIGHTS: LIGHT NOT WORKING

At the time of today's inspection one or more of the light fixtures was not operating properly. The fixture may need the bulb installed, replaced, or there may be something else wrong. Bulb replacement is a Handyman / DIY activity. I recommend that a qualified electrician be used for diagnosis, repair, or replacement of light fixtures.

Contact a handyman or DIY project

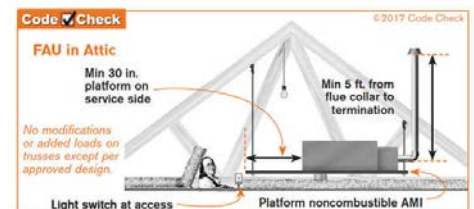
4.1.1 A. Heating Equipment **LACKS SERVICE PLATFORM**

At the time of today's inspection the HVAC system did not have a 36 inch deep service platform directly in front of the unit. The current condition makes it difficult to access the system and poses a hazard to service personnel. The current system installation location does not meet current building codes. Builder should close the gap between the platforms to provide a safe working platform as required by building code.

Illustration showing where platform should be.

Recommendation
Contact your builder.

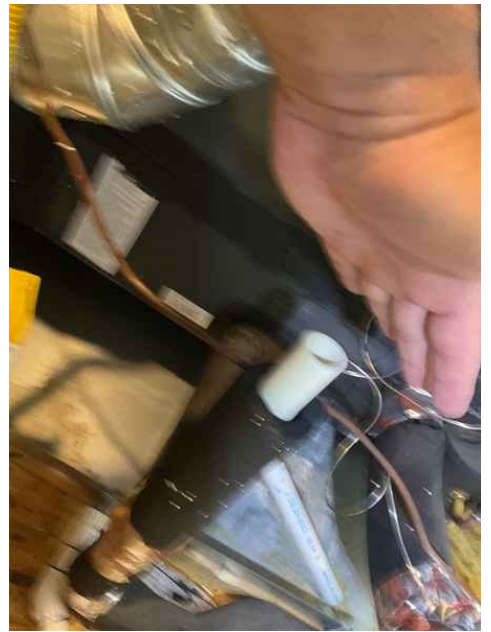
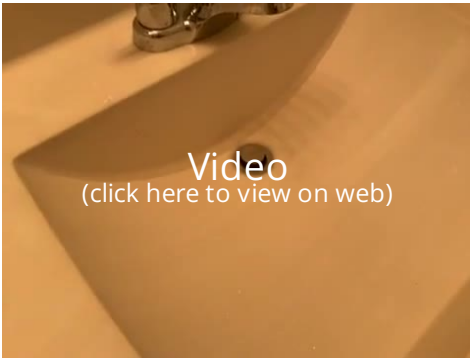
4.2.1 B. Cooling Equipment **CONDENSATE DRAIN TRAP NOT INSTALLED PROPERLY**

At the time of today's inspection the condensate drain trap was not installed properly. Recommend correction to comply with international mechanical code. The trap should be sealed to the attic space. And should be deep enough that it does not get pulled empty or blown empty by the unit running.

Trap discharge gurgles in upstairs hall bathroom when heater is running.

Recommendation
Contact a qualified HVAC professional.

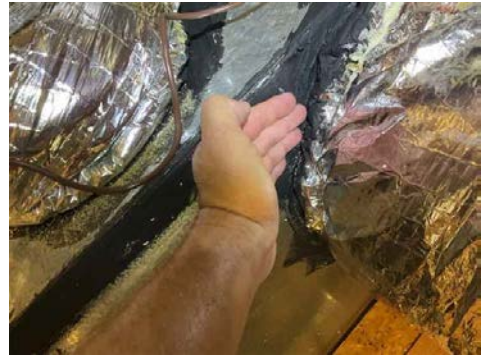
DUCT LEAKING

Air supply duct was leaking air. Recommend a qualified HVAC technician or vents & ducts contractor repair. Minor leak at plenum collar.

Recommendation
Contact a qualified HVAC professional.

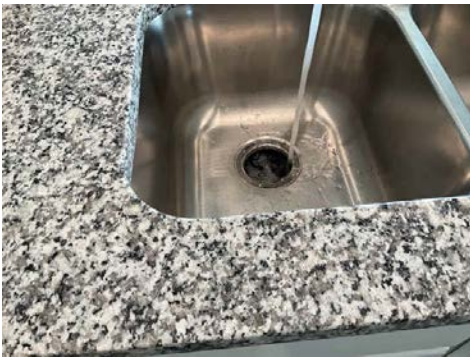
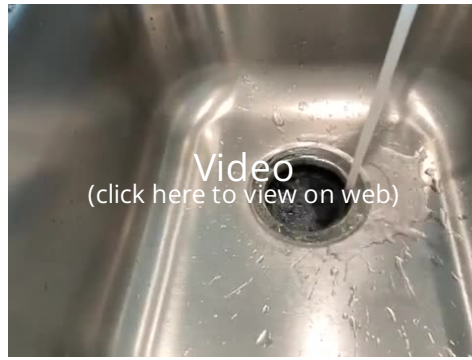
EXCESSIVE NOISE

Garbage disposal was excessively noisy. Recommend a qualified plumber evaluate and repair.

Recommendation
Contact a qualified handyman.

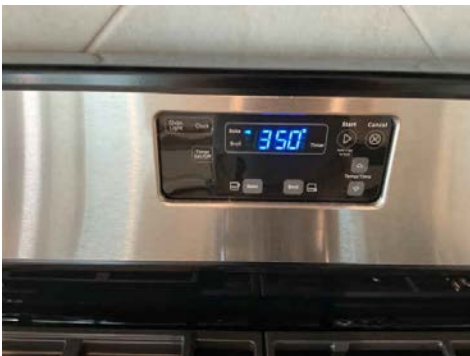
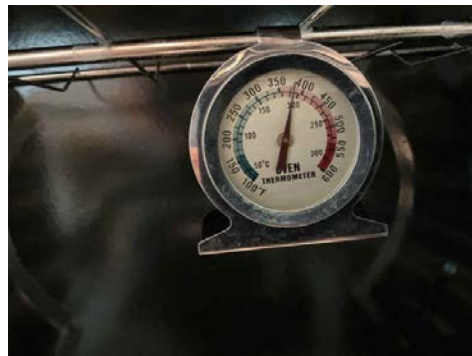
OVEN TEMPERATURE NOT ACCURATE

The oven was set to 350F. The oven was more than 25 degrees above or below this number after adequate time to warm up. This is a deficiency under TREC standards. There may be one or more ways to address this including, but not limited to:

- Adjust the temperature of what you are cooking and use an oven thermometer
- Calibrate the oven with a thermometer following the manufacturer instructions
- Have the oven repaired by a qualified contractor
- Replace the oven with one that will hold temperature accurately.

Contact a qualified professional.
