REPLY TO: 2520 Watershed Protection  
5130 Fire Suppression

SUBJECT: Boswick Fire Rehabilitation

TO: Bozeman District Ranger

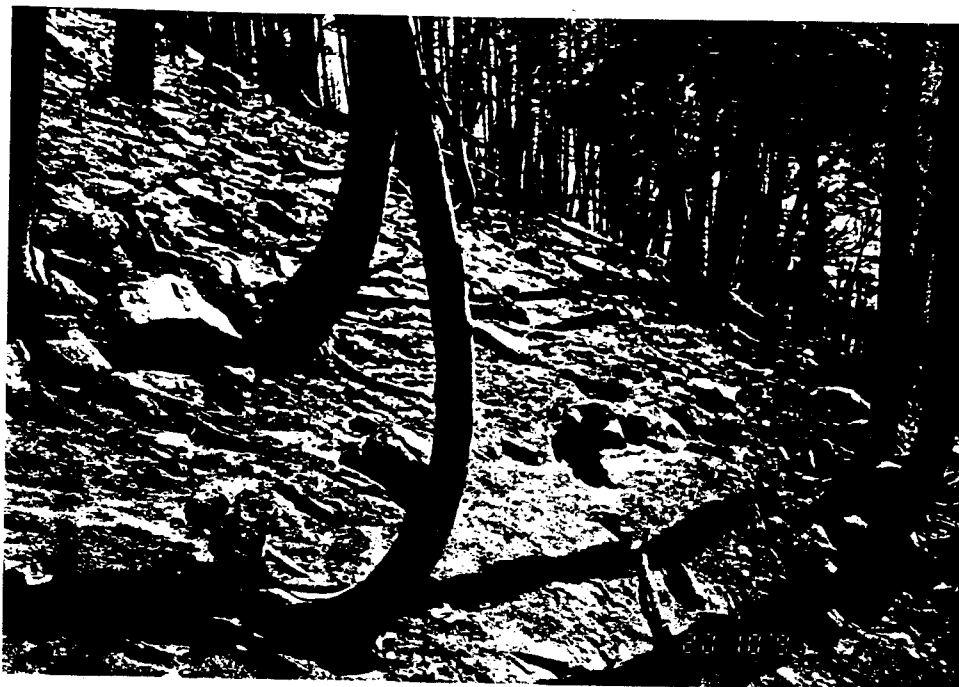
Most of the upper slopes in the Boswick fire are very rocky. Some surface erosion will occur until vegetation is re-established but these rocky areas were not considered suitable for rehabilitation because of the difficulty (and questionable cost effectiveness) in constructing log erosion barriers and insufficient soil development for effective seed catch.
